## UPPER COWL SIDE REINFORCEMENT REMOVAL [PANEL REPLACEMENT]

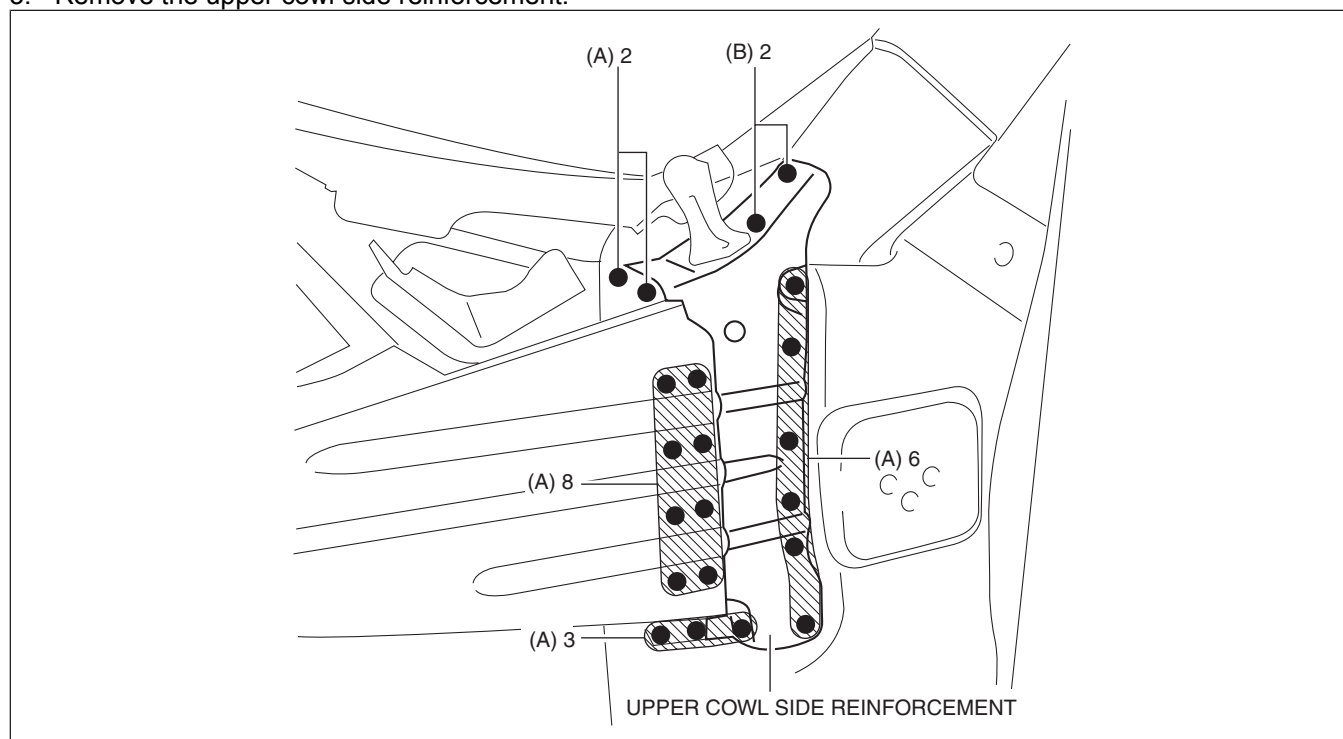
ac5wzb000000264

1. Drill the 13 locations indicated by (A) shown in the figure.
2. Drill the 8 locations indicated by (B) shown in the figure.

- When a drill the 8 locations indicated by (B) shown in the figure, the through hole is not made in consideration of the workability at the installing.

3. Remove the upper cowl side reinforcement.
