STEERING SHAFT INSPECTION

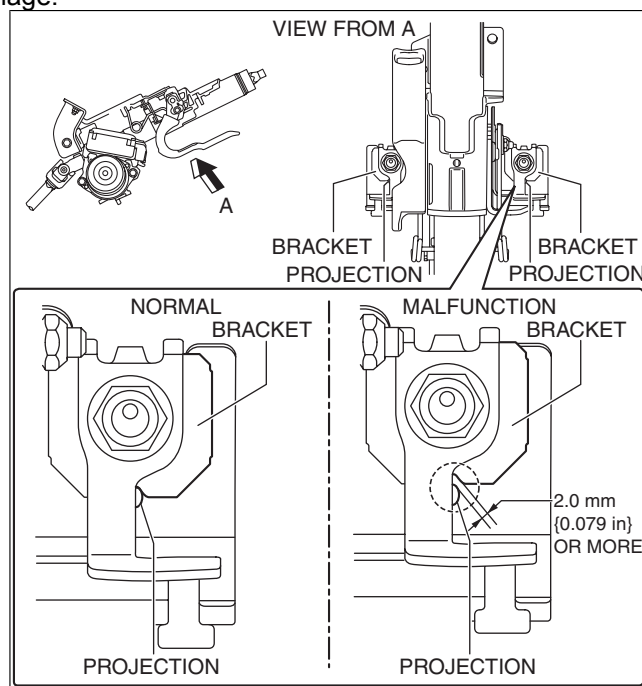
ac5uuw00002726

1. Inspect the steering column for excessive play and damage.
2. Verify that the clearance between the projection on the steering column shown in the figure and the bracket is **less than 2.0 mm {0.079 in}**.
 - If the clearance between the projection and bracket is **2.0 mm {0.079 in} or more**, replace the steering column component.

- If the clearance between the projection and bracket is **2.0 mm {0.079 in} or more**, the impact absorbing mechanism of the steering column will operate, therefore it is necessary to replace the steering column component.

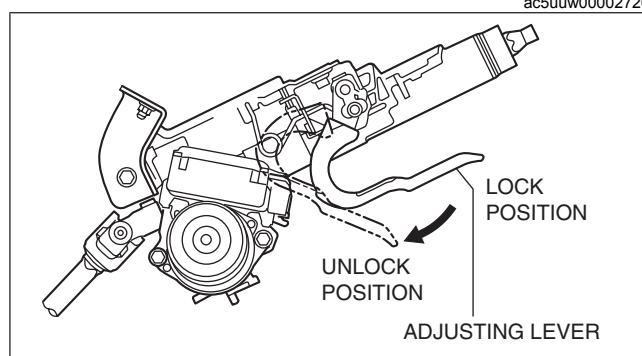
ac5wzw00001031

3. Inspect the tilt/telescope mechanism operation for the following:
 - (1) The adjusting lever moves smoothly from the lock to the unlock position.
 - (2) The steering shaft is fixed firmly when the adjusting lever is locked.
 - If there is any malfunction, replace the steering column.
