## **Technical Service Information**

## NISSSAN E/L4N71B BELLHOUSING LEAK

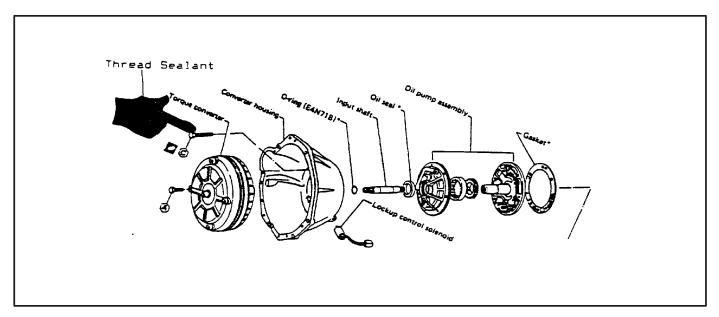
Figure 1

**COMPLAINT:** Oil leaking out of bell housing.

**CAUSE:** Bell housing to case bolts not sealed.

**CORRECTION:** All bell housing to case bolts <u>MUST</u> be installed with thread sealant. (See diagram below)
