BUILDING MOISTURE INDEX (BMI)

ENVIRONMENTAL DIAGNOSTIC REPORT

16 Spencer Hill, SW19 4NY

13 March 2025

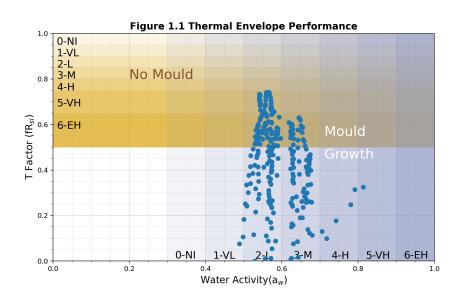
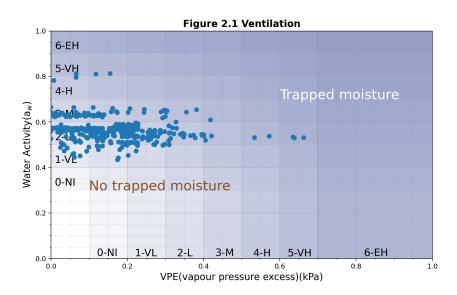
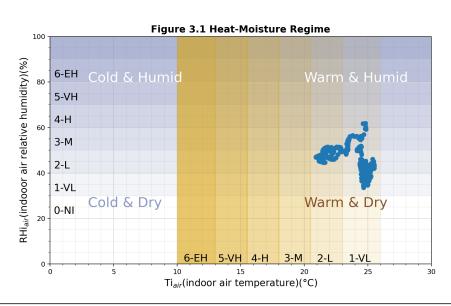
BMI causal factors graphs

Table 2.1 and Table 3.1 show average values of raw and calculated environmental parameters. The thermal envelope performance graph (Figure 1.1) shows that most data fall into an area where the temperature factor (T Factor) values (0.47 average), can be considered problematic. However this, together with most water activity (aw, surface RH) values obtained during the recorded period (0.59 average), do not present a high risk for condensation and mould growth.

The likelihood of surface condensation occurring is also related to surface temperature (Surface T) and dew point (Dew P) temperature differentials (Surface T- Dew P (°C)). During the monitoring period, average Surface T is 8.4°C above Dew P temperature to give rise to condensation (Figure 4.1 and Table 2.1). The lower this difference the higher the risk of surface condensation occurring, which happens when Surface T reaches and goes below Dew P temperature.

The ventilation, i.e. removal of the moisture produced in this dwelling, does not seem to be a problem, with most vapour pressure excess (VPE) and water activity (aw) data (Figure 2.1) showing Very Low score (0.06 kPa and 0.59 average, respectively), in a warm (23.5°C average) and dry (46.5% average RH) environment (Figure 3.1).

Possible causes and recommendations for rectification measures				
	The temperature factor results indicate that the building envelope performance in the			
C1	measured area is poor. An investigation of the thermal performance of the walls in this			
	area and surroundings is strongly recommended.
