CRANKSHAFT POSITION (CKP) SENSOR REMOVAL/INSTALLATION [SKYACTIV-D 2.2]

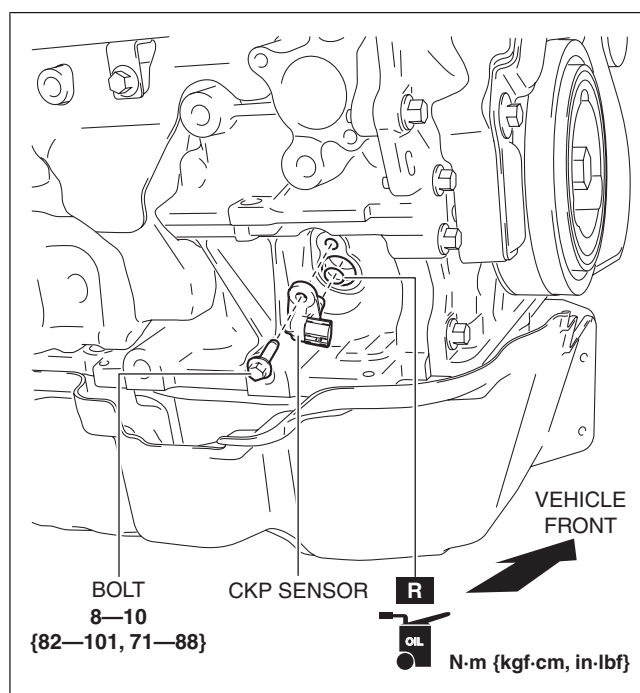
ac5wzw00005826

1. Disconnect the negative battery cable. (See NEGATIVE BATTERY CABLE DISCONNECTION/CONNECTION [SKYACTIV-D 2.2].)
2. Lift up the vehicle.
3. Remove the service hole cover (installed to front under cover No.2) used to remove the oil filter. (See OIL FILTER REPLACEMENT [SKYACTIV-D 2.2].)
4. Remove the splash shield. (See SPLASH SHIELD REMOVAL/INSTALLATION.)
5. Disconnect the CKP sensor connector.
6. Remove the CKP sensor.
7. Install in the reverse order of removal.
