### **BUILDING MOISTURE INDEX (BMI)**

### **ENVIRONMENTAL DIAGNOSTIC REPORT**

Date of Inspection: 9 September 2024 19:38:29

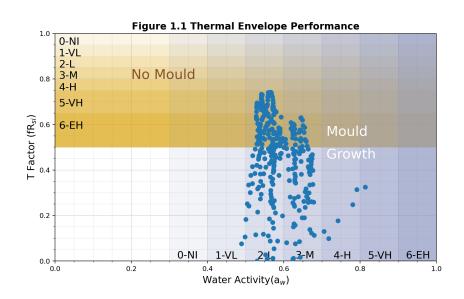
Table 2.1 and Table 3.1 show average values of raw and calculated environmental parameters. The thermal envelope performance graph (Figure 1.1) shows that most data fall into an area where the temperature factor (T Factor) values (0.48 average), can be considered problematic. However this, together with most water activity (aw, surface RH) values obtained during the recorded period (0.59 average), do not present a high risk for condensation and mould growth.

Possible causes and recommendations for rectification measures				
	The temperature factor results indicate that the building envelope performance in the			
C1	measured area is poor. An investigation of the thermal performance of the walls in this			
	area and surroundings is strongly recommended.

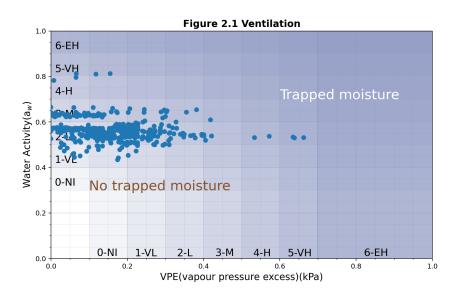
The ventilation, i.e. removal of the moisture produced in this dwelling, does not seem to be a problem, with most vapour pressure excess (VPE) and water activity (aw) data (Figure 2.1) showing Very Low score (0.05 kPa and 0.59 average, respectively), in a warm (23.5°C average) and dry (46.4% average RH) environment (Figure 3.1).

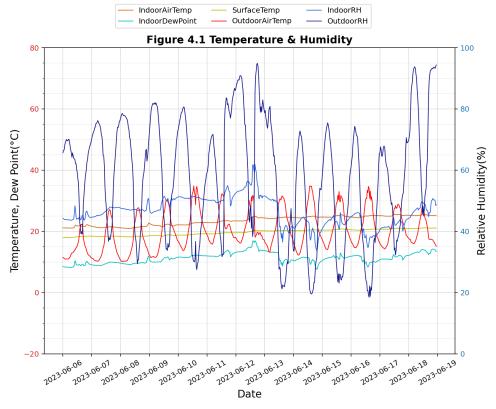
The likelihood of surface condensation occurring is also related to surface temperature (Surface T) and dew point (Dew P) temperature differentials (Surface T- Dew P (°C)). During the monitoring period, average Surface T is 8.4°C above Dew P temperature to give rise to condensation (Figure 4.1 and Table 2.1). The lower this difference the higher the risk of surface condensation occurring, which happens when Surface T reaches and goes below Dew P temperature.
