DETERMINING OPEN CIRCUIT LOCATION (MS-CAN) [SKYACTIV-G 2.0 (L.H.D.)]

DTC output pattern and malfunctioning location

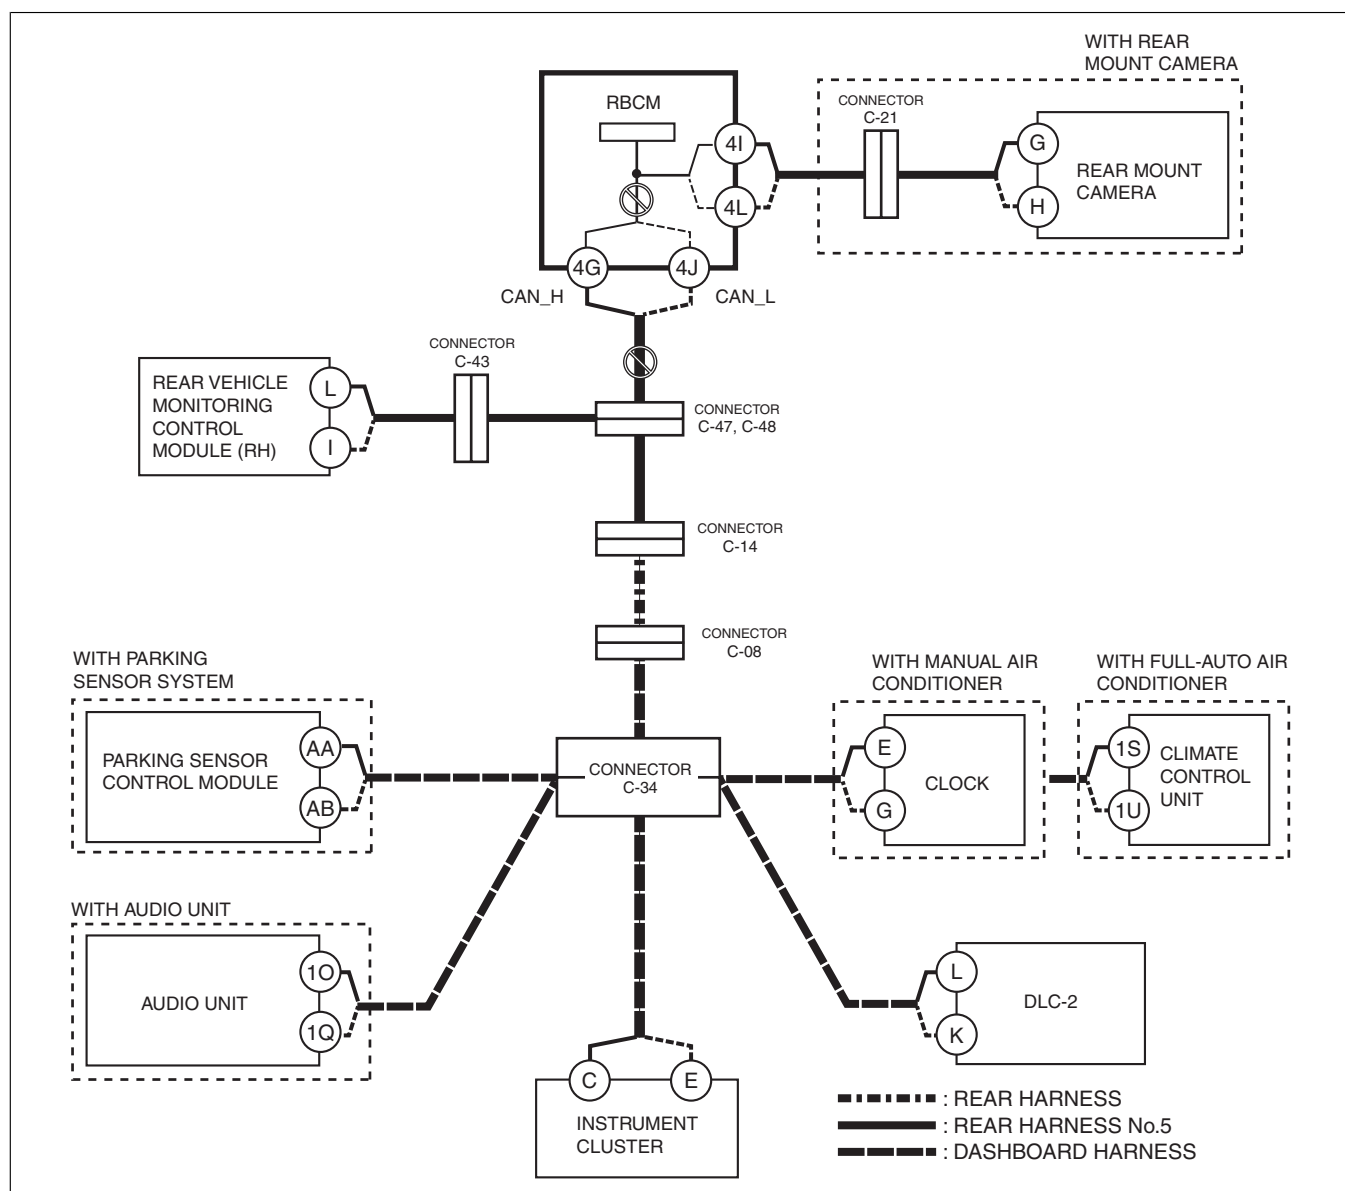
System wiring diagram

- Connector terminal disconnection, poor contact, damage, deformation, corrosion
- Open circuit in wiring harness between rear body control module (RBCM) and connectors C-47, C-48
- Connector C-47, C-48 malfunction
- CAN circuit in rear body control module (RBCM) malfunction

- Rear body control module (RBCM) connector
- Connectors C-47, C-48
- Wiring harness between rear body control module (RBCM) terminal 4G and connectors C-47
- Wiring harness between rear body control module (RBCM) terminal 4J and connectors C-48
- Rear body control module (RBCM)
 - Wiring harness between rear body control module (RBCM) terminal 4G and rear body control module (RBCM) terminal 4I
 - Wiring harness between rear body control module (RBCM) terminal 4J and rear body control module (RBCM) terminal 4L

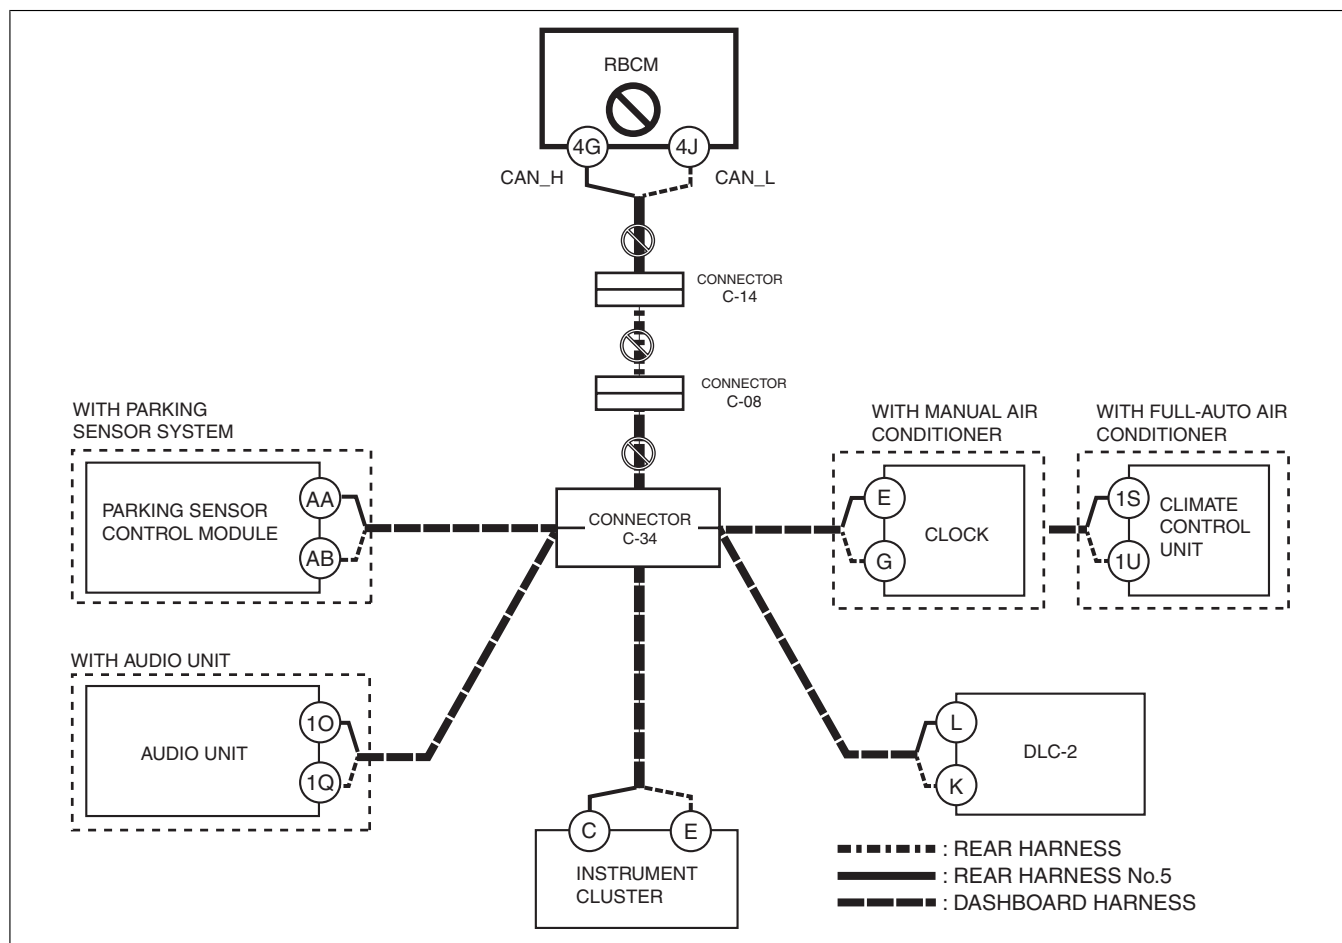
System wiring diagram

Without rear vehicle monitoring system

- Connector terminal disconnection, poor contact, damage, deformation, corrosion
- Open circuit in wiring harness between rear body control module (RBCM) and connector C-14
- Open circuit in wiring harness between connector C-14 and connector C-08
- Open circuit in wiring harness between connector C-08 and connector C-34
- Connector C-14 malfunction
- Connector C-08 malfunction
- Connector C-34 malfunction
- Rear body control module (RBCM) malfunction

- Rear body control module (RBCM) connector
- Connector C-14
- Connector C-08
- Connector C-34
- Wiring harness between rear body control module (RBCM) terminal 4G and connector C-14
- Wiring harness between rear body control module (RBCM) terminal 4J and connector C-14
- Wiring harness between connector C-14 and connector C-08
- Wiring harness between connector C-08 and connector C-34
- Rear body control module (RBCM)

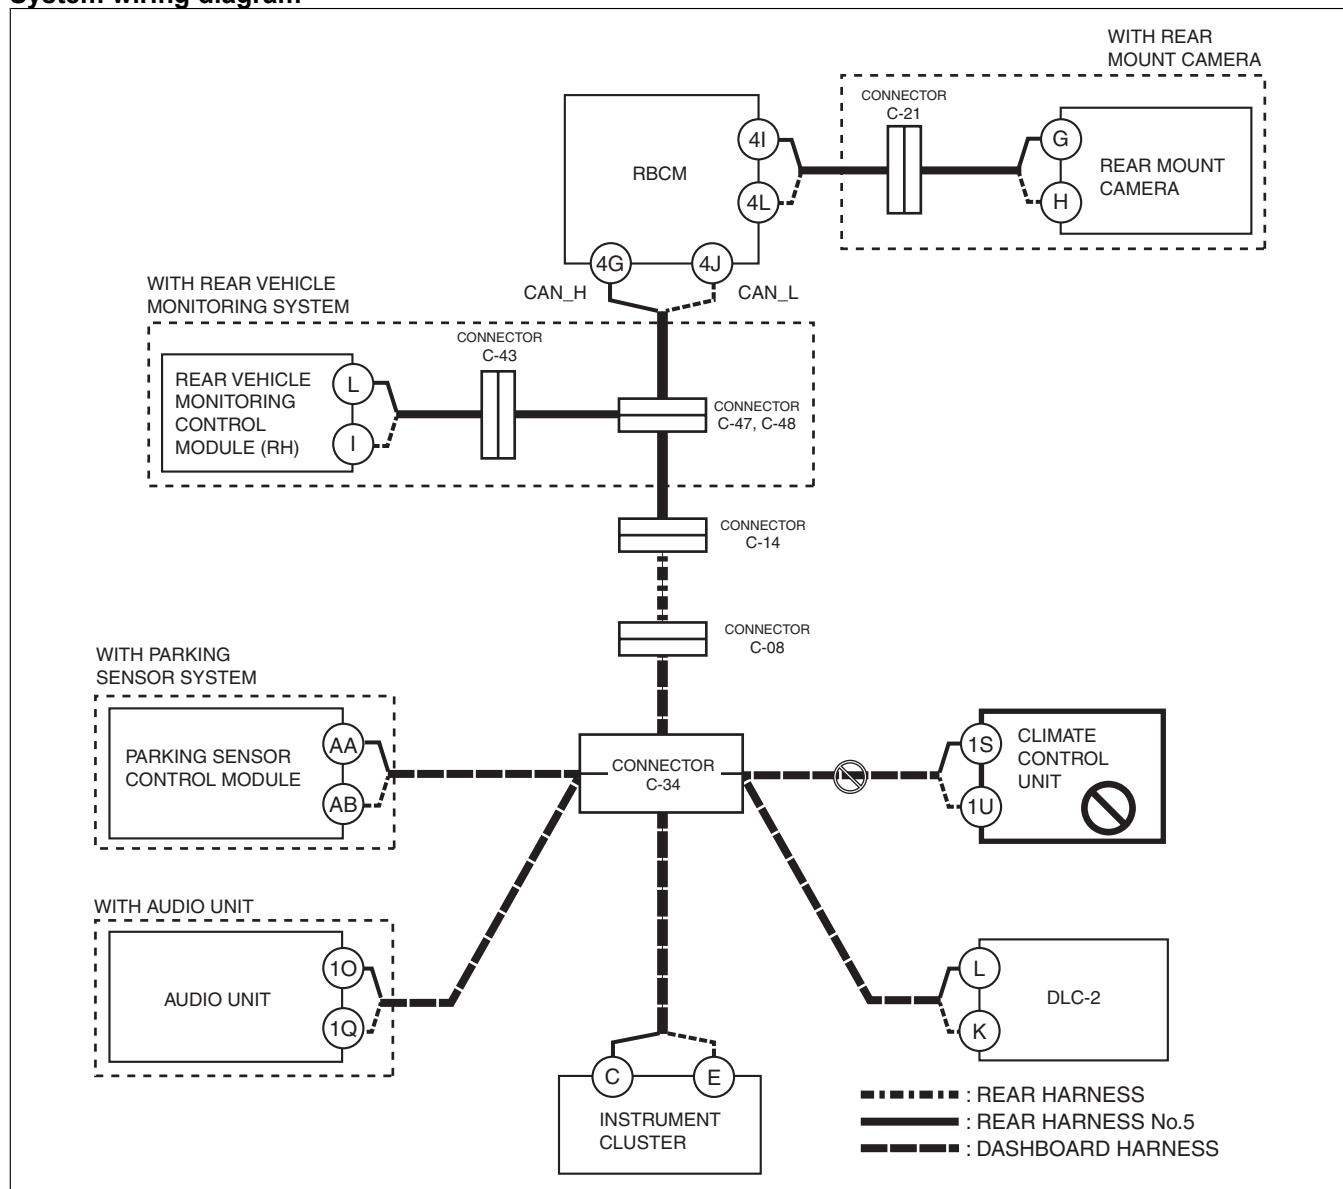
System wiring diagram

- Connector terminal disconnection, poor contact, damage, deformation, corrosion
- Open circuit in wiring harness between climate control unit and connector C-34
- Connector C-34 malfunction
- Climate control unit malfunction

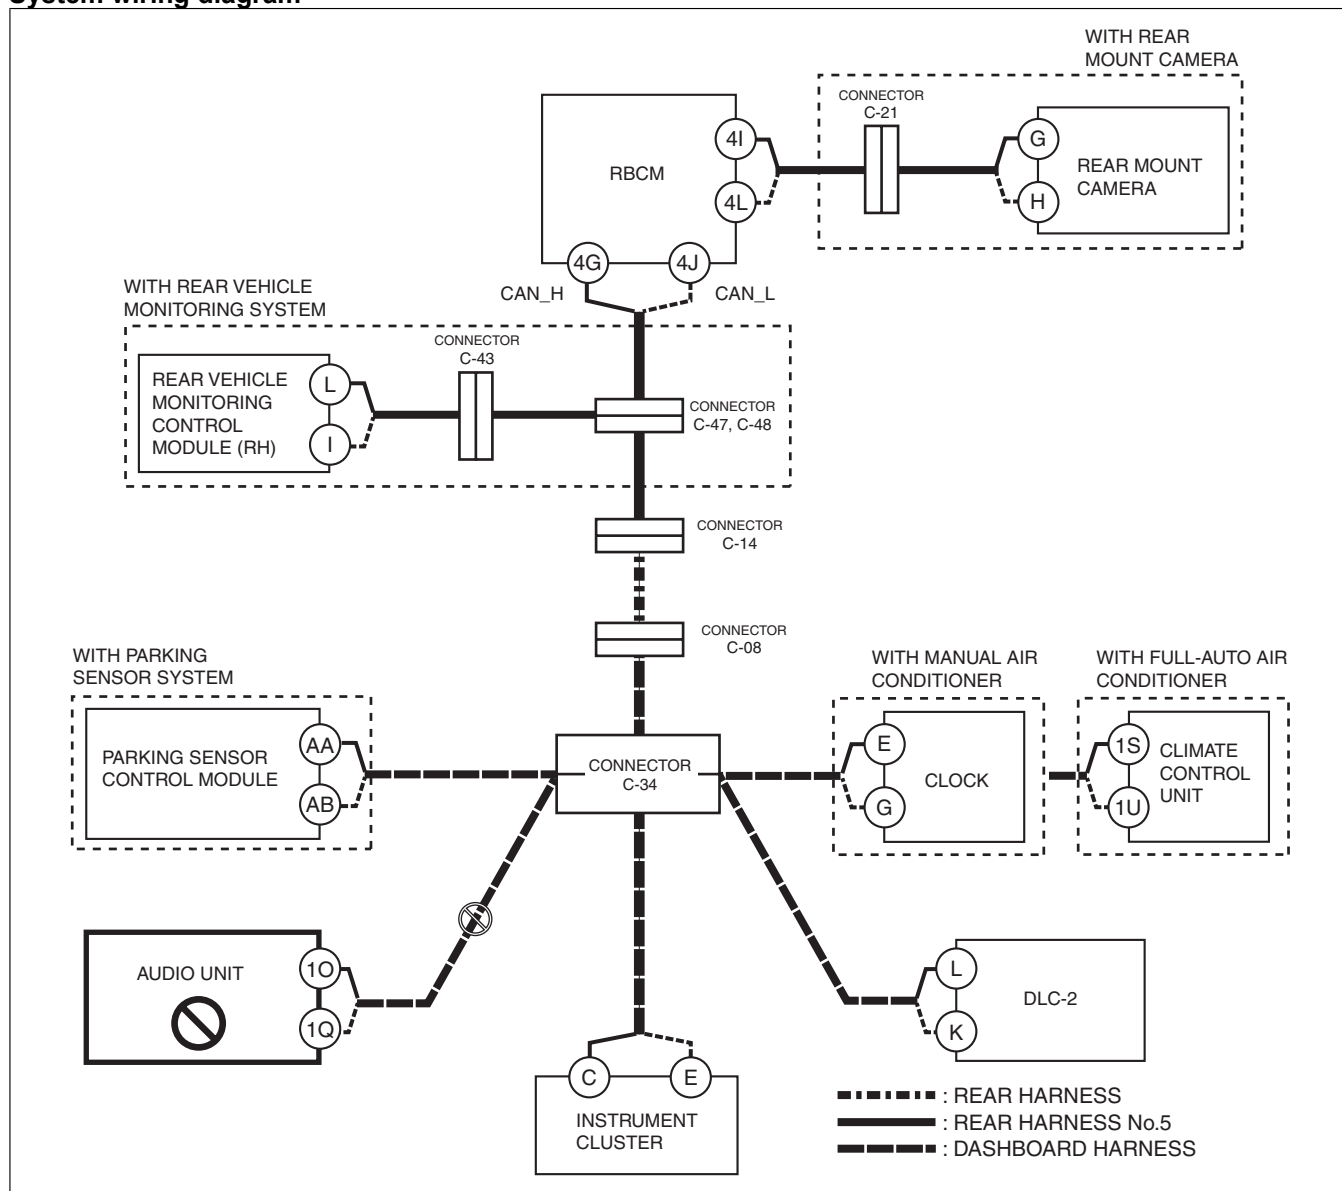
System wiring diagram

- Connector terminal disconnection, poor contact, damage, deformation, corrosion
- Open circuit in wiring harness between vehicle with audio unit and connector C-34
- Connector C-34 malfunction
- Audio unit malfunction

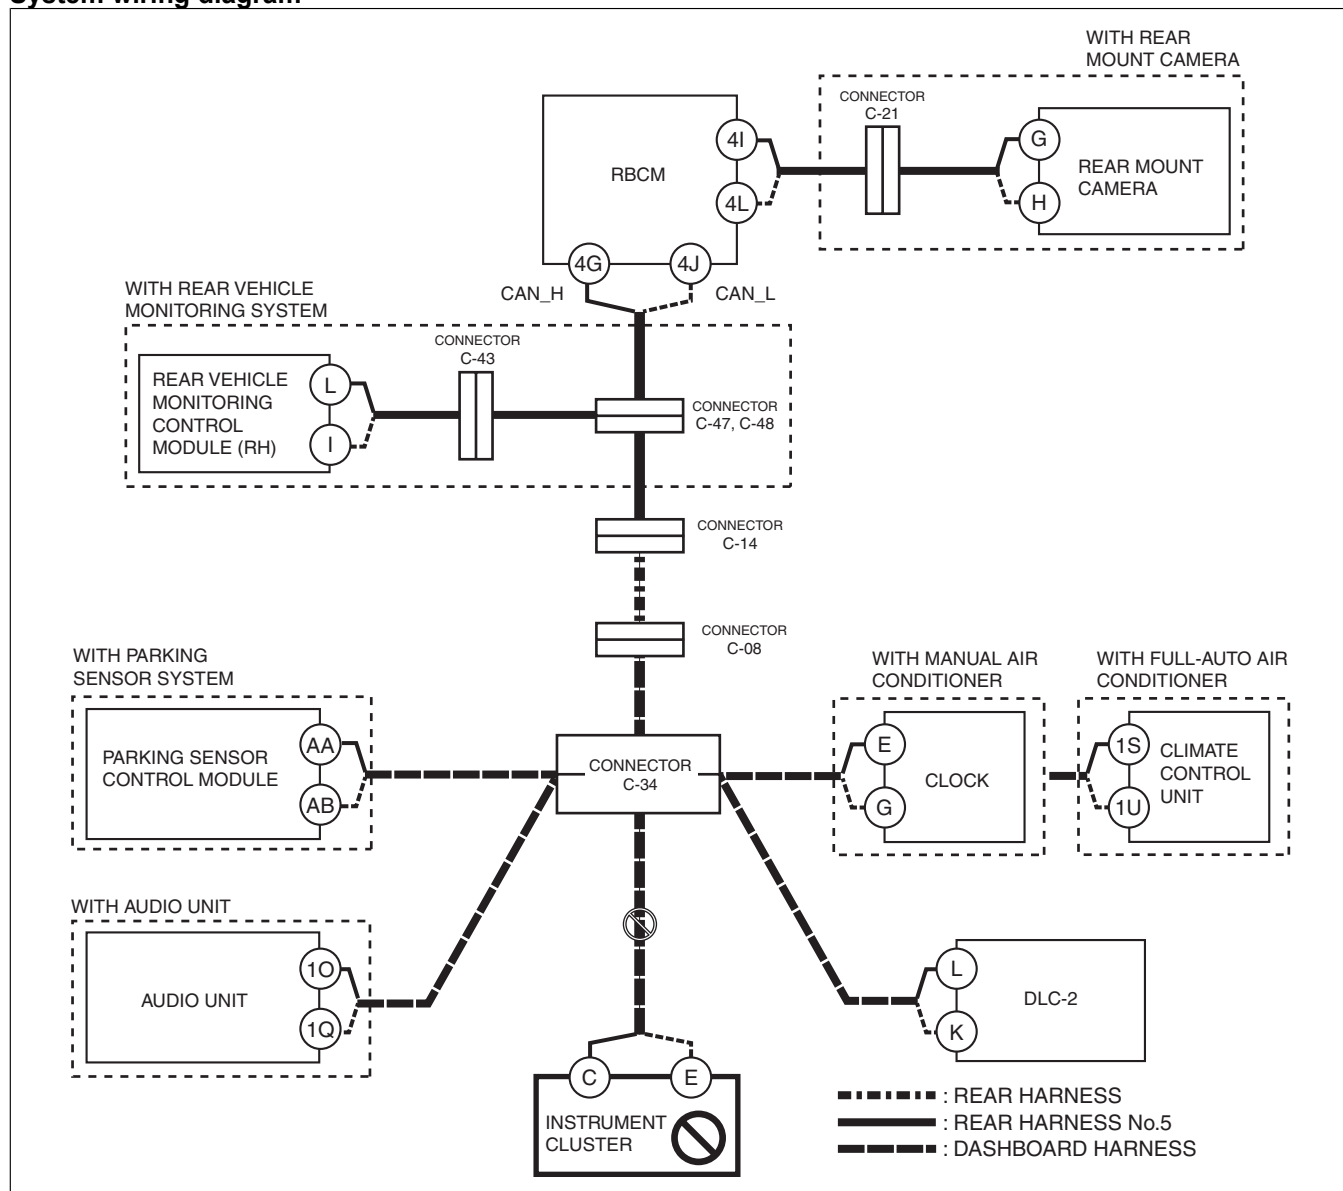
System wiring diagram

- Connector terminal disconnection, poor contact, damage, deformation, corrosion
- Open circuit in wiring harness between instrument cluster and connector C-34
- Connector C-34 malfunction
- Instrument cluster malfunction

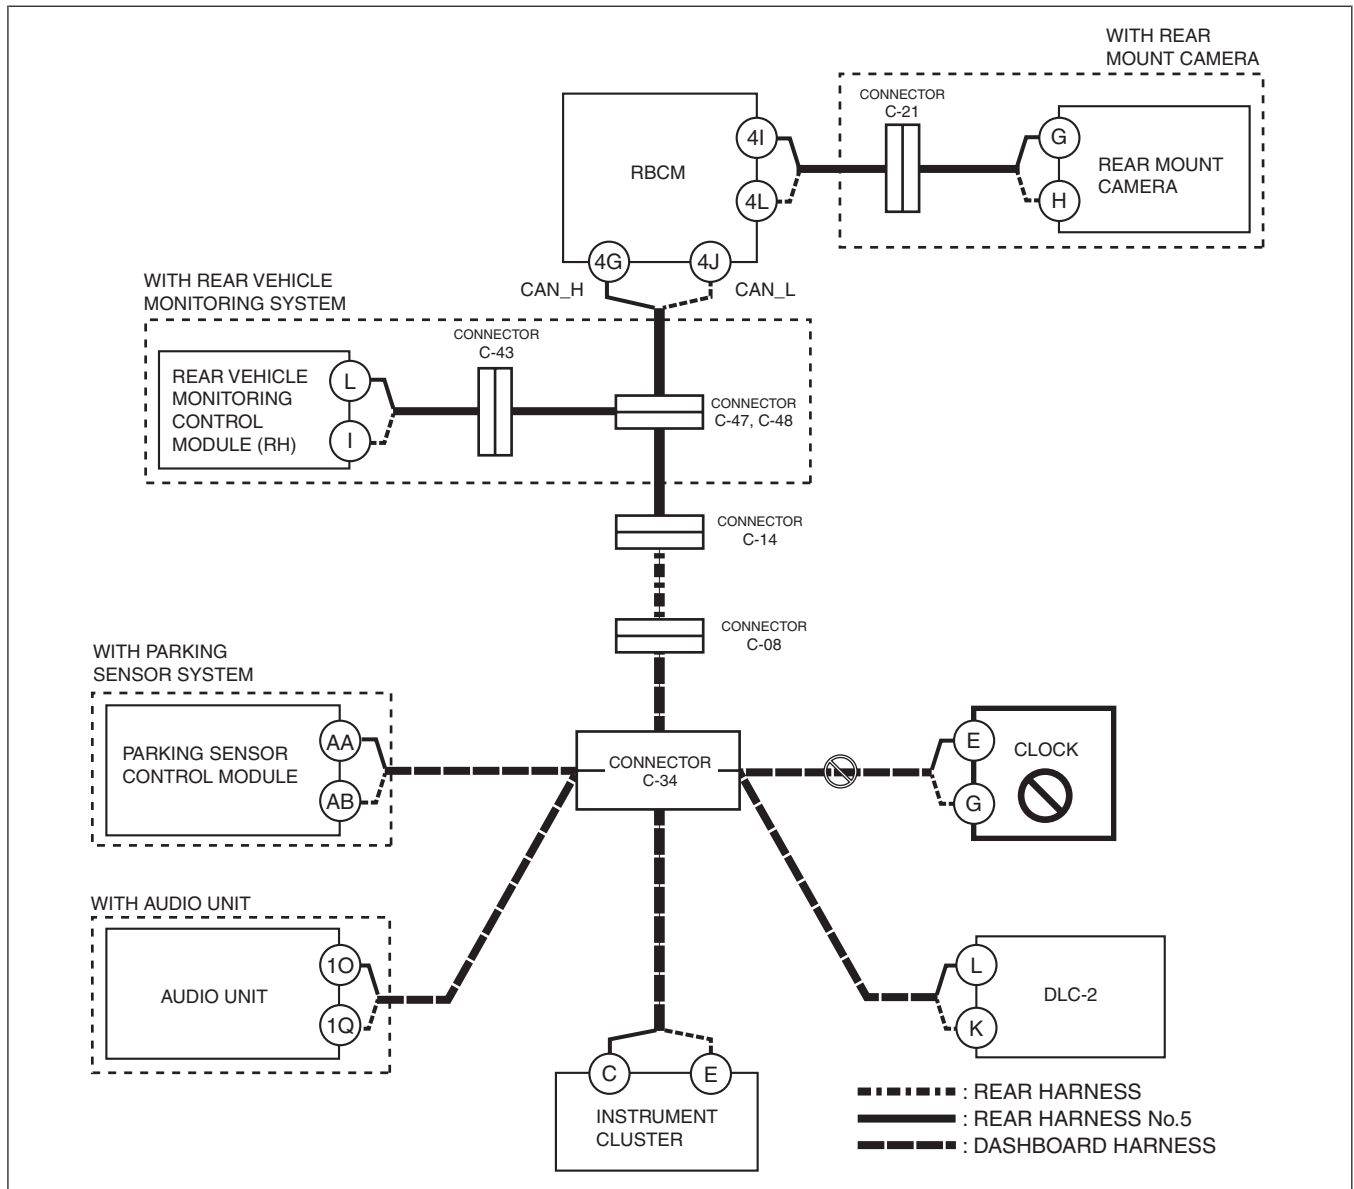
System wiring diagram

Clock Circuit Malfunction

- Connector terminal disconnection, poor contact, damage, deformation, corrosion
- Open circuit in wiring harness between clock component and connector C-34

- Connector C-34 malfunction
- Clock component malfunction

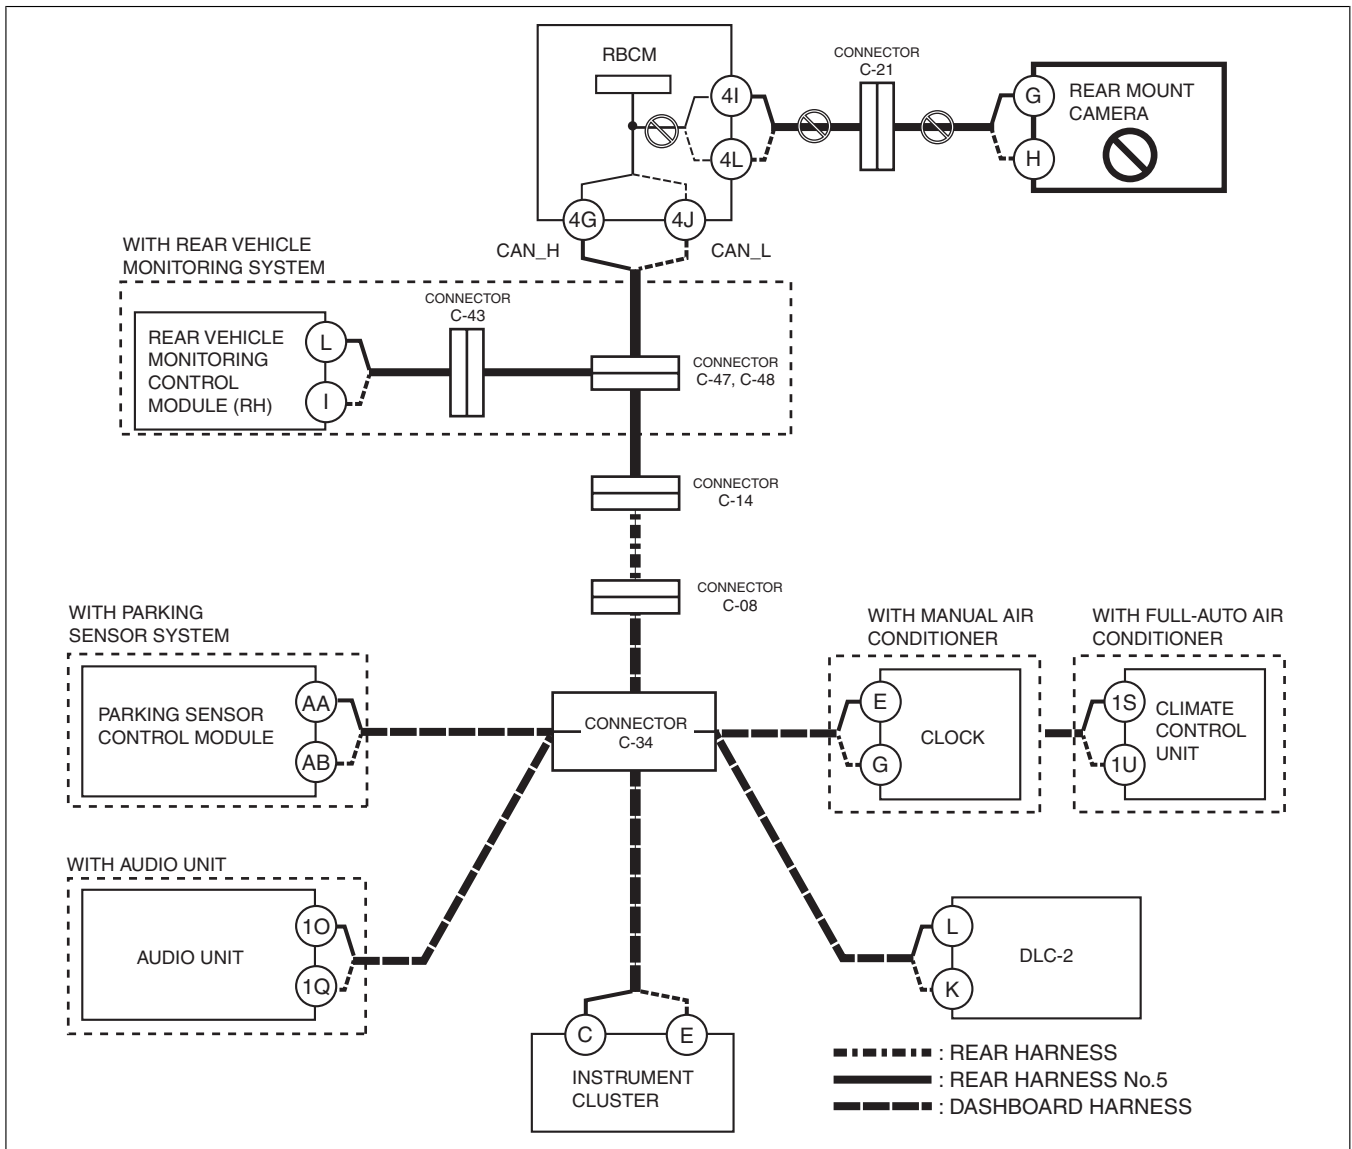
System wiring diagram

- Connector terminal disconnection, poor contact, damage, deformation, corrosion
- Open circuit in wiring harness between rear mount camera and connector C-21
- Open circuit in wiring harness between connector C-21 and RCBM
- Connector C-21 malfunction
- Rear mount camera malfunction
- CAN circuit in rear body control module (RCBM) malfunction
