CRANKSHAFT POSITION (CKP) SENSOR INSPECTION [SKYACTIV-G 2.0]

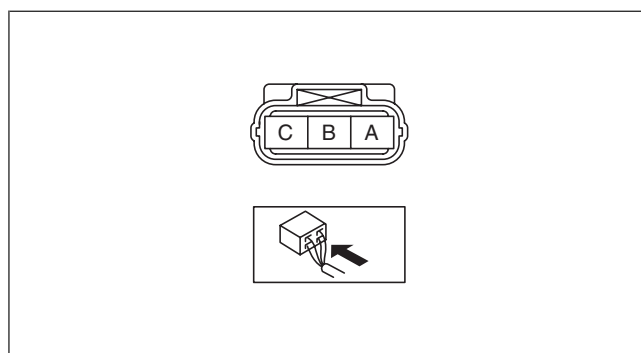
am3zzw00012560

1. Idle the engine.
2. Measure the CKP sensor output voltage using the oscilloscope.
 - If not as specified, replace the CKP sensor. (See CRANKSHAFT POSITION (CKP) SENSOR REMOVAL/INSTALLATION [SKYACTIV-G 2.0].)

Terminal	Voltage (V)	Condition
A	Approx. 5.0	Under any condition
B	Below 1.0	Under any condition
C	Above 4.5	High output*
	Below 0.8	Low output*

* : Output voltage varies with crankshaft rotation.
