Building Moisture Index (BMI) Environmental Diagnostic Report

3. PROPERTY AND SURVEYOR: MOISTURE OBSERVATIONS

Property Address: 16 Spencer Hill, SW19 4NY

4.1. TEST

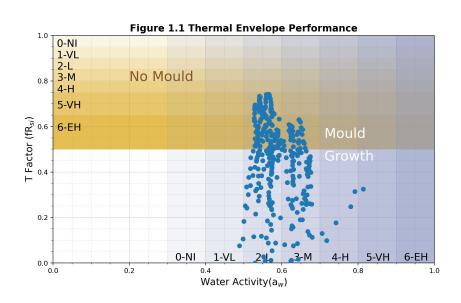
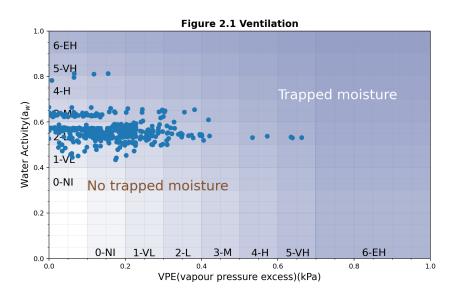
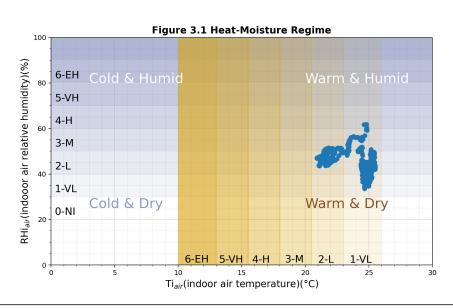
BMI causal factors graphs

Table 2.1 and Table 3.1 show average values of raw and calculated environmental parameters. The thermal envelope performance graph (Figure 1.1) shows that most data fall into an area where the temperature factor (T Factor) values (0.48 average), can be considered problematic. However this, together with most water activity (aw, surface RH) values obtained during the recorded period (0.59 average), do not present a high risk for condensation and mould growth.

The ventilation, i.e. removal of the moisture produced in this dwelling, does not seem to be a problem, with most vapour pressure excess (VPE) and water activity (aw) data (Figure 2.1) showing Very Low score (0.05 kPa and 0.59 average, respectively), in a warm (23.5°C average) and dry (46.4% average RH) environment (Figure 3.1).

Possible causes and recommendations for rectification measures				
	The temperature factor results indicate that the building envelope performance in the			
C1	measured area is poor. An investigation of the thermal performance of the walls in this			
	area and surroundings is strongly recommended.

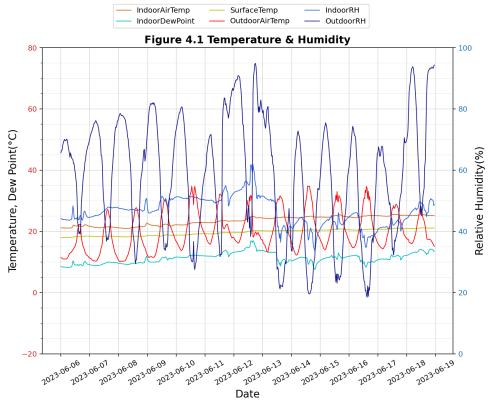
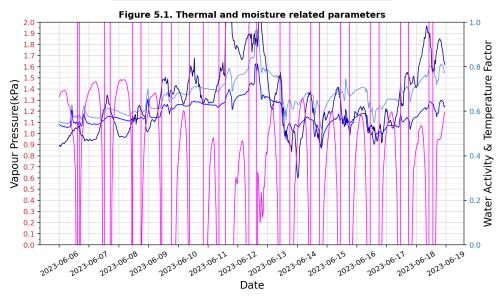
Raw and calculated parameters graphs

The likelihood of surface condensation occurring is also related to surface temperature (Surface T) and dew point (Dew P) temperature differentials (Surface T- Dew P (°C)). During the monitoring period, average Surface T is 8.4°C above Dew P temperature to give rise to condensation (Figure 4.1 and Table 2.1). The lower this difference the higher the risk of surface condensation occurring, which happens when Surface T reaches and goes below Dew P temperature.
