BUILDING MOISTURE INDEX (BMI)

ENVIRONMENTAL DIAGNOSTIC REPORT

16 Spencer Hill, SW19 4NY

26/08/2024 13:22:46

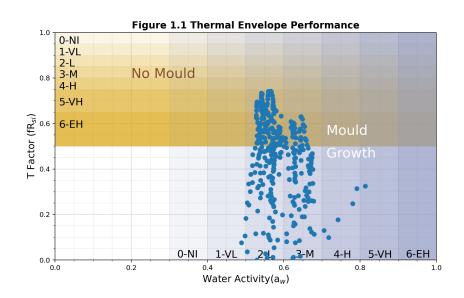
Table 2.1 and Table 3.1 show average values of raw and calculated environmental parameters. The thermal envelope performance graph (Figure 1.1) shows that most data fall into an area where the temperature factor (T Factor) values (0.48 average), can be considered problematic. However this, together with most water activity (aw, surface RH) values obtained during the recorded period (0.58 average), do not present a high risk for condensation and mould growth.

Possible causes and recommendations for rectification measures				
	The temperature factor results indicate that the building envelope performance in the			
C1	measured area is poor. An investigation of the thermal performance of the walls in this			
	area and surroundings is strongly recommended.

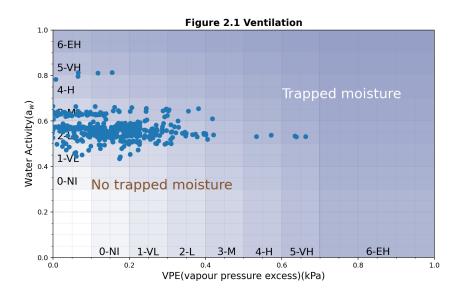
The ventilation, i.e. removal of the moisture produced in this dwelling, does not seem to be a problem, with most vapour pressure excess (VPE) and water activity (aw) data (Figure 2.1) showing Very Low score (0.05 kPa and 0.58 average, respectively), in a warm (23.2°C average) and dry (46.7% average RH) environment (Figure 3.1).

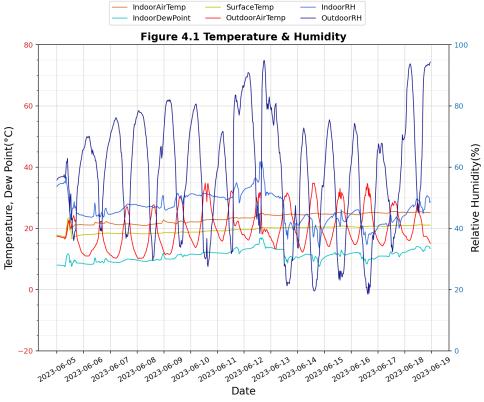
The likelihood of surface condensation occurring is also related to surface temperature (Surface T) and dew point (Dew P) temperature differentials (Surface T- Dew P (°C)). During the monitoring period, average Surface T is 8.5°C above Dew P temperature to give rise to condensation (Figure 4.1 and Table 2.1). The lower this difference the higher the risk of surface condensation occurring, which happens when Surface T reaches and goes below Dew P temperature.
