DETERMINING OPEN CIRCUIT LOCATION (MS-CAN) [SKYACTIV-D 2.2 (L.H.D.)]

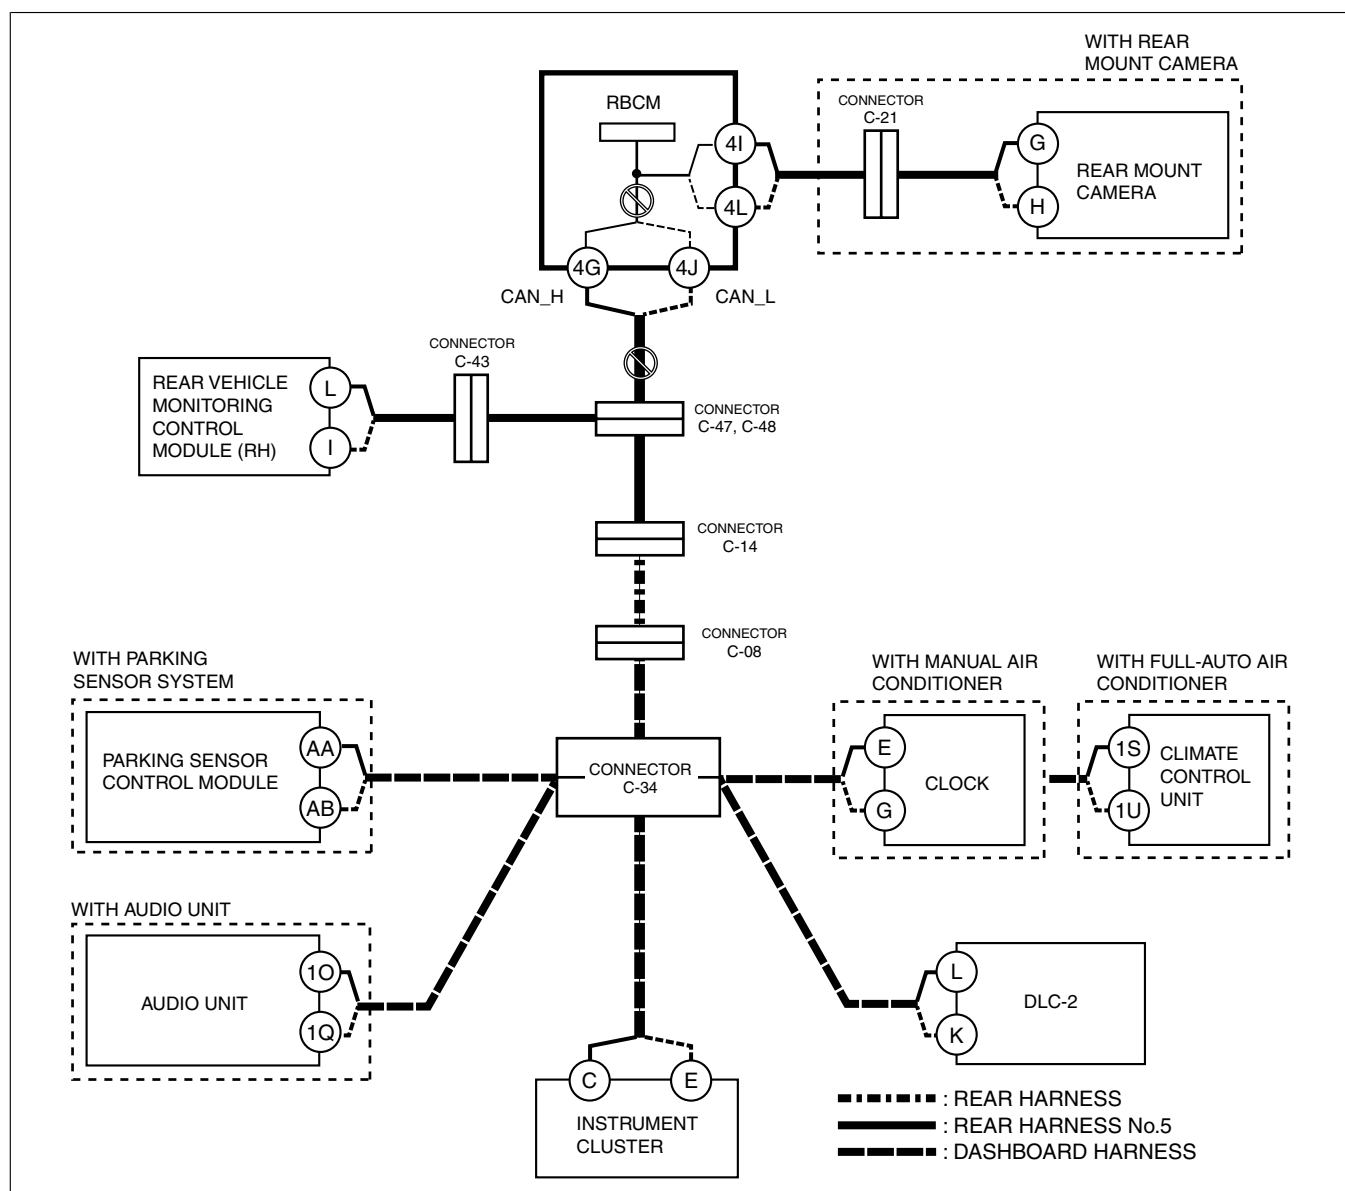
ac5wzw00000635

- Connector terminal disconnection, poor contact, damage, deformation, corrosion
- Open circuit in wiring harness between rear body control module (RBCM) and connectors C-47, C-48
- Connector C-47, C-48 malfunction
- CAN circuit in rear body control module (RBCM) malfunction

System wiring diagram

- Rear body control module (RBCM) connector
- Connectors C-47, C-48
- Wiring harness between rear body control module (RBCM) terminal 4G and connectors C-47
- Wiring harness between rear body control module (RBCM) terminal 4J and connectors C-48
- Rear body control module (RBCM)
 - Wiring harness between rear body control module (RBCM) terminal 4G and rear body control module (RBCM) terminal 4I
 - Wiring harness between rear body control module (RBCM) terminal 4J and rear body control module (RBCM) terminal 4L

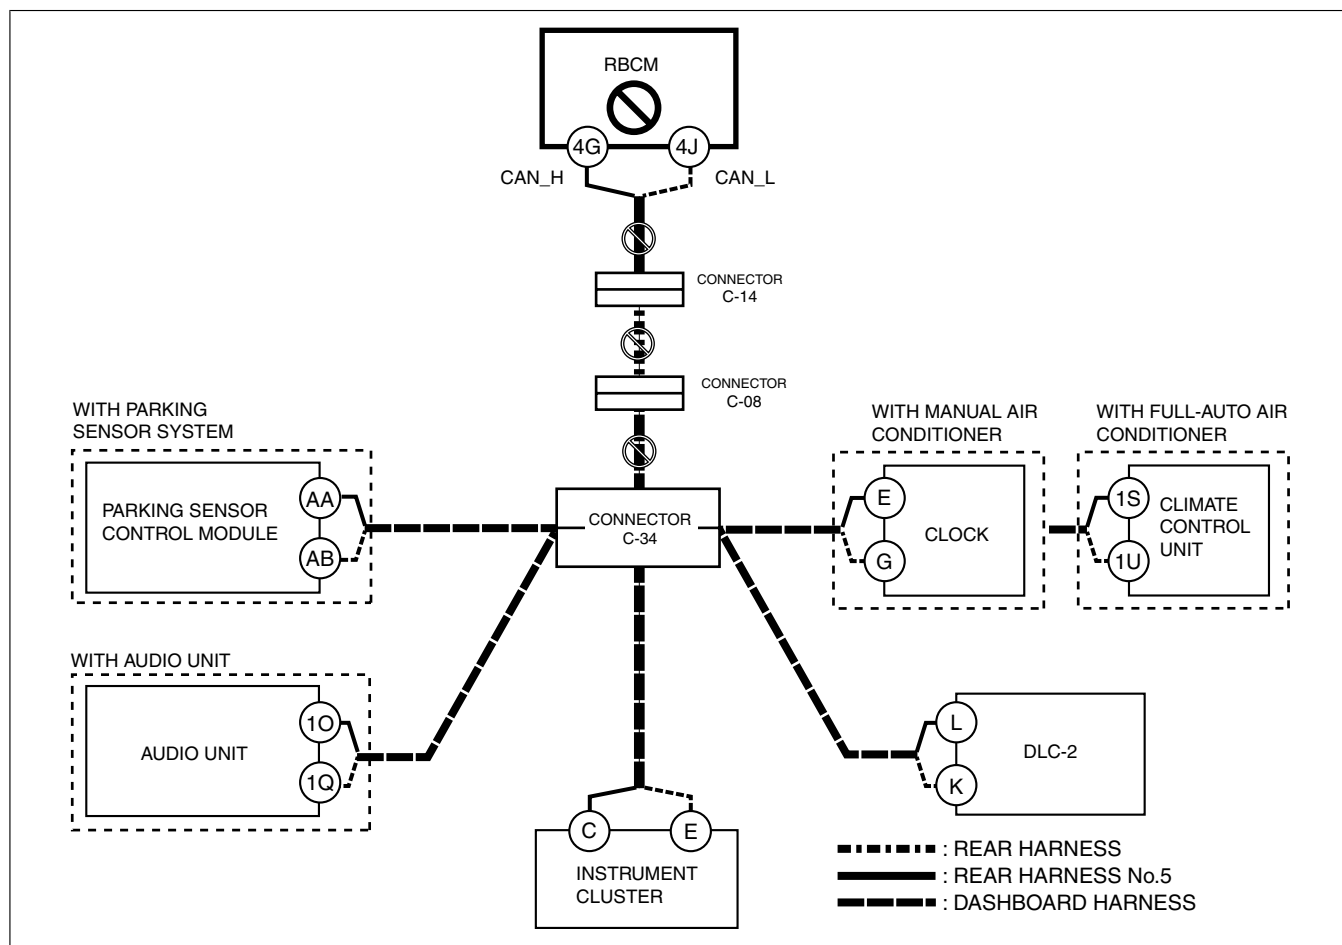
ac5wzw00000636

- Connector terminal disconnection, poor contact, damage, deformation, corrosion
- Open circuit in wiring harness between rear body control module (RBCM) and connector C-14
- Open circuit in wiring harness between connector C-14 and connector C-08
- Open circuit in wiring harness between connector C-08 and connector C-34
- Connector C-14 malfunction
- Connector C-08 malfunction
- Connector C-34 malfunction
- Rear body control module (RBCM) malfunction

System wiring diagram

- Rear body control module (RBCM) connector
- Connector C-14
- Connector C-08
- Connector C-34
- Wiring harness between rear body control module (RBCM) terminal 4G and connector C-14
- Wiring harness between rear body control module (RBCM) terminal 4J and connector C-14
- Wiring harness between connector C-14 and connector C-08
- Wiring harness between connector C-08 and connector C-34
- Rear body control module (RBCM)

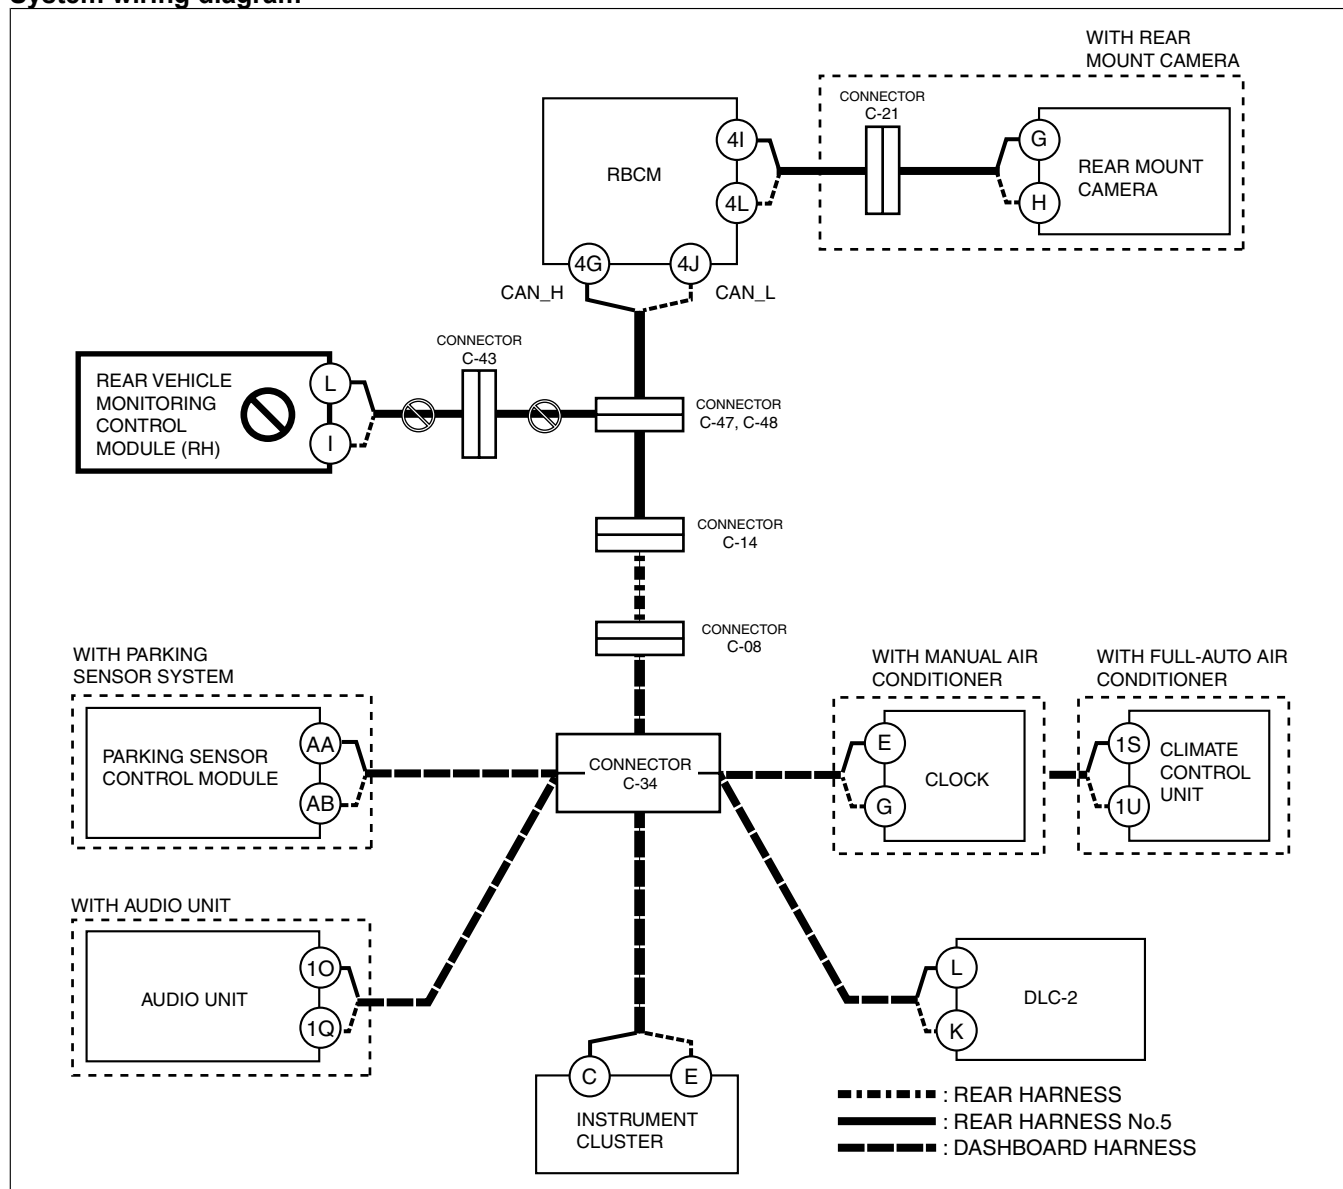
ac5wzw00000637

- Connector terminal disconnection, poor contact, damage, deformation, corrosion
- Open circuit in wiring harness between rear vehicle monitoring (RH) and connectors C-43
- Open circuit in wiring harness between connectors C-43 and connectors C-47, C-48
- Connector C-43 malfunction
- Connector C-47, C-48 malfunction
- Rear vehicle monitoring control module (RH) malfunction

System wiring diagram

- Rear vehicle monitoring control module (RH) connector
- Connectors C-43
- Connectors C-47, C-48
- Wiring harness between Rear vehicle monitoring control module (RH) terminal L and connector C-43
- Wiring harness between Rear vehicle monitoring control module (RH) terminal I and connector C-43
- Wiring harness between connector C-43 and connector C-47, C-48
- Rear vehicle monitoring control module (RH)

The diagram illustrates the electrical connections for the Rear Vehicle Monitoring Control Module (RH). The central component is the RBCM (Rear Body Control Module), which is connected to the RH via connectors C-43 and C-47/C-48. The RH is also connected to the rear mount camera via connector C-21. The RBCM is connected to the CAN bus (CAN_H, CAN_L) and the instrument cluster via connectors C-14 and C-08. The RH is connected to the parking sensor control module via connector C-34. The RH is also connected to the audio unit via connector C-34. The RH is connected to the instrument cluster via connector C-34. The RH is connected to the climate control unit via connector C-34. The RH is connected to the DLC-2 via connector C-34. The diagram includes a legend for line types: dashed for rear harness, solid for rear harness No.5, and dash-dot for dashboard harness.

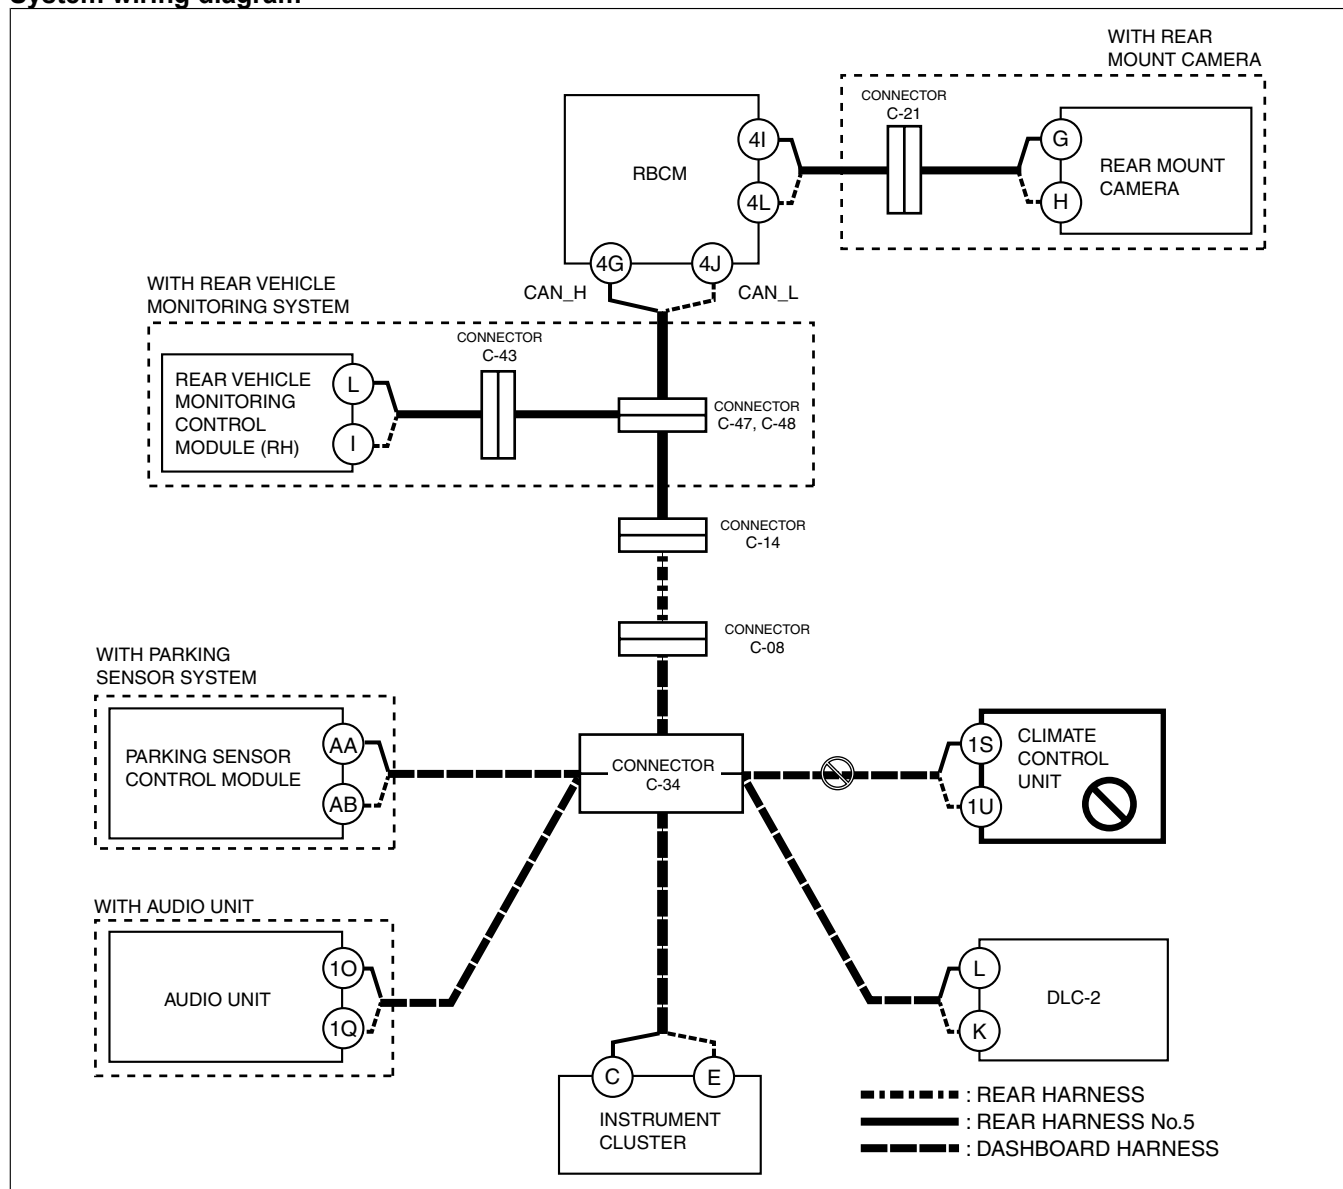
ac5wzw00000640

- Connector terminal disconnection, poor contact, damage, deformation, corrosion
- Open circuit in wiring harness between climate control unit and connector C-34
- Connector C-34 malfunction
- Climate control unit malfunction

System wiring diagram

- Climate control unit connector
- Connector C-34
- Wiring harness between climate control unit terminal 1S and connector C-34
- Wiring harness between climate control unit terminal 1U and connector C-34
- Climate control unit

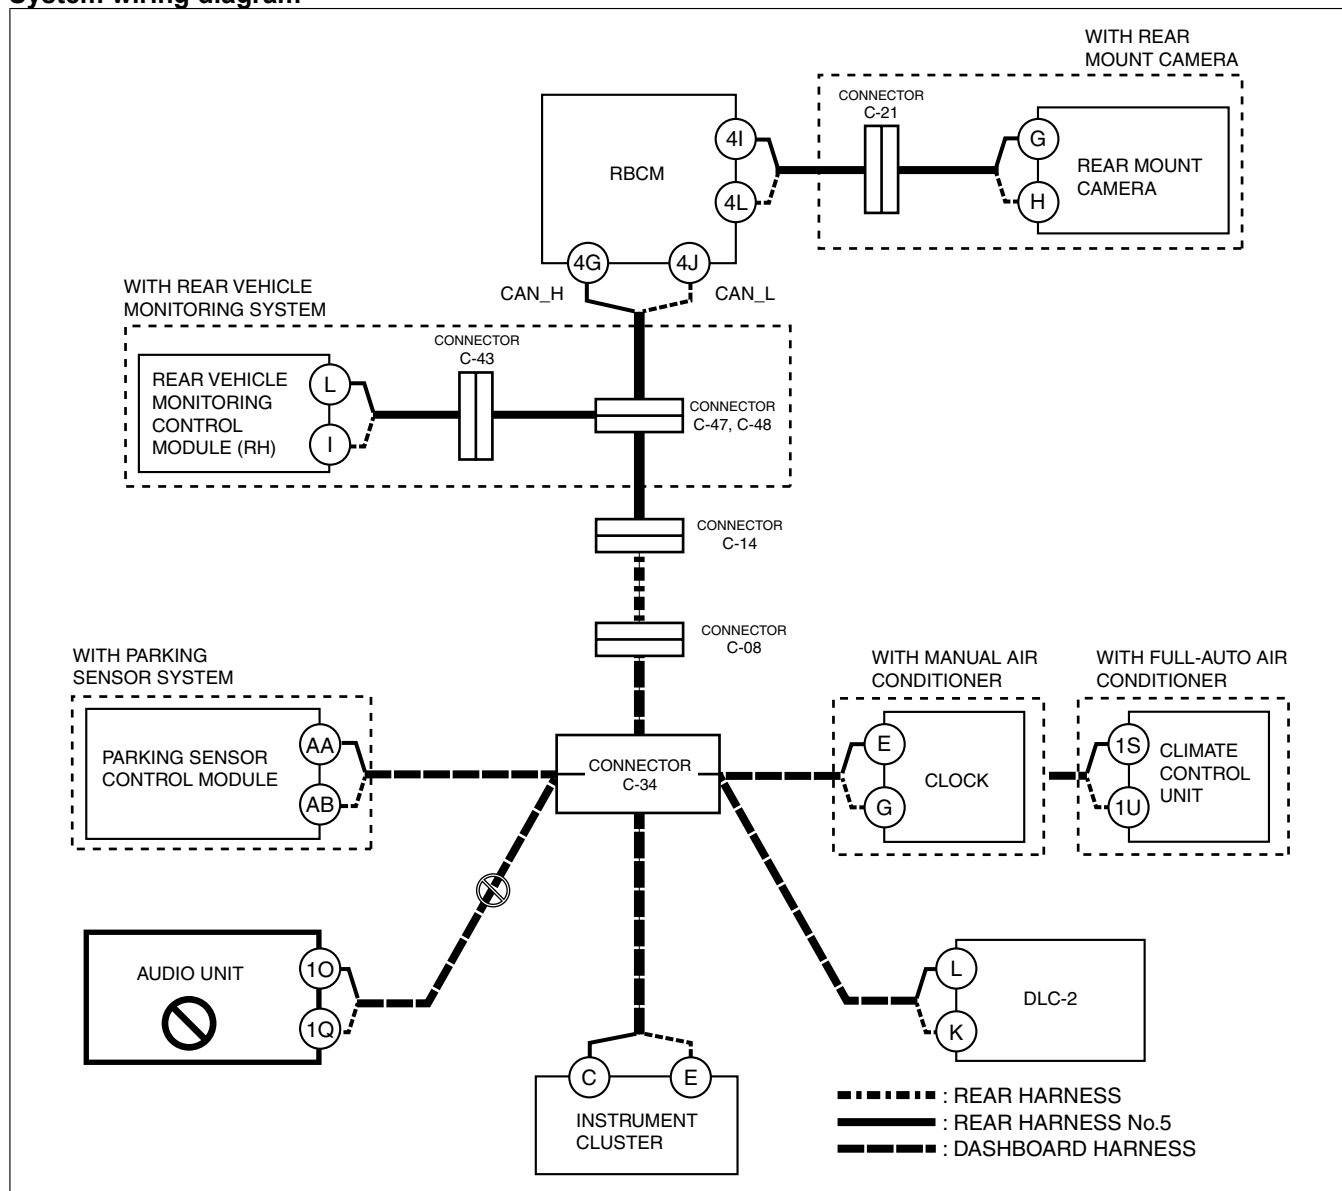
ac5wzw00000641

- Connector terminal disconnection, poor contact, damage, deformation, corrosion
- Open circuit in wiring harness between vehicle with audio unit and connector C-34
- Connector C-34 malfunction
- Audio unit malfunction

System wiring diagram

- Audio unit connector
- Connector C-34
- Wiring harness between audio unit terminal 1O and connector C-34
- Wiring harness between audio unit terminal 1Q and connector C-34
- Audio unit

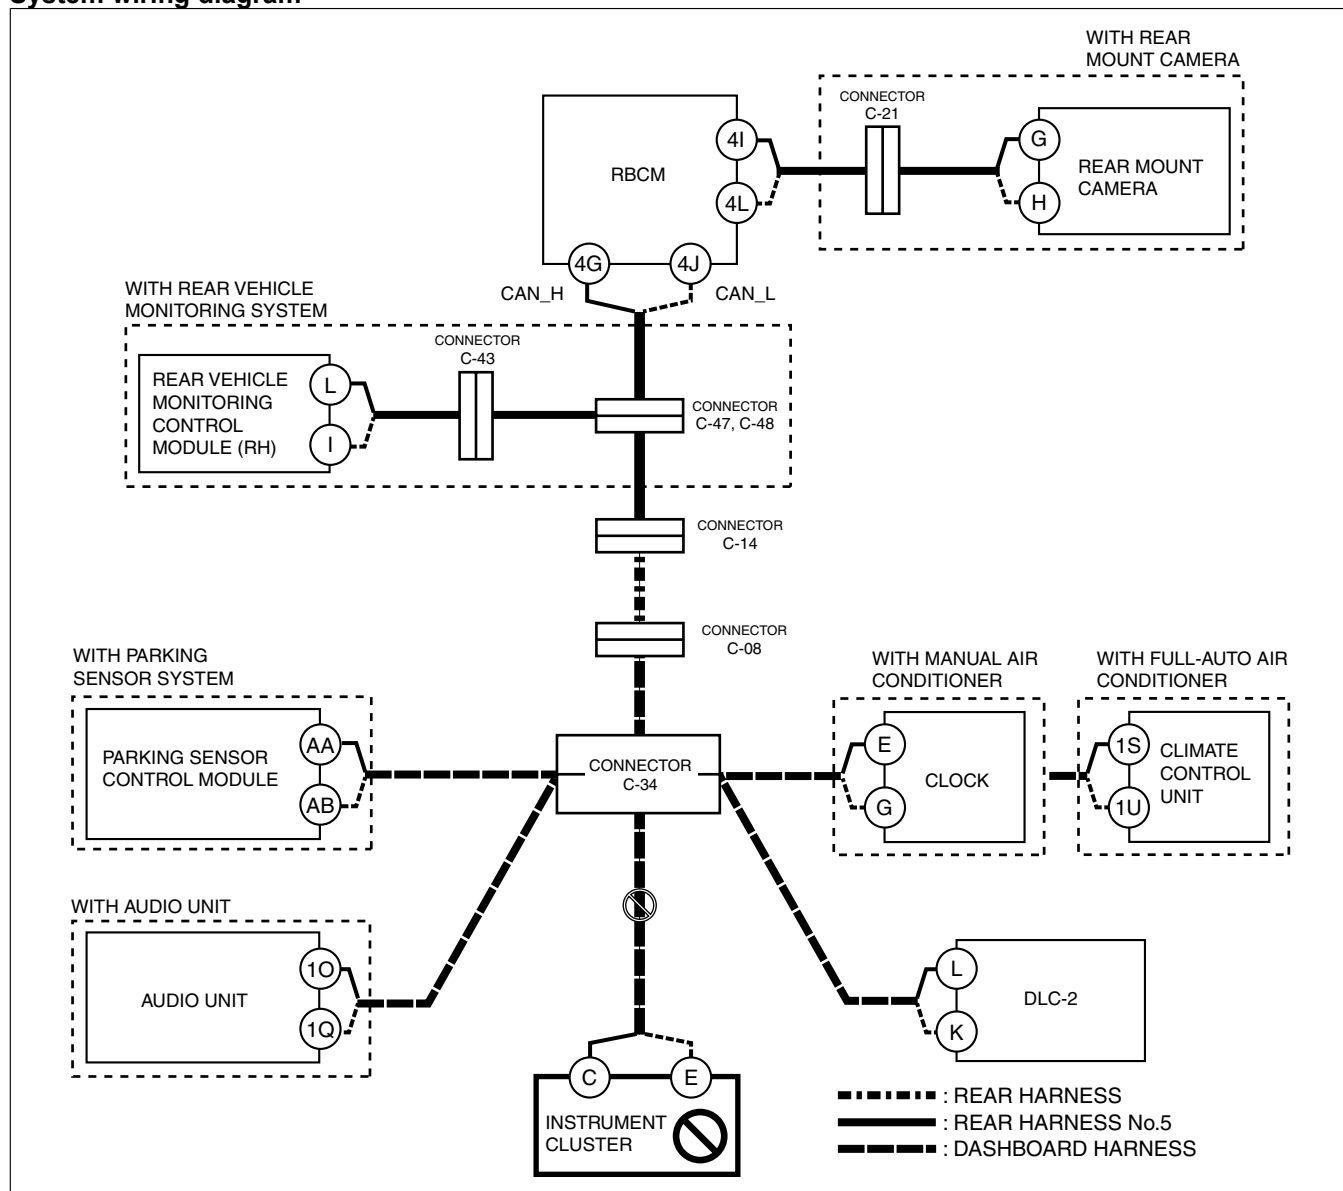
ac5wzw00000642

- Connector terminal disconnection, poor contact, damage, deformation, corrosion
- Open circuit in wiring harness between instrument cluster and connector C-34
- Connector C-34 malfunction
- Instrument cluster malfunction

System wiring diagram

- Instrument cluster connector
- Connector C-34
- Wiring harness between instrument cluster terminal C and connector C-34
- Wiring harness between instrument cluster terminal E and connector C-34
- Instrument cluster

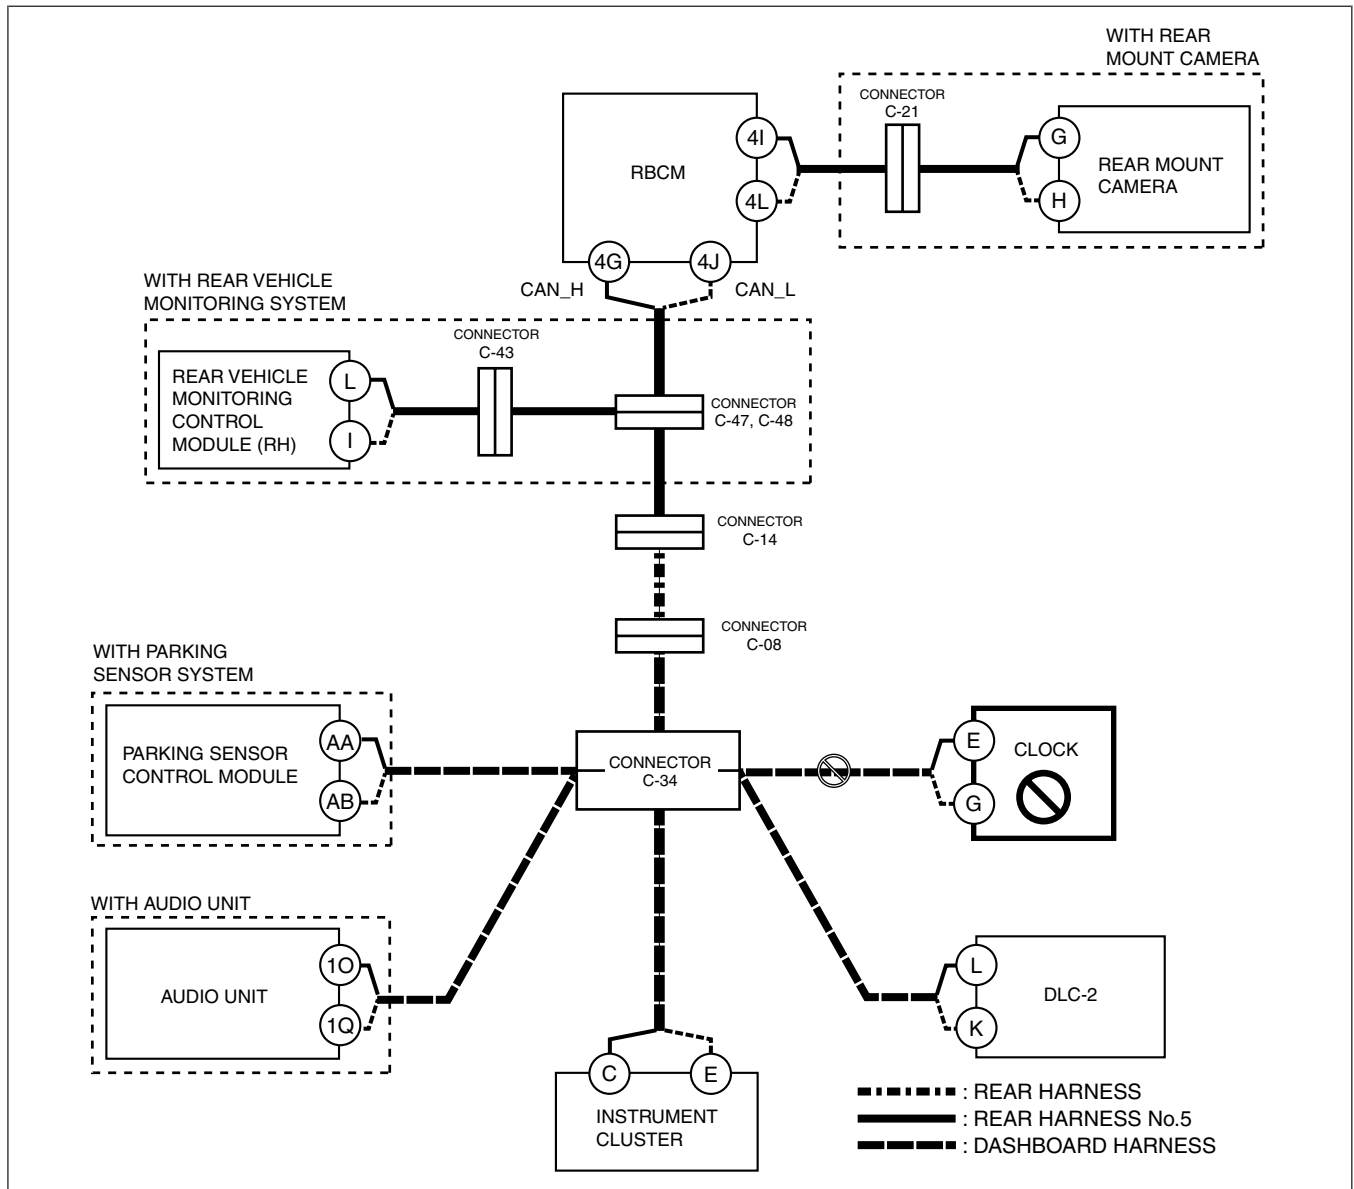
ac5wzw00002444

- Connector terminal disconnection, poor contact, damage, deformation, corrosion
- Open circuit in wiring harness between clock component and connector C-34

- Connector C-34 malfunction
- Clock component malfunction

System wiring diagram

- Clock component connector
- Connector C-34
- Wiring harness between clock component terminal E and connector C-34
- Wiring harness between clock component terminal G and connector C-34
- Clock component

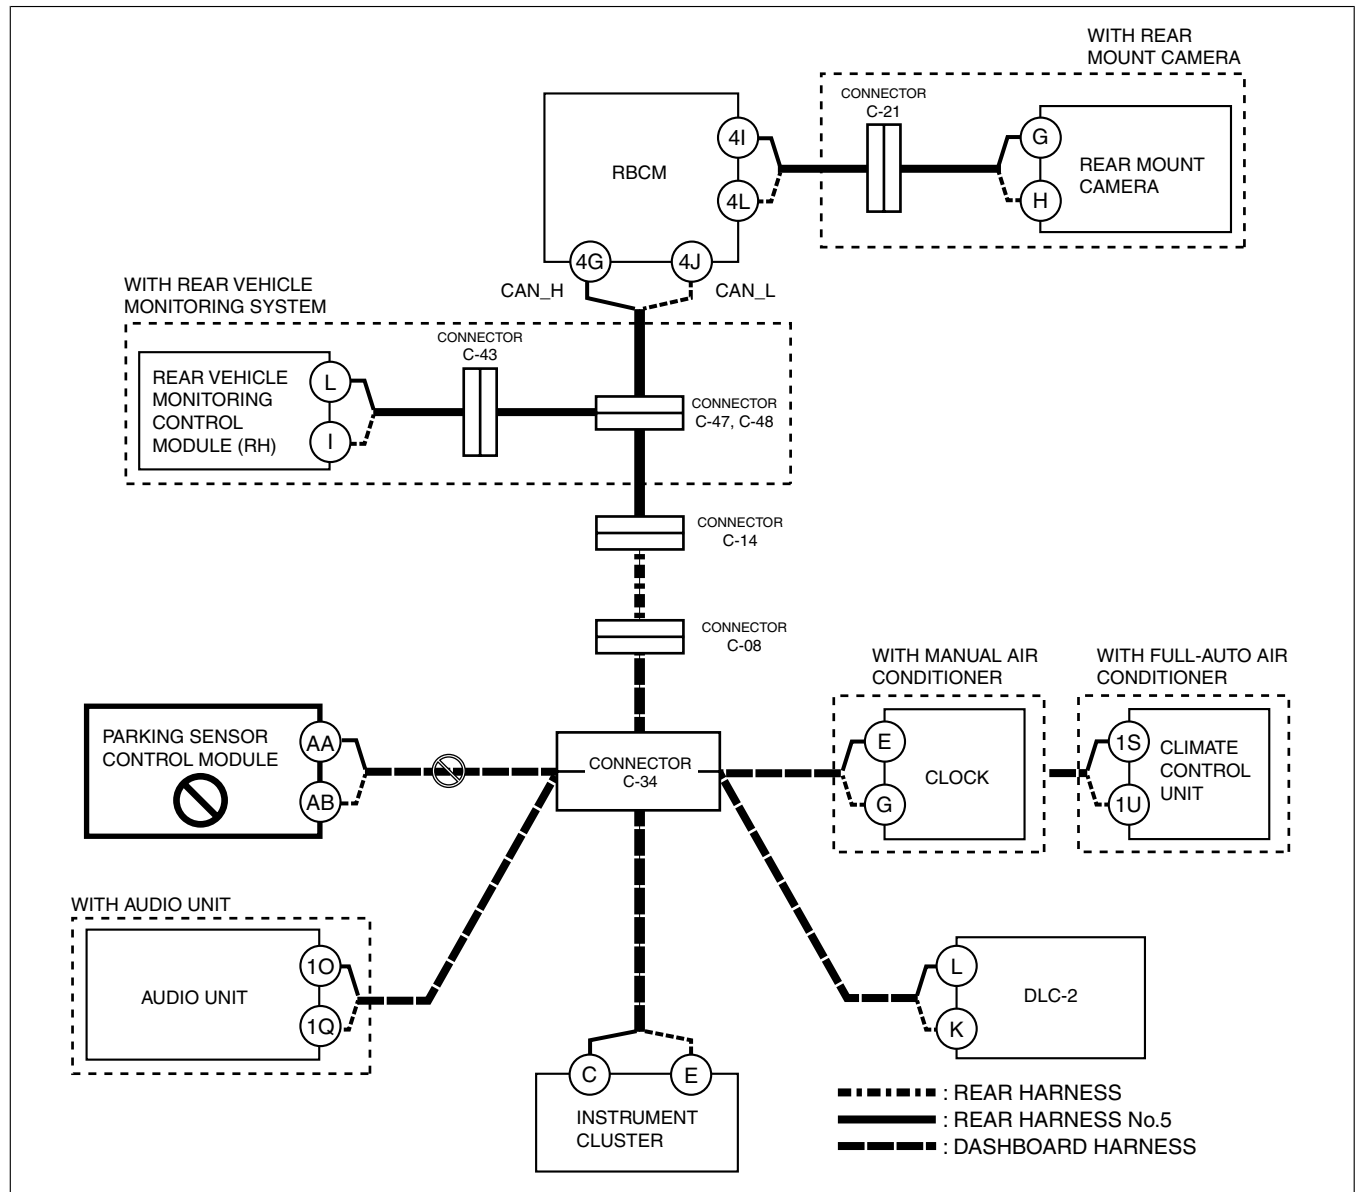
ac5wzw00000639

Parking Sensor Control Module Circuit Malfunction

- Connector terminal disconnection, poor contact, damage, deformation, corrosion
- Open circuit in wiring harness between parking sensor control module and connector C-34
- Connector C-34 malfunction
- Parking sensor control module malfunction

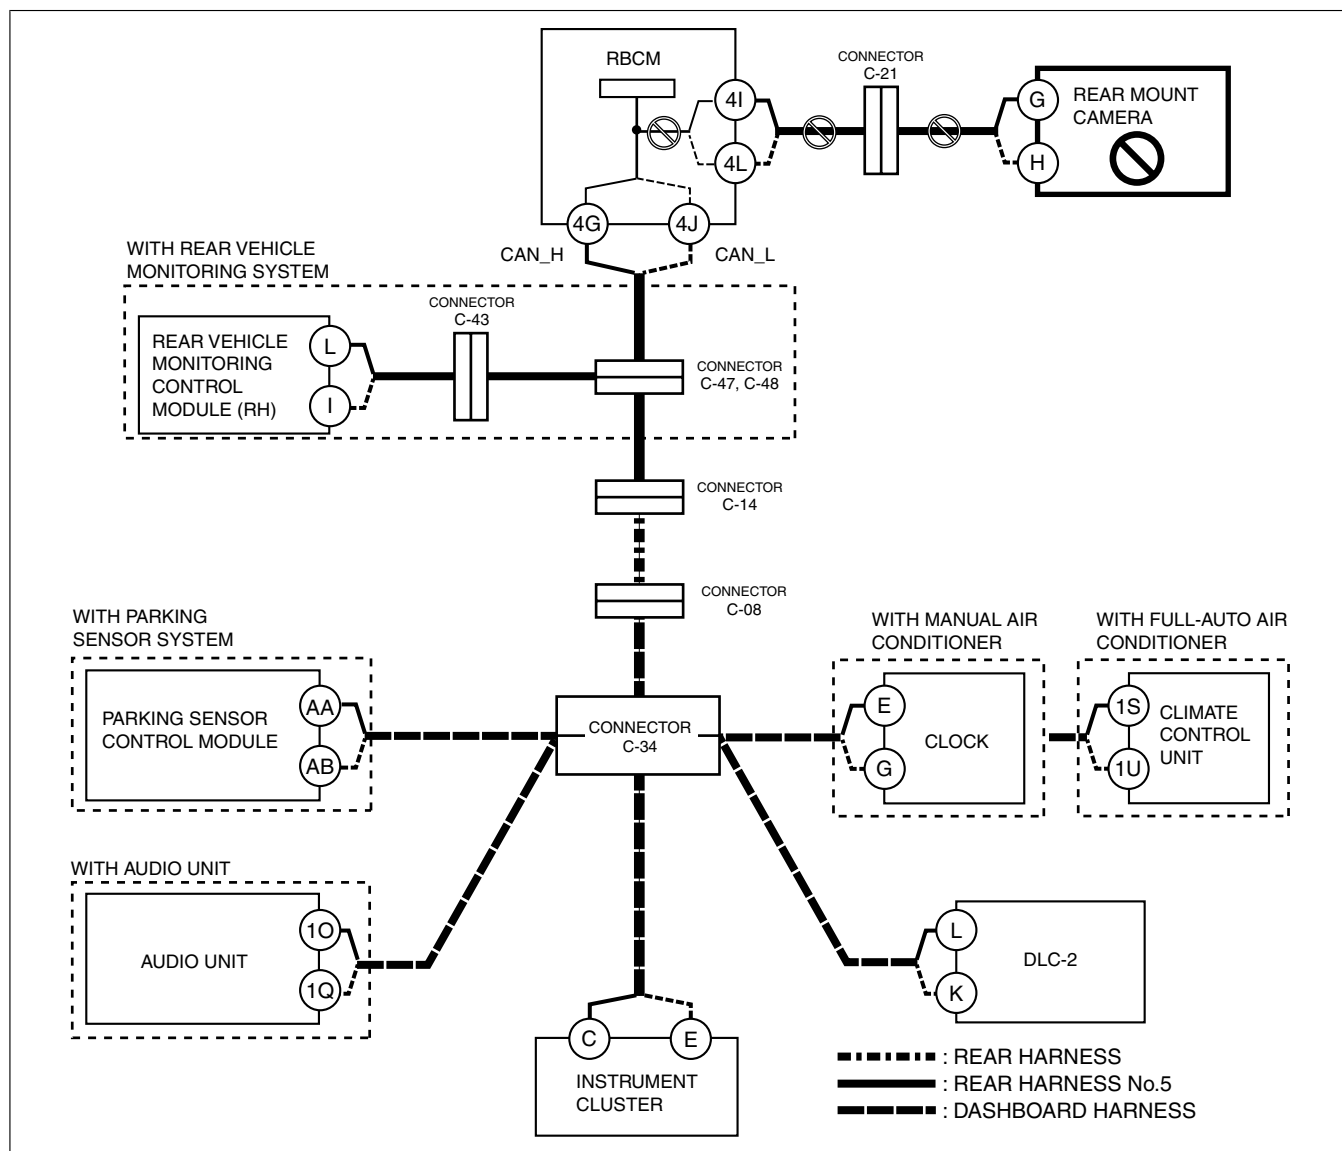
ac5wzw00001132

- Connector terminal disconnection, poor contact, damage, deformation, corrosion
- Open circuit in wiring harness between rear mount camera and connector C-21
- Open circuit in wiring harness between connector C-21 and RCBM
- Connector C-21 malfunction
- Rear mount camera malfunction
- CAN circuit in rear body control module (RCBM) malfunction

System wiring diagram
