BUILDING MOISTURE INDEX (BMI)

ENVIRONMENTAL DIAGNOSTIC REPORT

16 Spencer Hill, SW19 4NY

26/08/2024 13:33:45

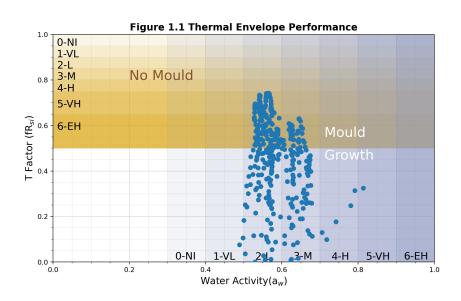
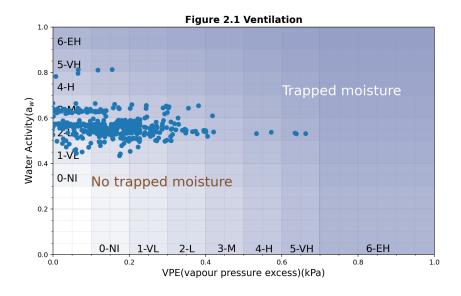
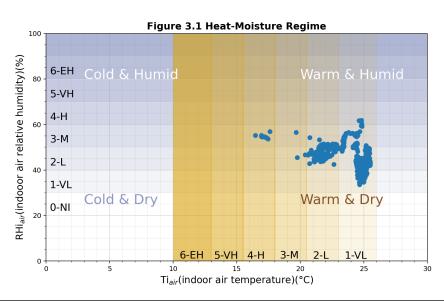
BMI causal factors graphs

Table 2.1 and Table 3.1 show average values of raw and calculated environmental parameters. The thermal envelope performance graph (Figure 1.1) shows that most data fall into an area where the temperature factor (T Factor) values (0.48 average), can be considered problematic. However this, together with most water activity (aw, surface RH) values obtained during the recorded period (0.58 average), do not present a high risk for condensation and mould growth.

The ventilation, i.e. removal of the moisture produced in this dwelling, does not seem to be a problem, with most vapour pressure excess (VPE) and water activity (aw) data (Figure 2.1) showing Very Low score (0.05 kPa and 0.58 average, respectively), in a warm (23.2°C average) and dry (46.7% average RH) environment (Figure 3.1).

Possible causes and recommendations for rectification measures				
	The temperature factor results indicate that the building envelope performance in the			
C1	measured area is poor. An investigation of the thermal performance of the walls in this			
	area and surroundings is strongly recommended.

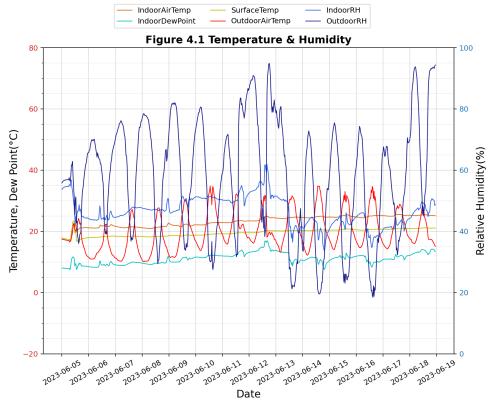
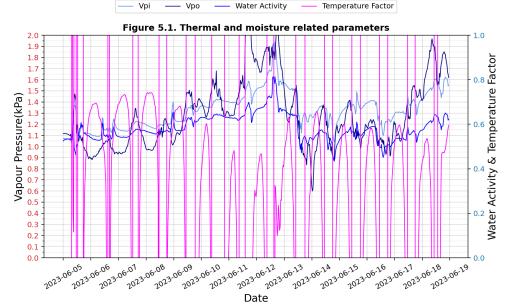
Raw and calculated parameters graphs

The likelihood of surface condensation occurring is also related to surface temperature (Surface T) and dew point (Dew P) temperature differentials (Surface T- Dew P (°C)). During the monitoring period, average Surface T is 8.5°C above Dew P temperature to give rise to condensation (Figure 4.1 and Table 2.1). The lower this difference the higher the risk of surface condensation occurring, which happens when Surface T reaches and goes below Dew P temperature.
