LOWER COWL SIDE REINFORCEMENT REMOVAL [PANEL REPLACEMENT]

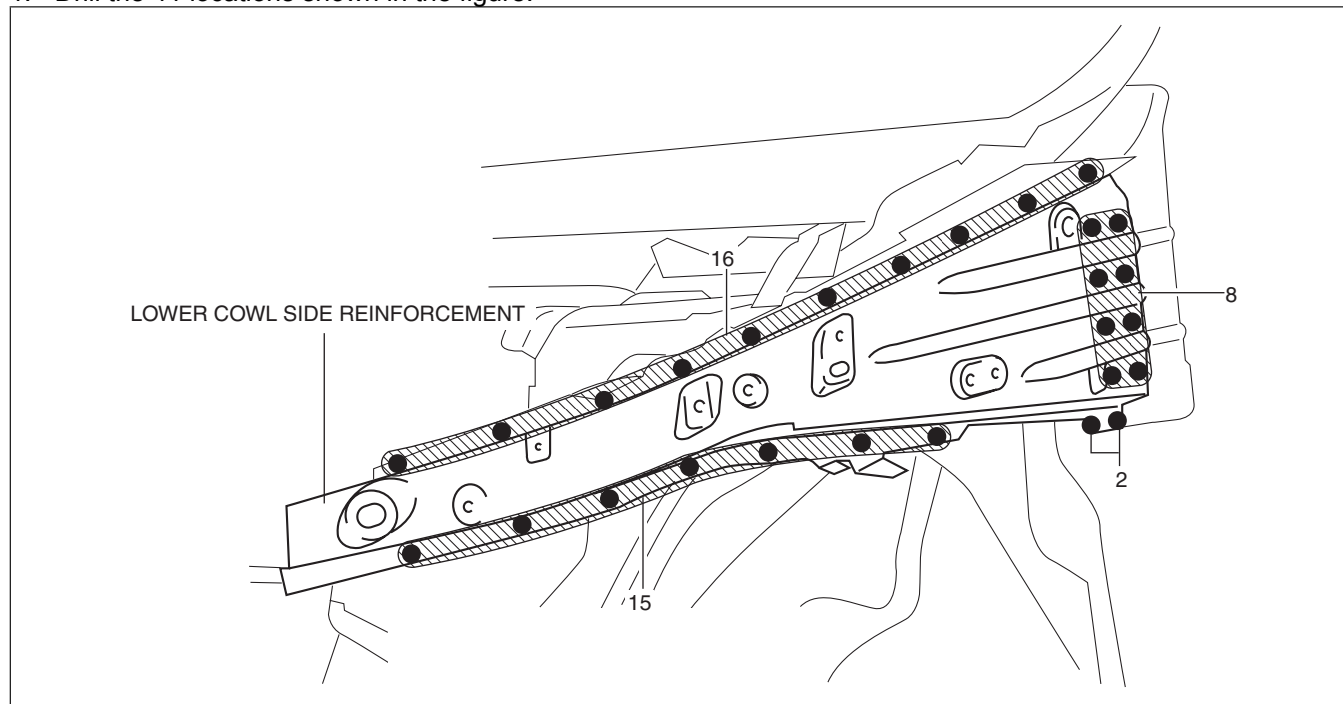
ac5wzb000000265

SYMBOL MARK	MEANING
●	SPOT WELDING

1. Drill the 41 locations shown in the figure.
