## CLUTCH PEDAL POSITION (CPP) SWITCH INSPECTION [SKYACTIV-G 2.0]

### Continuity Inspection

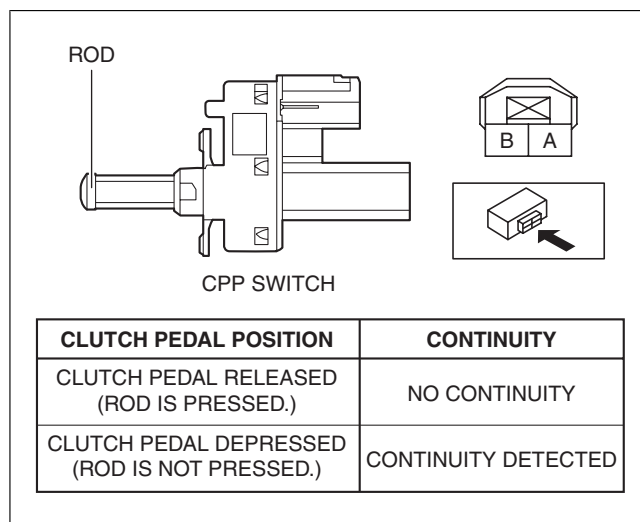
am3uuw00008741

1. Verify that the CPP switch is installed properly. (See CLUTCH PEDAL POSITION SWITCH REMOVAL/INSTALLATION [C66M-R, C66MX-R].)
2. Disconnect the negative battery cable. (See NEGATIVE BATTERY CABLE DISCONNECTION/CONNECTION [SKYACTIV-G 2.0].) (See NEGATIVE BATTERY CABLE DISCONNECTION/CONNECTION [SKYACTIV-G 2.0 (WITHOUT i-stop)].)
3. Disconnect the CPP switch connector.
4. Verify that the continuity between CPP switch terminals A and B when the clutch pedal is depressed and when it is released is according to the following table:
  - If not as verified, replace the CPP switch. (See CLUTCH PEDAL POSITION SWITCH REMOVAL/INSTALLATION [C66M-R, C66MX-R].)
