BUILDING MOISTURE INDEX (BMI)

ENVIRONMENTAL DIAGNOSTIC REPORT

16 Spencer Hill, SW19 4NY

15 October 2024

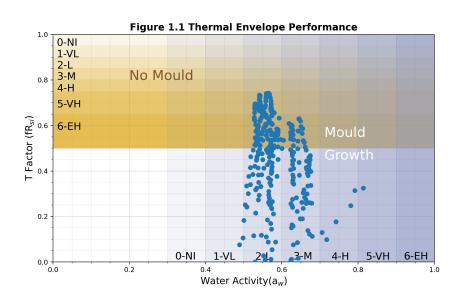
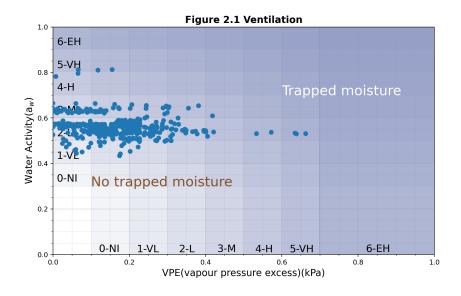
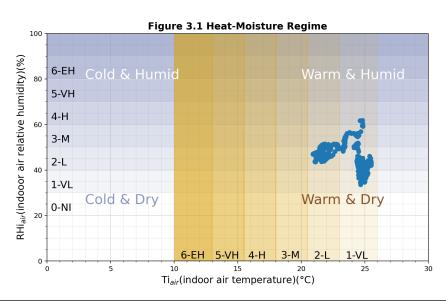
BMI causal factors graphs

Table 2.1 and Table 3.1 show average values of raw and calculated environmental parameters. The thermal envelope performance graph (Figure 1.1) shows that most data fall into an area where the temperature factor (T Factor) values (0.48 average), can be considered problematic. However this, together with most water activity (aw, surface RH) values obtained during the recorded period (0.58 average), do not present a high risk for condensation and mould growth.

The ventilation, i.e. removal of the moisture produced in this dwelling, does not seem to be a problem, with most vapour pressure excess (VPE) and water activity (aw) data (Figure 2.1) showing Very Low score (0.07 kPa and 0.58 average, respectively), in a warm (23.3°C average) and dry (46.4% average RH) environment (Figure 3.1).

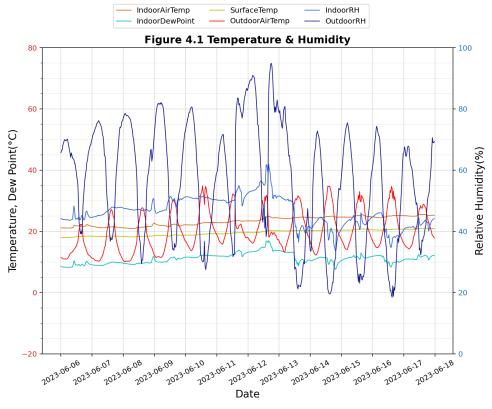
Raw and calculated parameters graphs

The likelihood of surface condensation occurring is also related to surface temperature (Surface T) and dew point (Dew P) temperature differentials (Surface T- Dew P (°C)). During the monitoring period, average Surface T is 8.4°C above Dew P temperature to give rise to condensation (Figure 4.1 and Table 2.1). The lower this difference the higher the risk of surface condensation occurring, which happens when Surface T reaches and goes below Dew P temperature.
