SAMSUNG SM-G965F TroubleShooting Guide

No Power

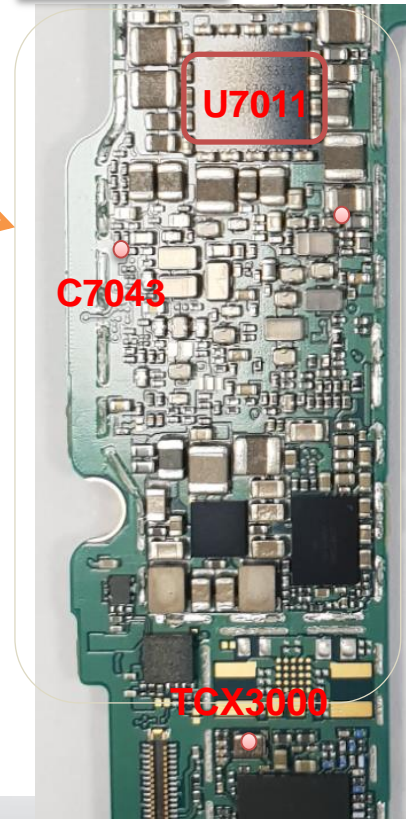
Step5, 6

3.1	Check if it's rooted. MT Pro	Rooted	OOW
		Normal	S/W update
4	Check the voltage of C7118	C7118= Power supply voltage	Go to the step 5
		If not the correct value	Replace the U7006(=IF PMIC)
5	Check the voltage of C7043(=PMIC Output)	C7043 = 1.8V	Go to the step 6
		If not the correct value	Replace the U7011
6	Check the frequency of TCX3000	26MHz	Main chip (UCP500)
		If not the correct value	TCXO (TCX300)

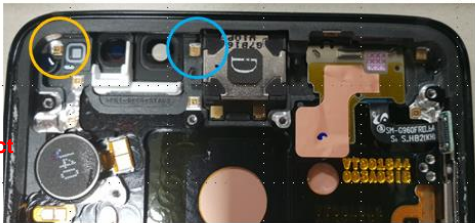
Step4

Diversity
ANTENNA contact

Step	Check point	Result value	Defect point
1	Confirm the defect symptom	-	-
2	Check the settings (airplane mode, Mobile networks)	Abnormal	Settings
		Normal	Go to the next step
3	Check the debug screen *#0011# (Compare to normal device)	Abnormal	Go to the next step
		Normal	Network
4	Check the RF parts except PBA. (Coaxial cable, Antenna, Shielding condition, etc..)	Broken, dust, corrosion	RF parts
		Loose fitting	Connection
		Normal	Go to the next step
5	Check the status visually(crack, missing, Corrosion..etc) of RF components. (compare to normal PBA)	Abnormal	RF components.
		Normal	CP(Call Processor) (UCP500) CP PMIC(U7011)
	U2001 Transceiver PAM1000 PAM1002 LPAMID PAM1001 2G PAM F2001 F2005 F2007 LFEM U1003 ET Modulator
