BUILDING MOISTURE INDEX (BMI)

ENVIRONMENTAL DIAGNOSTIC REPORT

16 Spencer Hill, SW19 4NY

15 October 2024

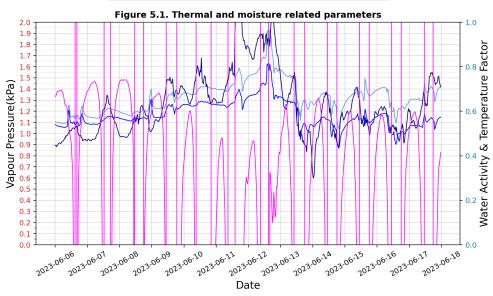
Raw and calculated parameters graphs

The likelihood of surface condensation occurring is also related to surface temperature (Surface T) and dew point (Dew P) temperature differentials (Surface T- Dew P (°C)). During the monitoring period, average Surface T is 8.4°C above Dew P temperature to give rise to condensation (Figure 4.1 and Table 2.1). The lower this difference the higher the risk of surface condensation occurring, which happens when Surface T reaches and goes below Dew P temperature.
