12th Generation Intel® Core™ Processor

Specification Update

Supporting 12th Generation Intel® Core™ Processor for S, H, U, P, and HX Processor Line Platforms, formerly known as Alder Lake

Revision 011

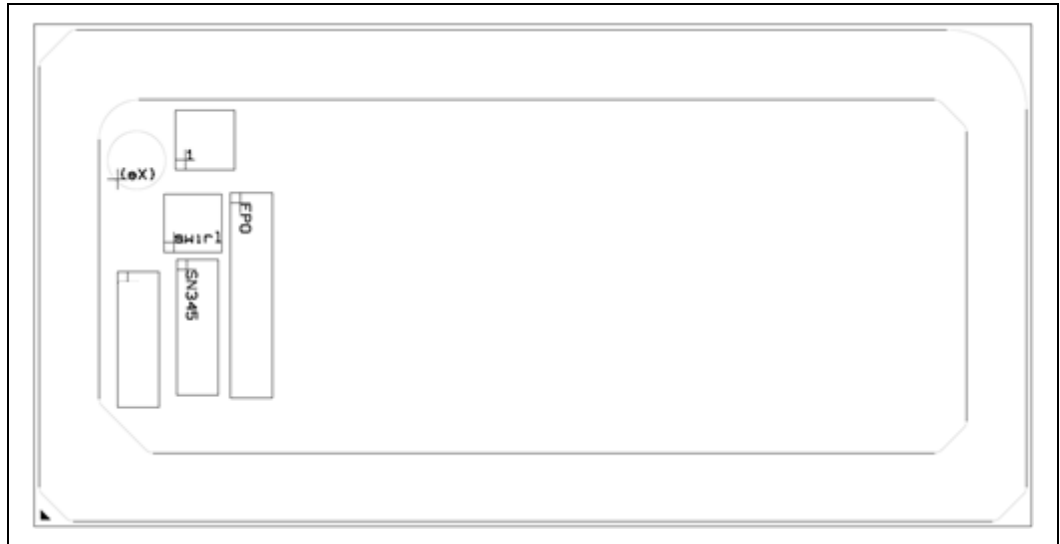
Figure 3. Processor Based on U15 Processor Line Chip Package BGA Top-Side Markings

Pin Count: 1744

Package Size: 50mm x 25mm

Figure 1. Processor Based on S Processor Line Chip Package LGA Top-Side Markings.....	8
Figure 2. Processor Based on H/P Processor Line Chip Package BGA Top-Side Markings	9
Figure 3. Processor Based on U15 Processor Line Chip Package BGA Top-Side Markings.....	10
Figure 4. Processor Based on U9 Processor Line Chip Package BGA Top-Side Markings	11
Figure 5. Processor Based on HX Processor Line Chip Package BGA Top-Side Markings	12
