BUILDING MOISTURE INDEX (BMI)

ENVIRONMENTAL DIAGNOSTIC REPORT

16 Spencer Hill, SW19 4NY

26/08/2024 12:15:30

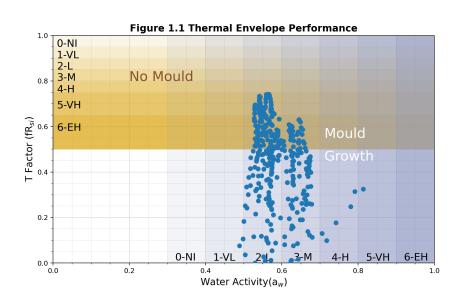
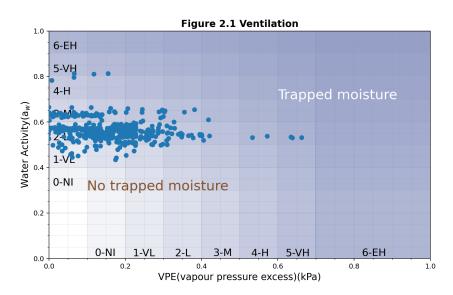
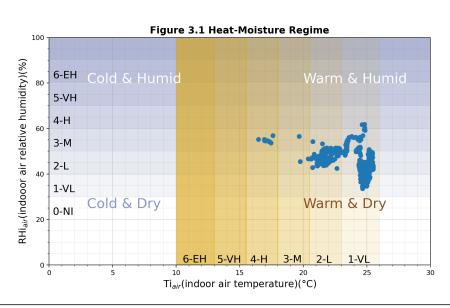
BMI causal factors graphs

Table 2.1 and Table 3.1 show average values of raw and calculated environmental parameters. The thermal envelope performance graph (Figure 1.1) shows that most data fall into an area where the temperature factor (T Factor) values (0.48 average), can be considered problematic. However this, together with most water activity (aw, surface RH) values obtained during the recorded period (0.58 average), do not present a high risk for condensation and mould growth.

The ventilation, i.e. removal of the moisture produced in this dwelling, does not seem to be a problem, with most vapour pressure excess (VPE) and water activity (aw) data (Figure 2.1) showing Very Low score (0.05 kPa and 0.58 average, respectively), in a warm (23.2°C average) and dry (46.7% average RH) environment (Figure 3.1).

Possible causes and recommendations for rectification measures				
	The temperature factor results indicate that the building envelope performance in the			
C1	measured area is poor. An investigation of the thermal performance of the walls in this			
	area and surroundings is strongly recommended.

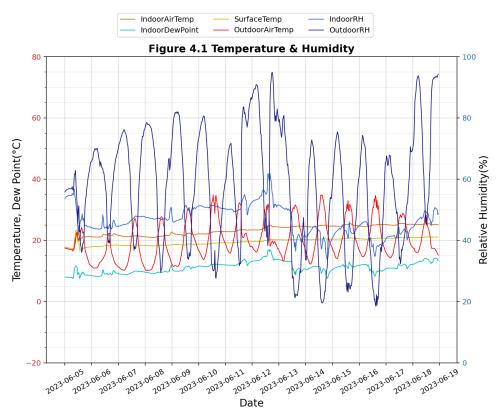
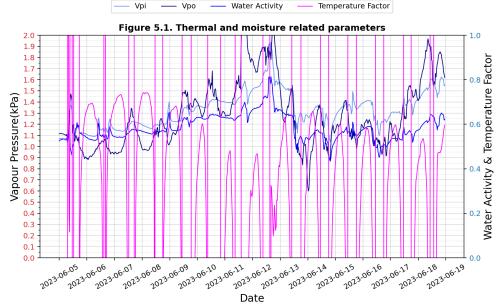
Raw and calculated parameters graphs

The likelihood of surface condensation occurring is also related to surface temperature (Surface T) and dew point (Dew P) temperature differentials (Surface T- Dew P (°C)). During the monitoring period, average Surface T is 8.5°C above Dew P temperature to give rise to condensation (Figure 4.1 and Table 2.1). The lower this difference the higher the risk of surface condensation occurring, which happens when Surface T reaches and goes below Dew P temperature.
