BUILDING MOISTURE INDEX (BMI)

ENVIRONMENTAL DIAGNOSTIC REPORT

16 Spencer Hill, SW19 4NY

26/08/2024 13:28:14

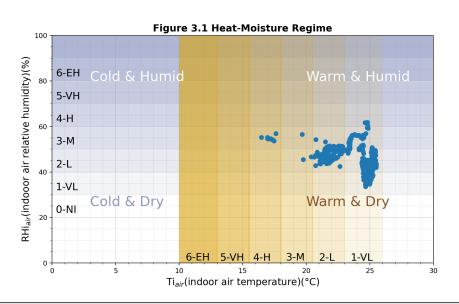
BMI causal factors graphs

Table 2.1 and Table 3.1 show average values of raw and calculated environmental parameters. The thermal envelope performance graph (Figure 1.1) shows that most data fall into an area where the temperature factor (T Factor) values (0.48 average), can be considered problematic. However this, together with most water activity (aw, surface RH) values obtained during the recorded period (0.58 average), do not present a high risk for condensation and mould growth.

The ventilation, i.e. removal of the moisture produced in this dwelling, does not seem to be a problem, with most vapour pressure excess (VPE) and water activity (aw) data (Figure 2.1) showing Very Low score (0.05 kPa and 0.58 average, respectively), in a warm (23.2°C average) and dry (46.7% average RH) environment (Figure 3.1).

Possible causes and recommendations for rectification measures				
	The temperature factor results indicate that the building envelope performance in the			
C1	measured area is poor. An investigation of the thermal performance of the walls in this			
	area and surroundings is strongly recommended.
