**TMS320F28030, TMS320F28031,
TMS320F28032, TMS320F28033,
TMS320F28034, TMS320F28035 Piccolo MCU**

Silicon Errata

Literature Number: SPRZ295M
April 2009–Revised November 2015

TMS320F2803x Piccolo™ MCU Silicon Errata

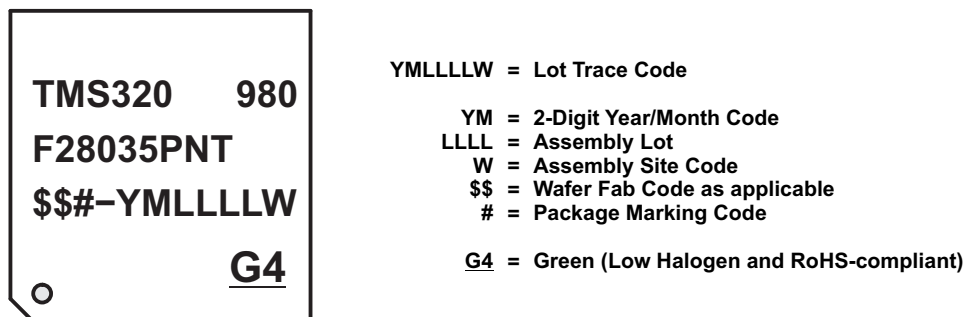
Figure 1. Example of Device Markings

Figure 1 provides an example of the 2803x device markings and defines each of the markings. The device revision can be determined by the symbols marked on the top of the package as shown in Figure 1. Some prototype devices may have markings different from those illustrated. Figure 2 shows the device nomenclature.

Table 1. Determining Silicon Revision From Lot Trace Code

PACKAGE MARKING CODE	SILICON REVISION	REVISION ID Address: 0x0883	COMMENTS
Blank	Indicates Revision 0	0x0000	This silicon revision is available as TMX and TMS.
A	Indicates Revision A	0x0001	This silicon revision is available as TMS.
