BUILDING MOISTURE INDEX (BMI)

ENVIRONMENTAL DIAGNOSTIC REPORT

16 Spencer Hill, SW19 4NY

27 August 2024 12:36:55

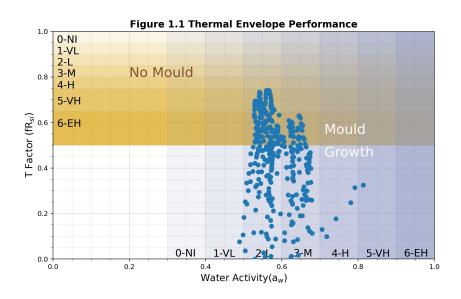
Table 2.1 and Table 3.1 show average values of raw and calculated environmental parameters. The thermal envelope performance graph (Figure 1.1) shows that most data fall into an area where the temperature factor (T Factor) values (0.48 average), can be considered problematic. However this, together with most water activity (aw, surface RH) values obtained during the recorded period (0.58 average), do not present a high risk for condensation and mould growth.

Possible causes and recommendations for rectification measures				
	The temperature factor results indicate that the building envelope performance in the			
C1	measured area is poor. An investigation of the thermal performance of the walls in this			
	area and surroundings is strongly recommended.

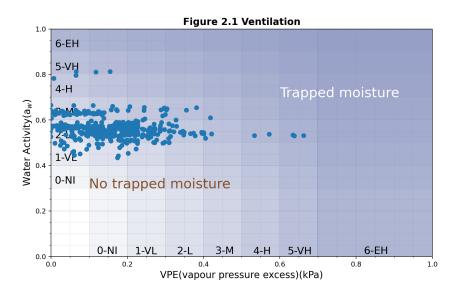
The ventilation, i.e. removal of the moisture produced in this dwelling, does not seem to be a problem, with most vapour pressure excess (VPE) and water activity (aw) data (Figure 2.1) showing Very Low score (0.05 kPa and 0.58 average, respectively), in a warm (23.2°C average) and dry (46.7% average RH) environment (Figure 3.1).

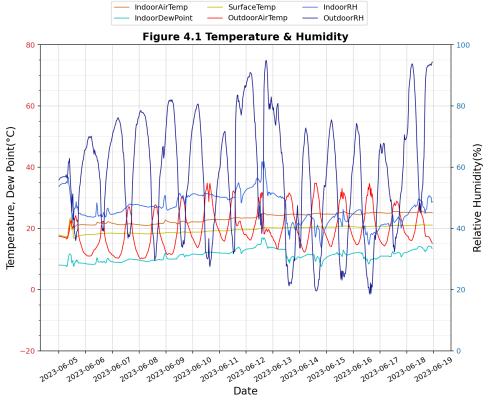
The likelihood of surface condensation occurring is also related to surface temperature (Surface T) and dew point (Dew P) temperature differentials (Surface T- Dew P (°C)). During the monitoring period, average Surface T is 8.5°C above Dew P temperature to give rise to condensation (Figure 4.1 and Table 2.1). The lower this difference the higher the risk of surface condensation occurring, which happens when Surface T reaches and goes below Dew P temperature.

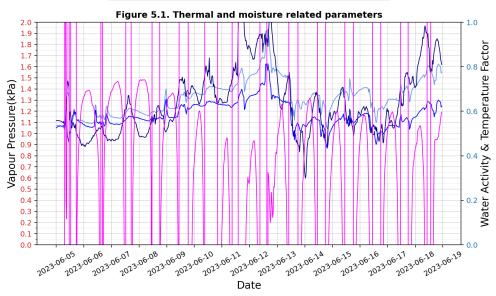
Table 3.1 Average calculated parameters from raw data

Conditions	Water Activity	T Factor	Vpi(kPa)	Vpo(kPa)	VPE(kPa)
Average	0.58	0.48	1.3	1.3	0.0
Max	0.81	0.74	1.9	2.2	0.7
Min	0.43	0.01	1.0	0.6	-0.6
