LEVEL 2

Survey & Valuation

44 Queen Victoria Drive,
Swadlincote, Derbyshire, DE11
0LA

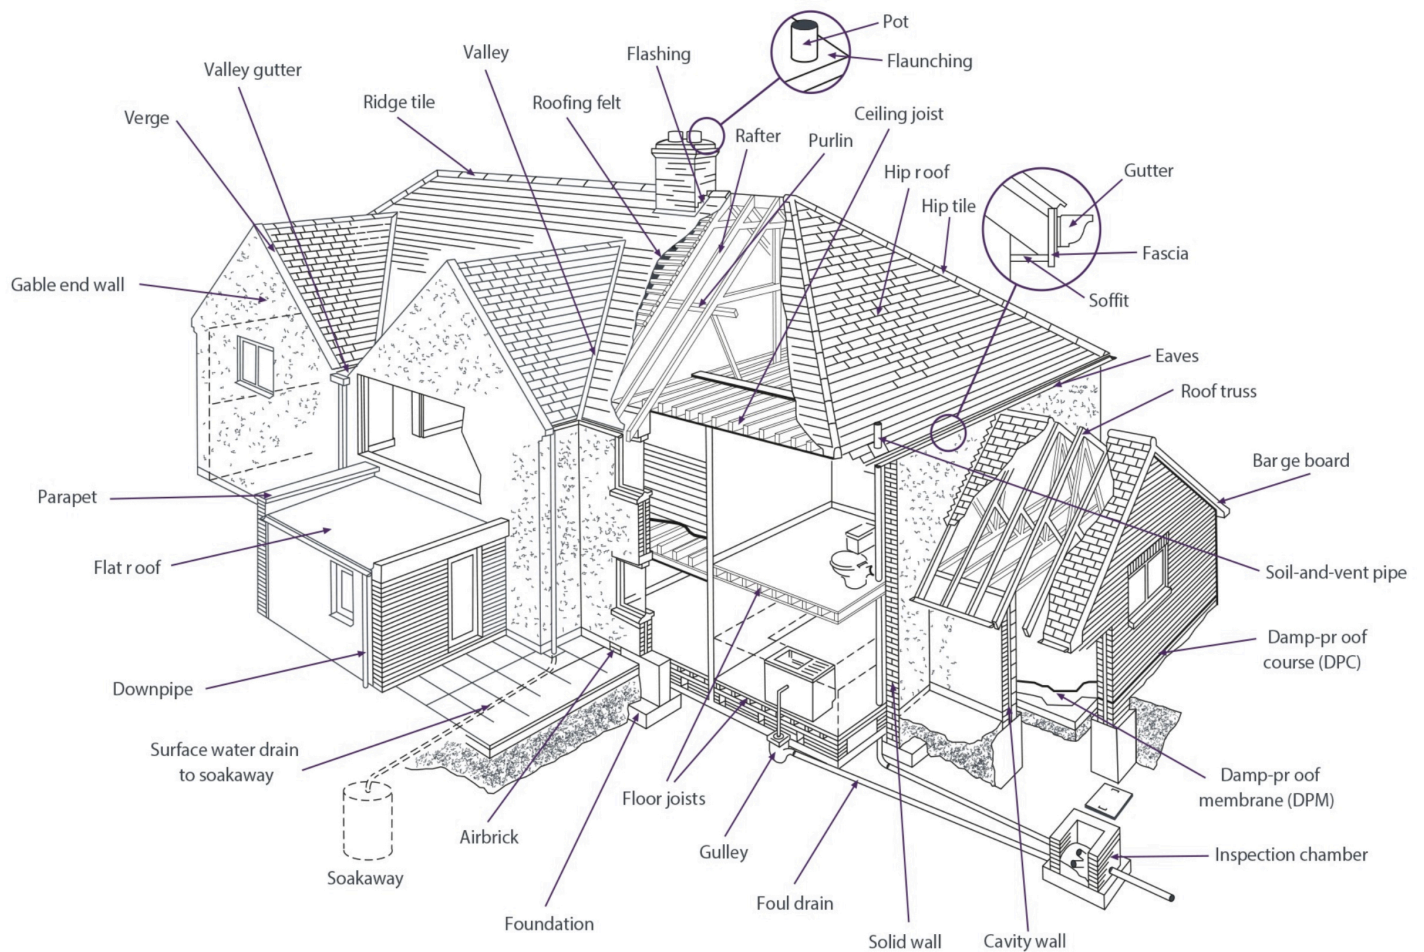
N Typical house diagram

This diagram illustrates where you may find some of the building elements referred to in the report.
