**Exercise Manual**  
*for*  
**Quartus II Software Design Series:  
Optimization**

# **Exercise 1:**

## **General Timing Optimization**

## Top-Level Design

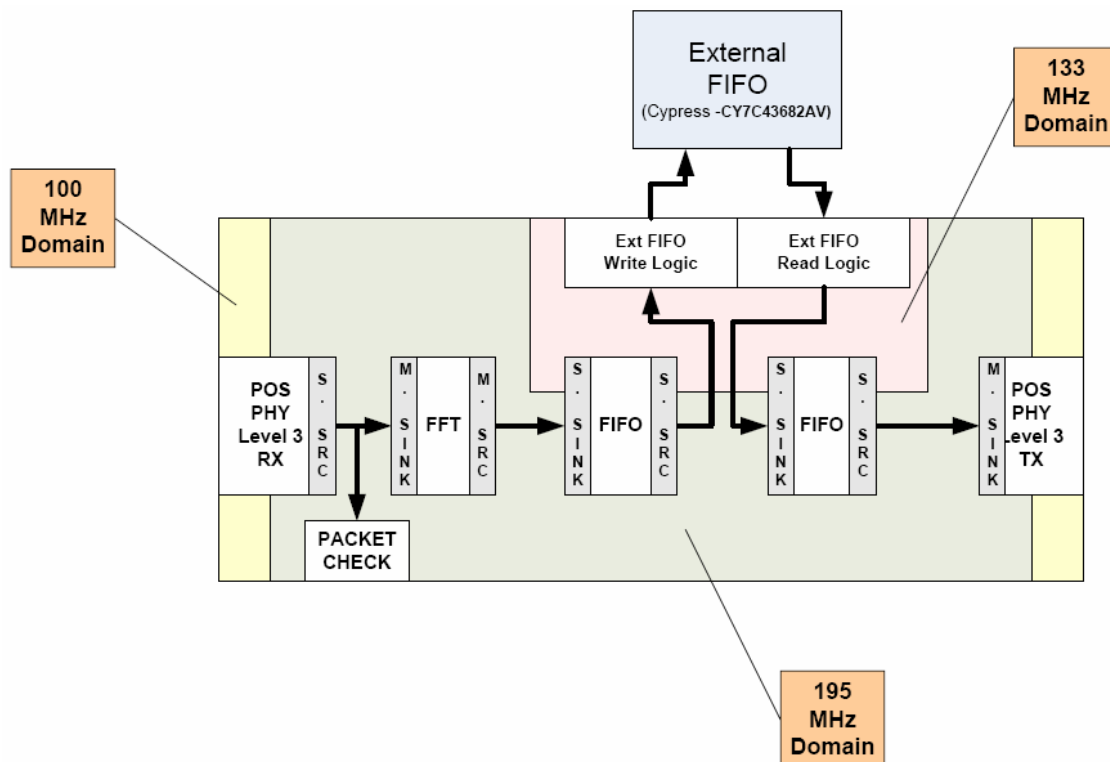
This networking design, named **lab\_design**, implements a POS-PHY level 3 link between two systems. After being received by the POS-PHY Level 3 receiver block, the “packet check” block analyzes a packet of data to ensure it is correct, e.g. making sure that a packet is 1K words long and that the ERR flag from the receiver is not asserted. The packet then passes through an FFT and a series of FIFOs, with an external FIFO being used for increased storage capability. The packet is finally transmitted by the POS-PHY level 3 transmitter to another device.

There are 3 clock domains in the design, a 100-MHz external domain, a 195-MHz internal clock domain, and a 133-MHz domain to drive the external FIFO.

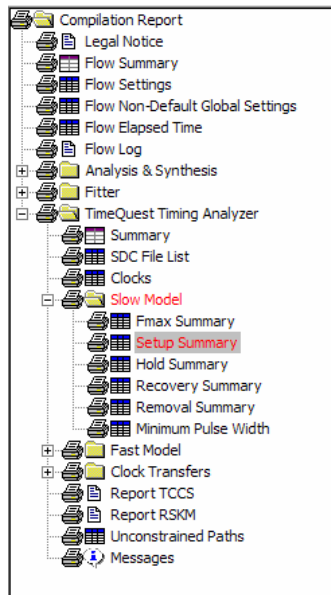
button or, from the **Processing** menu, click **Start Compilation**. Click **OK** when complete.
3. Check timing summaries. In the **Compilation Report**, expand the **TimeQuest Timing Analyzer** folder. Click on the **Setup Summary** (appearing in red to indicate there are failing paths) to see that the SCLK domain is failing.

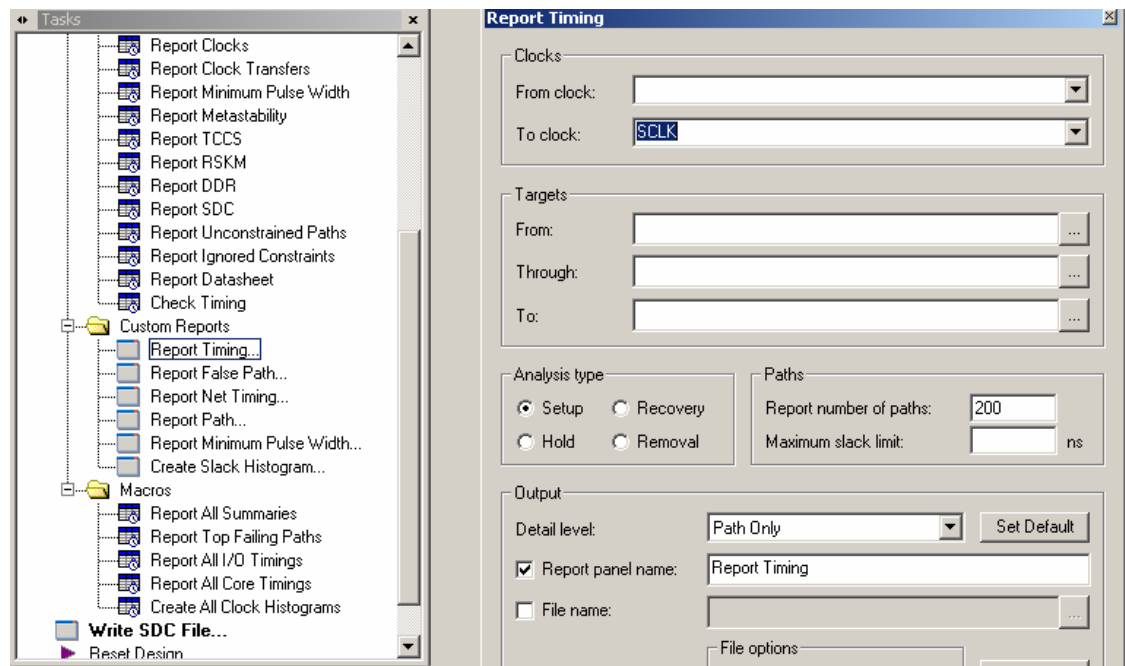
3. Run a setup analysis report of the SCLK domain. From the **Tasks** pane in **TimeQuest**, choose **Report Timing**. Edit the following sections and choose **Report Timing**.

To clock	SCLK
Analysis type	Setup
Paths (Report number of paths)	200
Output (Detail level)	Summary

The **Report Timing Summary** report appears. What a sea of RED!!

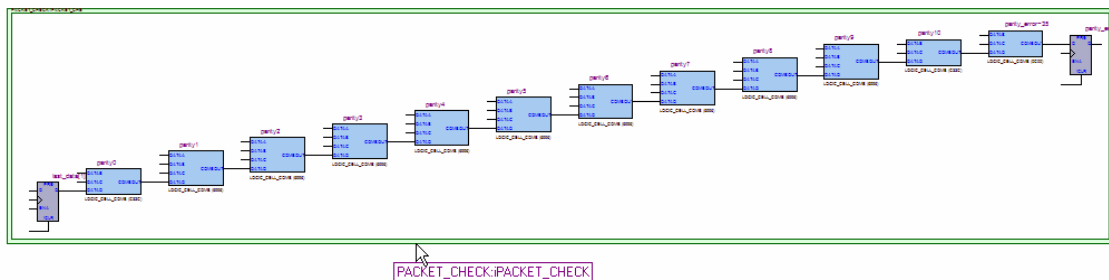
*In the **Technology Map Viewer** graphical display, you can see that there are **12** logic levels between the **last\_data** and **parity\_error** registers. This is good evidence that this is a **Case 1** timing failure: Too many logic levels.*

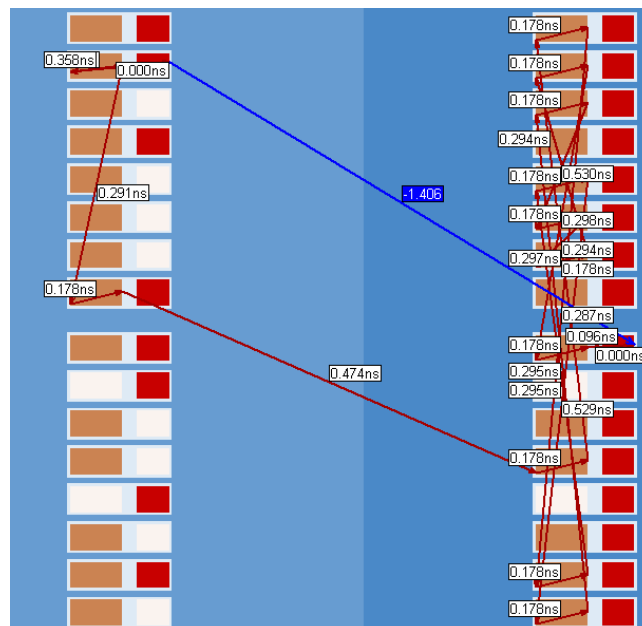
*To fix this Case 1 timing path, you will add pipeline registers. This is a valid solution because, understanding the design, you know that when a parity error occurs, it is not critical that this error be caught immediately. A lag of a few cycles can easily be tolerated by the logic.*

*The code for the corrected design has already been written for you. This code involves adding multiple stages through the parity checking logic*

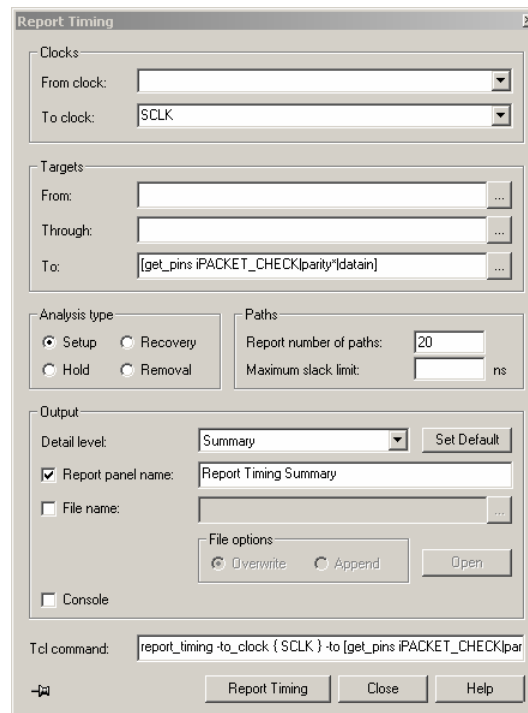
To clock	SCLK
To	[get_pins iPACKET_CHECK parity* datain]
Analysis type	Setup
Paths (Report number of paths)	20
Output (Detail level)	Summary

*From this report you can see that all parity checking registers are now meeting timing.*

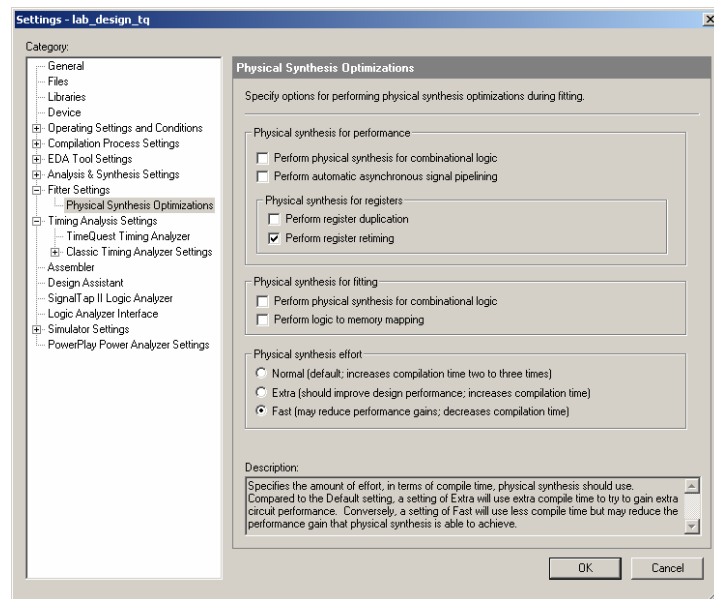
- Turn on physical synthesis. From the **Assignments** menu, choose **Settings**. Choose the **Physical Synthesis Optimizations** category under **Fitter Settings**. Enable **Perform register retiming**. Set the **Physical synthesis effort** to **Fast**. Click **OK**.

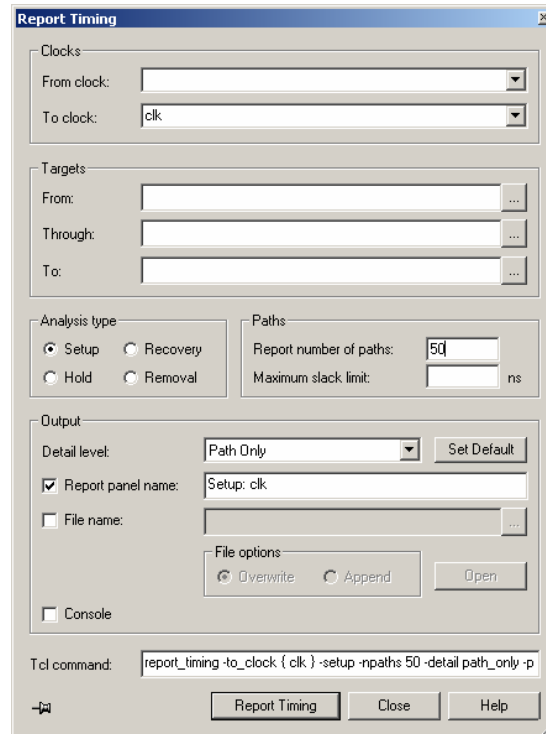
(**Setup**) report, right-click on **row 1** and choose **Report Timing**. In the **Report Timing** dialog box, change the **Report number of paths (Paths section)** to **50** and use the **Detail level:** drop-down menu (**Output section**) to select **Summary**. Click on the **Report Timing** button.

*Why do this? This report is generated in order to determine how many paths are actually failing (e.g. a few paths versus hundreds of paths) and if any relationships can be found amongst the failing paths. Can you notice any such relationships?*

- *You should notice that the top 23 failing paths are all between the design outputs (**dct\_out** and **data\_valid**) and the registers driving them, and that they are all failing by over 1 ns. You should analyze more closely to see if we are getting the best placement for the output registers.*

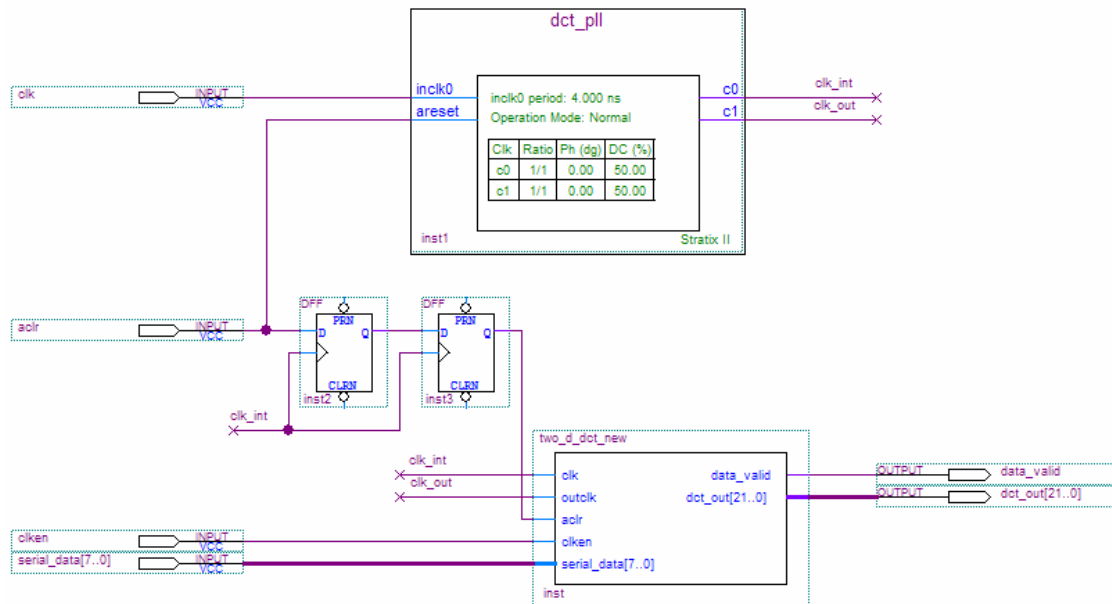
A new top-level design file (**top\_dct.bdf**) has been created for you. It incorporates a PLL named **dct\_pll** as well as adds some synchronizations registers to your asynchronous input path.

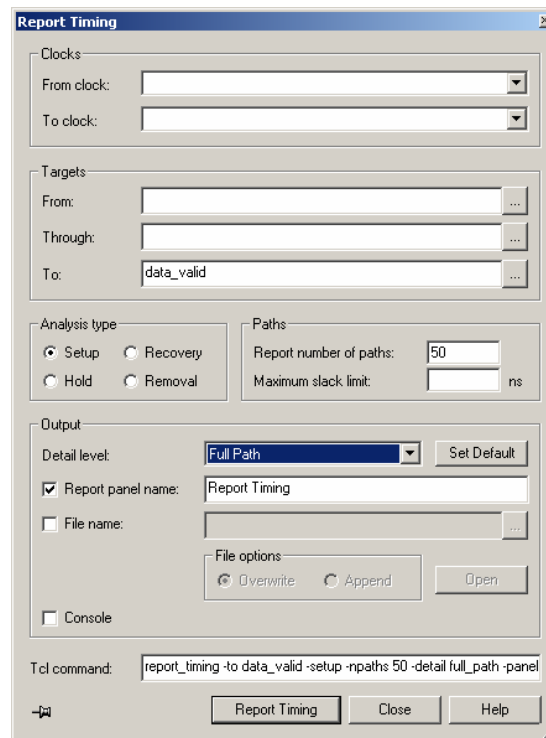
6. Verify the above information regarding the output registers. Open **TimeQuest**. In the **Tasks** pane, double click on **Report Timing**. In the **To:** field (**Targets** section), type **data\_valid**. In the **Detail level:** field (**Output** section), use the drop-down menu to select **Full Path**. Click **Report Timing**.

*This time, you will see full path for the clock expanded. On line 6 of the **Data Arrival Path**, you can see that the PLL inserts a **-5.049 ns** phase compensation offset to account for the global clock tree delay. This reduces the data arrival time enough for you to meet your setup time requirement for the outputs.*
