Important note on cable insertion on WSPR-RX Hardware Version 4.3 and 4.4

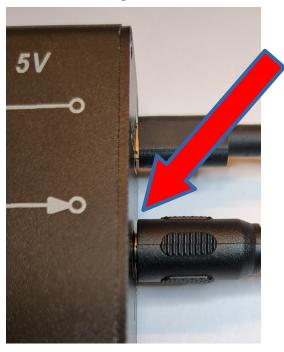
In version 4.3 and 4.4 of the WSPR receivers the audio out female does not protrude long enough to give a good connection unless the audio cable is pushed all the way in.

If the cable is not pushed all the way so the side of the audio cable is flush to side of the box there will be no sound out.

The difference in distance is just one millimeter.

Pushing it all the way in makes all the difference and the audio will be sent to the cable. Audio functions properly.
