Bearing temperature drift on the HX-400 pump series

Technical Note TN-2026-014 · Halvorsen Fluid Systems, Reliability Engineering

Document	TN-2026-014, revision A
Issued	12 March 2026
Author	Ingrid Moe, Reliability Engineering
Applies to	HX-400, HX-420 and HX-460 centrifugal pumps
Status	Released for field service

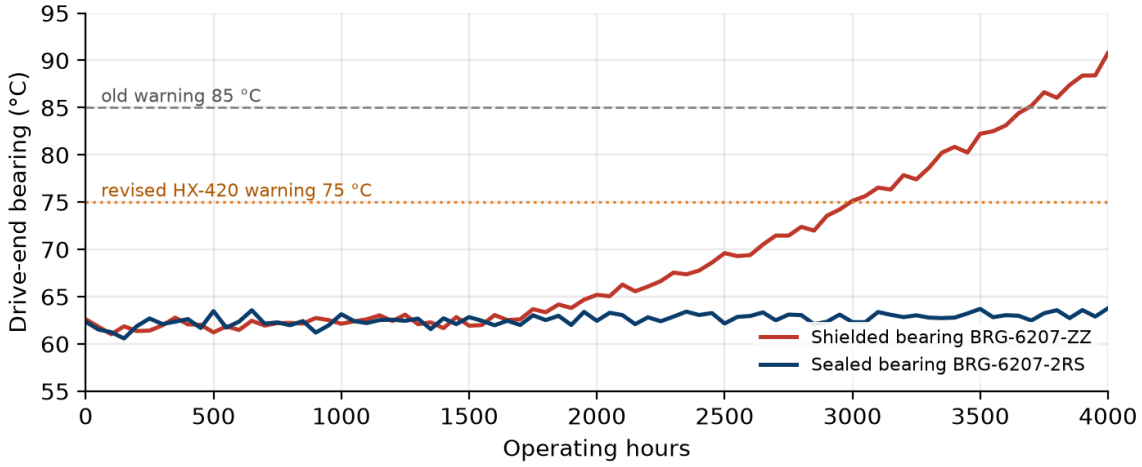
Figure 1: Drive-end bearing temperature of two HX-420 pumps on the same site, one with the shielded bearing BRG-6207-ZZ and one with the sealed bearing BRG-6207-2RS, over the first 4,000 operating hours.

Figure 1 shows the pattern seen across the affected sites. Both pumps start at the same temperature. After about 1,500 hours the pump with the shielded bearing begins to drift upwards and crosses the old warning threshold shortly after 3,000 hours, while the pump with the sealed bearing stays within two degrees of its starting value.

Teardown of six failed bearings showed dry, darkened grease and polished raceways, the typical signature of lubricant starvation rather than overload or misalignment. The shielded bearing has a small gap between the shield and the inner ring. At high operating temperature the base oil of the grease migrates out through that gap, and the remaining thickener no longer lubricates the rolling elements. Friction then rises, which raises the temperature further and speeds up the loss of oil. The sealed bearing has a contact seal instead of a gap and keeps its grease charge for the full service interval.

The sealed bearing BRG-6207-2RS is now the standard drive-end bearing for the whole series. It has been fitted in production from serial number HX4-26-0410 onwards. Pumps

below that serial number keep the shielded bearing BRG-6207-ZZ until their next bearing change, at which point the sealed bearing must be fitted instead. The two parts are dimensionally identical and no other component changes, so the replacement can be done during a routine service visit.
