Artifacts in AFM

Kishan K. Sinha
Xiaoshan Xu's group
Department of Physics and Astronomy
University of Nebraska-Lincoln

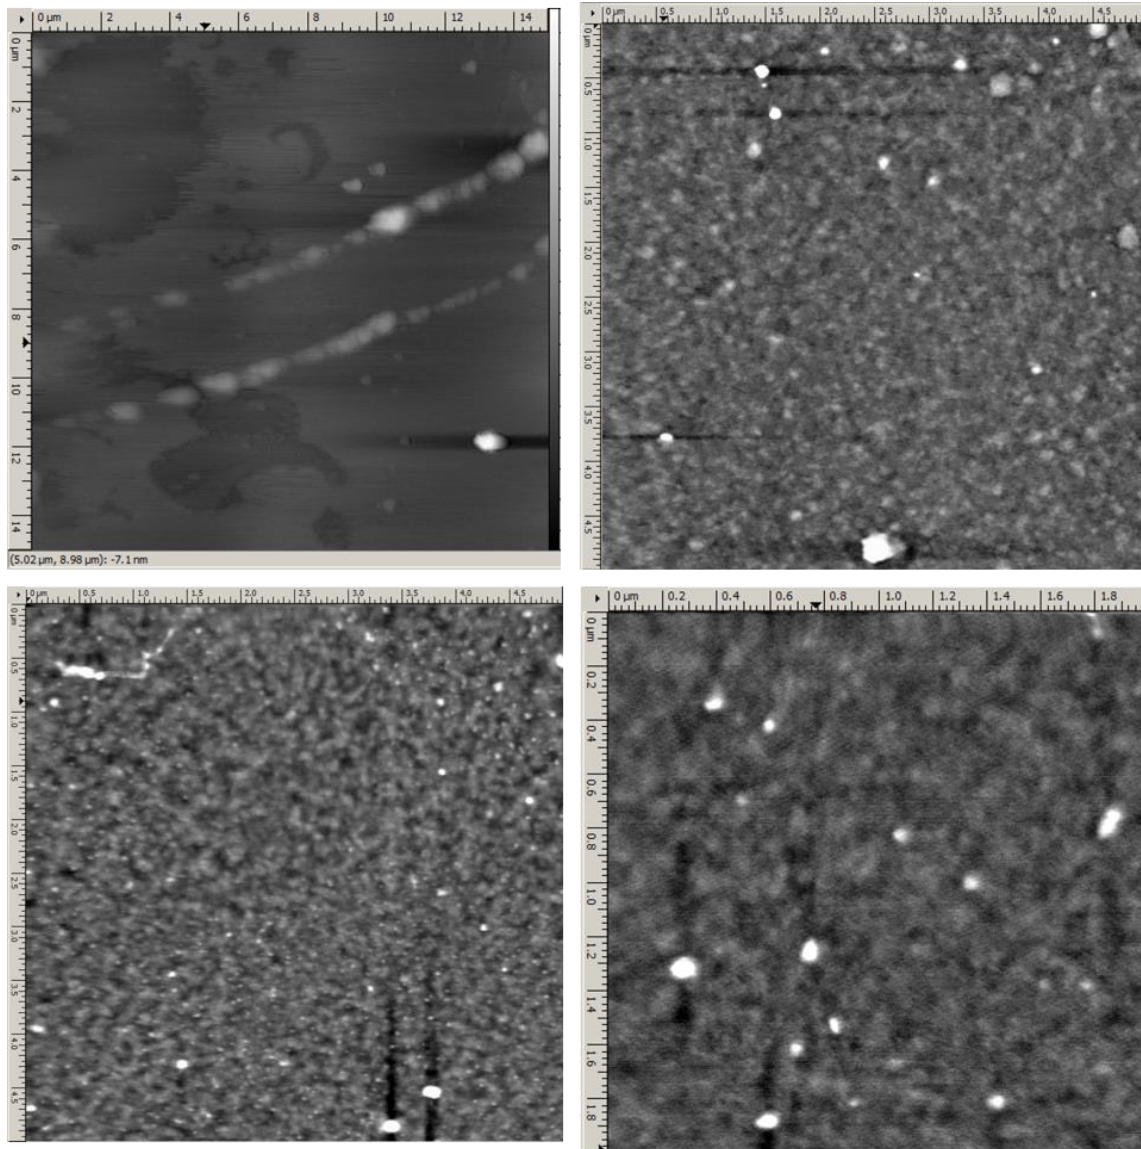
Fig. 1: Artifacts introduced when large particles are not excluded from line-levelling process

Below are a few images that exhibit artifacts induced by applying line-leveling without excluding particles on the surface.

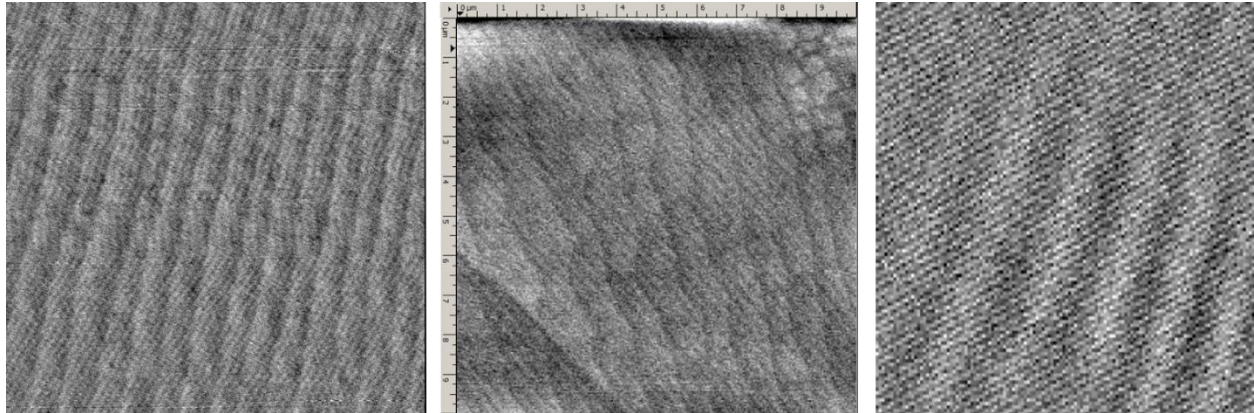
Fig. 2: AFM scans of step-terrace morphology on 0001 surface of alumina. The non-uniform lines are the steps whereas overlying uniform and periodic high frequency lines are the artifacts. In the third image, severity of artifacts render steps completely invisible (low frequency oscillations are not steps but artifacts from interference).

Images below exhibit the effect of not having the ground wire attached to the sample stage and/or having high gain value. Note that images are also ridden with artifacts other than high frequency oscillations. All of them will be addressed as we proceed.

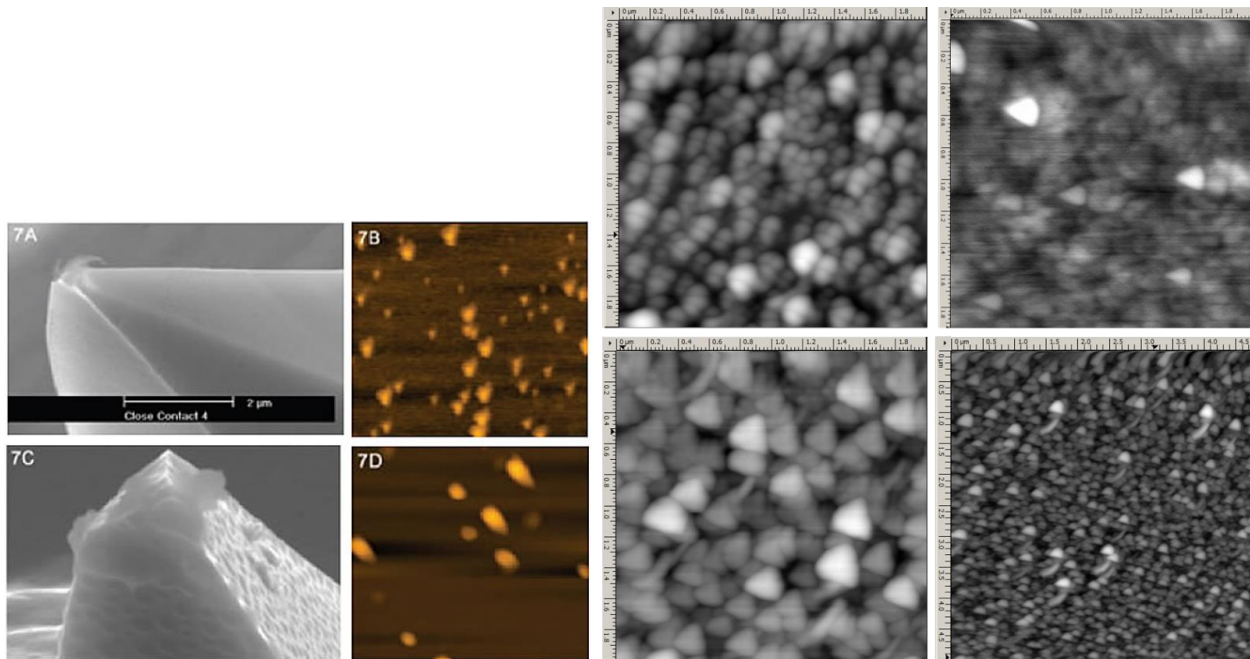
Fig. 3: Artifacts due to chipped/broken tip.

For example, if the tip has a triangular cross-section and is damaged, particles with dimensions comparable to that of the tip will appear as triangular objects, as shown in the images below. If the tip is conical, the shape of particles in the scan will be different. It is quite possible to encounter other peculiar shapes depending on the way the tip is broken.

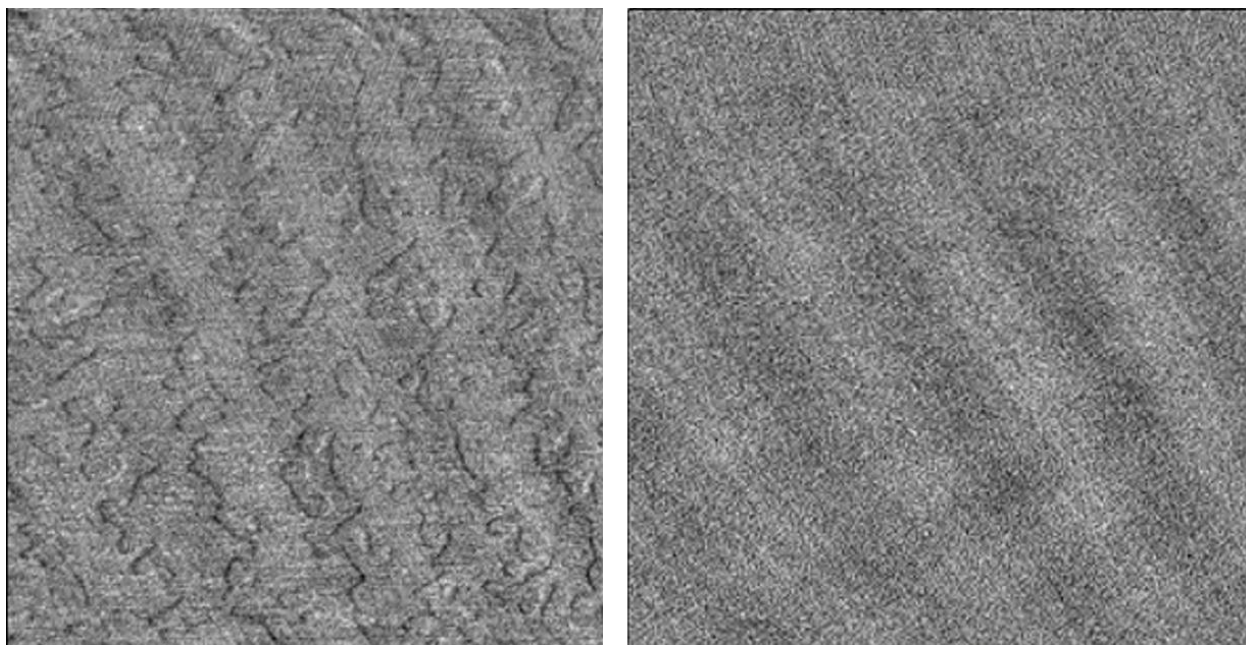
Fig. 4: Low-frequency oscillations induced due to interference of reflected off of cantilever and sample surface.

If the surface being scanned is flat, the laser beam reflected off of the cantilever and some part of the surface may interfere. This interference introduces artifacts in the form of low frequency undulations on AFM image. Below are a couple of examples where the interference dominates the actual underlying surface features. The period of these oscillations is typically close to the wavelength of the laser light.

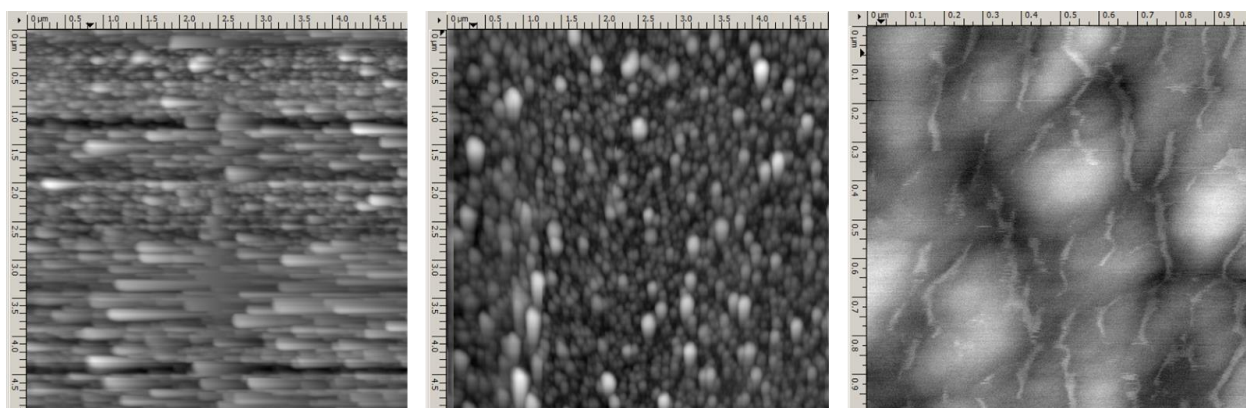
Fig. 5: Artifacts introduced due to interaction of AFM probe and contaminated surface.

Contamination of the surface by fingerprint, oil film, etc. can cause artifacts such as smearing of the features or streaks in regions with sharp features as the tip may drag/pull material while scanning. Such artifacts can be eliminated by cleaning the sample with a suitable solvent.

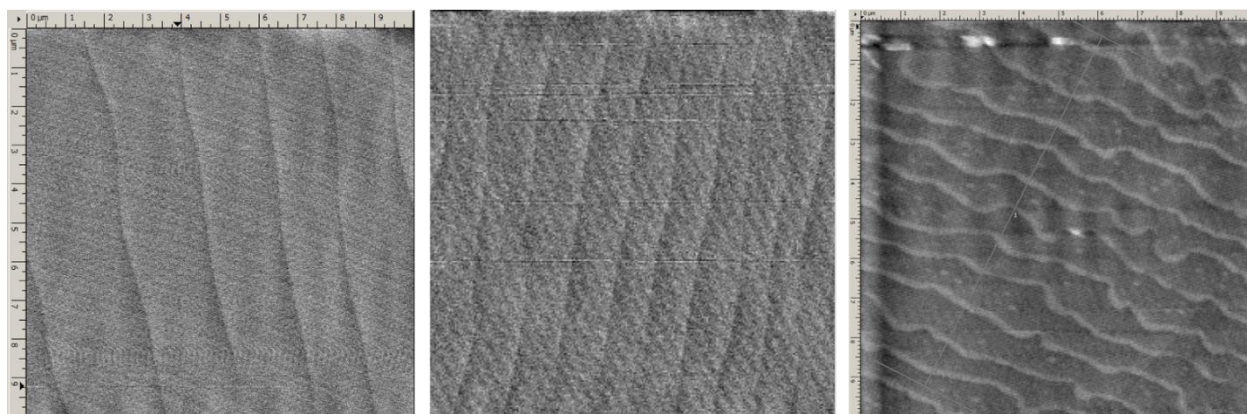
Fig. 6: Enhanced contrast (overshoot and undershoot) at edges due to hysteresis in piezo-scanners.

Ceramic piezo-scanners often exhibit hysteresis meaning they respond differently when scanning the over the same feature in different directions. Hysteresis along z-direction can influence the tip motion across an edge or a step leading to erroneous measured heights. Unlike other artifacts, hysteresis along z-axis tends to enhance the image especially at edges by increasing apparent contrast and hence distorting the actual difference in heights. Hysteresis can be effectively suppressed by reducing the scan speed. If this does not work, one might have to resort to optimizing the GPID parameters. Images in fig. 6 exhibit the typical enhanced contrast across the 0001 alumina steps. Notice that the first two images also exhibit the electronic noise suggesting lack of proper sample grounding whereas the third one exhibits artifacts due to interference in addition to hysteresis.

Hysteresis along x (or y) direction generally appear as a line across the image in y (or x) direction. Third image, which is already processed to remove background, exemplifies this where the scan direction is along x-axis and hysteresis in this direction results in a line on the left side of the image. A fix to this problem would include optimization of GPID parameters along with a slow scan rate.

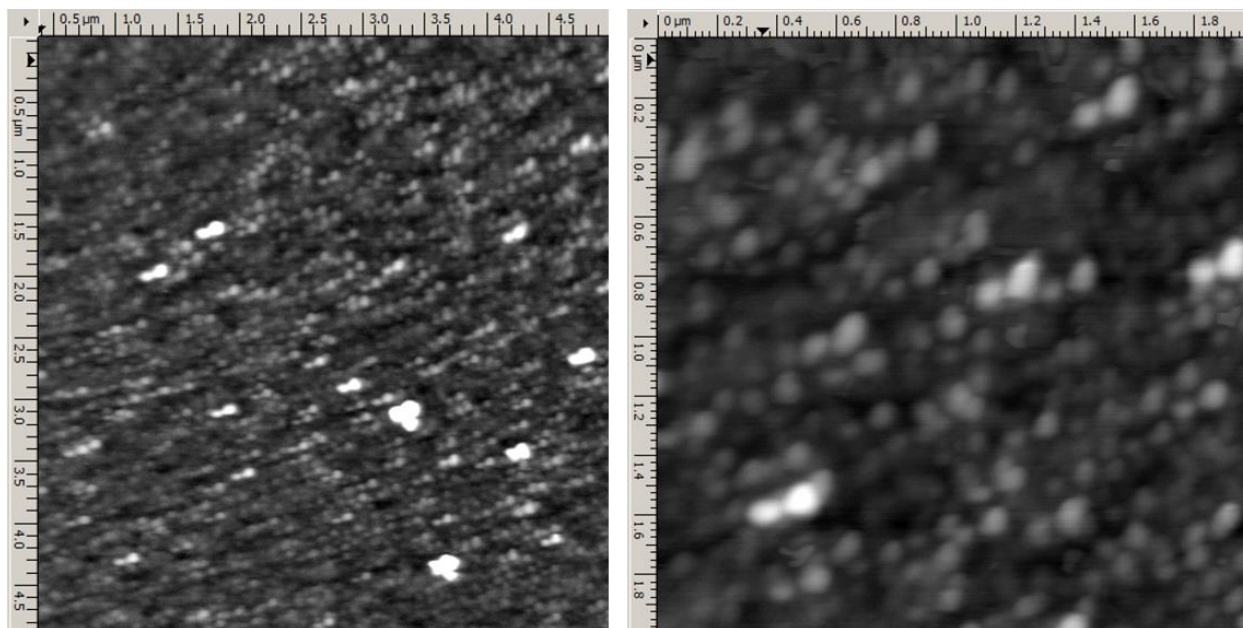
Fig. 7: Repetitive patterns due to contaminated tip.

A tip may gather dirt while scanning a dirty surface. These dirt particles act as secondary tip and usually result in repetitive pattern with peculiar shapes on AFM image. The details of particle shape on image depend upon the resultant geometry of the dirty tip. Sometimes it could also lead to triangle-shaped particles (as are observed with a chipped tip) in the image. If luck is in favor, one could get rid of dirt by vibrating the tip vigorously or scanning a hard surface. However, changing the tip is usually a better option.

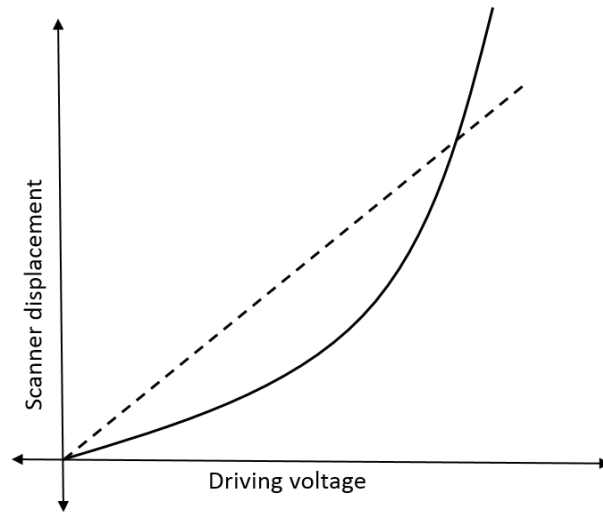
Non-linear response of a ceramic piezo-scanner

Fig. 8: Examples of non-linear response (a) and trajectory of ceramic piezo-scanners (b).

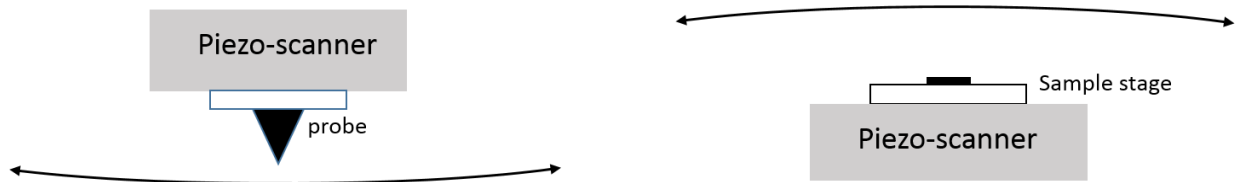
(b)

Typical curved trajectories of probe (when scanners are attached to the probe) or sample stage (when scanners are attached to the sample stage).

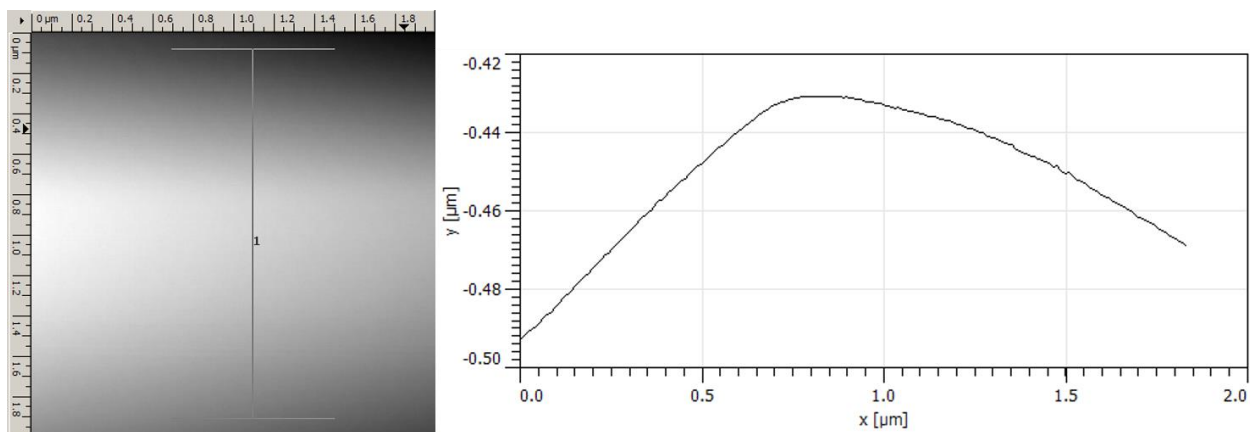
Fig. 9: A typical bow (in this particular case, the piezo-scanner is attached to sample stage and AFM probe remains stationary)

Ceramic piezo-scanners are non-linear devices, i.e. they respond non-linearly to applied voltage. Due to this non-linearity, piezoelectric scanners move AFM probes over curved trajectories. Such a curved motion naturally results in a typical large “bow” like background in an AFM image. This background could range from several nanometers to a few microns, thus, making it impossible to view finer surface features during an ongoing scan. This can be dealt with by turning ON the line-leveling feature located somewhere on AFM software. This feature subtracts bow *line-by-line* while the data is being accumulated. This, however, is only to facilitate live viewing and does not alter the original data which includes bow. One can eliminate the bow post-data acquisition using selective (to avoid streaks) *line-leveling* option in image processing software.

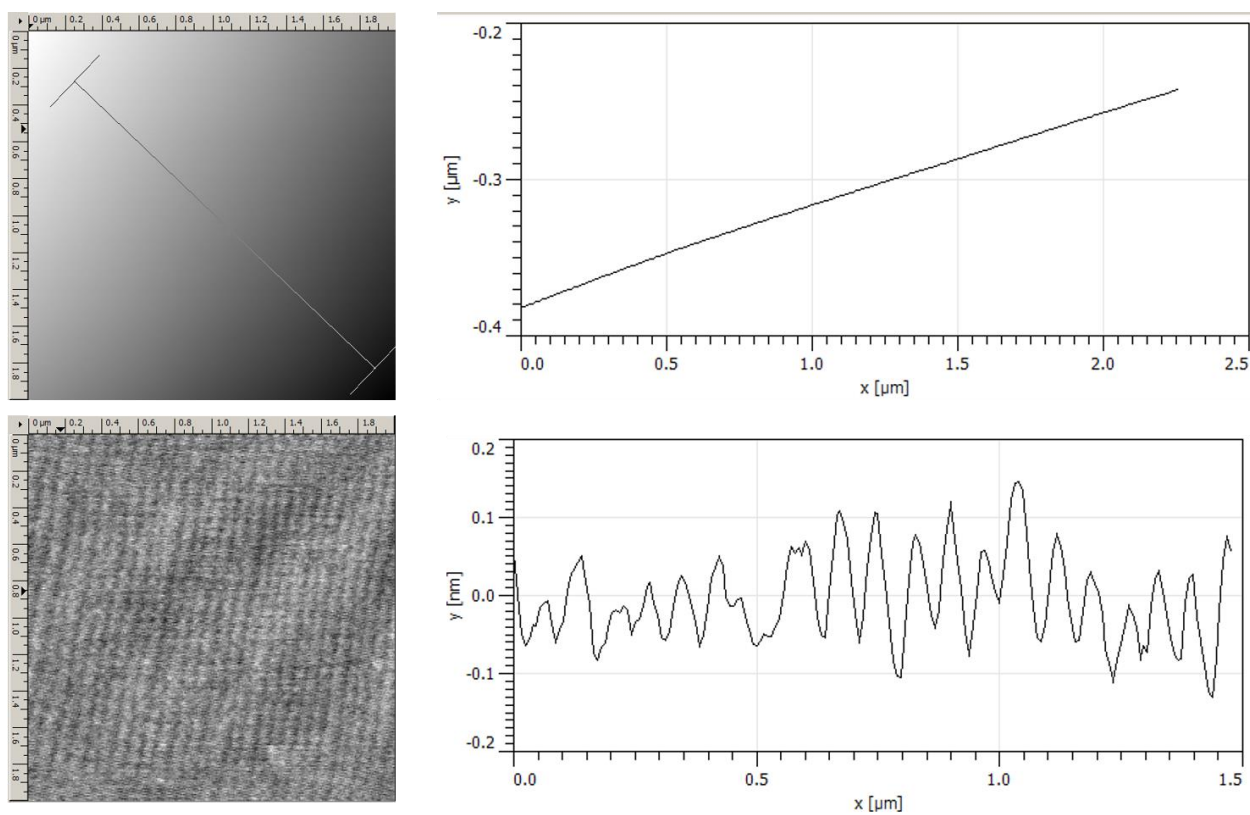
Fig. 10: A typical “tilt” and image after subtracting the background. Notice that the tilt adds a large background (measuring in microns), however, the details measuring fractions of a nanometre are easily retained after background subtraction (area-leveling).

When the probe is not perpendicular to the sample surface, another type of background, known as "tilt", is introduced during data acquisition. This can be easily eliminated using *area-leveling* during image processing.

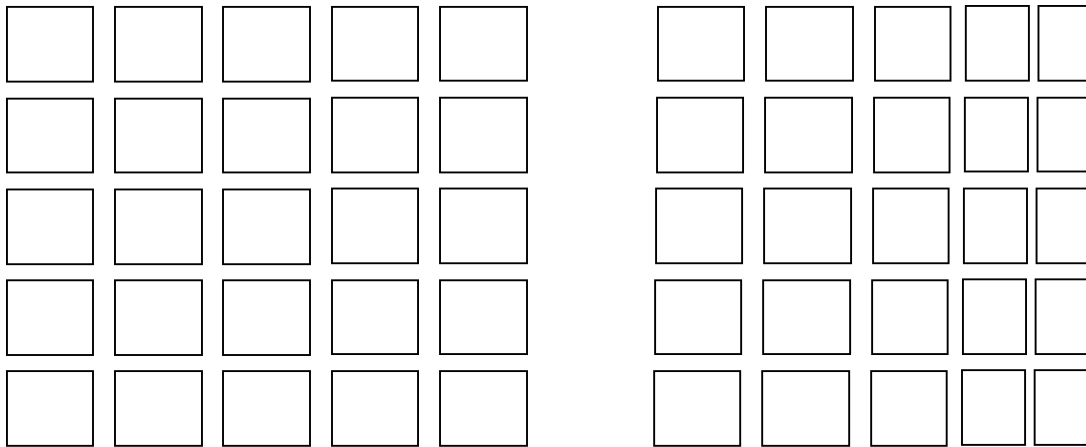
Fig. 11

Distortion due to non-linear piezo-scanner

As stated above, ceramic piezo-scanners are non-linear devices i.e. they move non-linearly to applied voltage as suggested in the figure below. If this non-linear nature of scanners is not accounted for in the xy plane, the image appears distorted. The effect becomes obvious when the surface contains even periodic pattern and will be present in scans of uneven surfaces but may not be as obvious. In order to eliminate such artifacts, we need to *linearize* the scanners. This can be achieved in two ways:

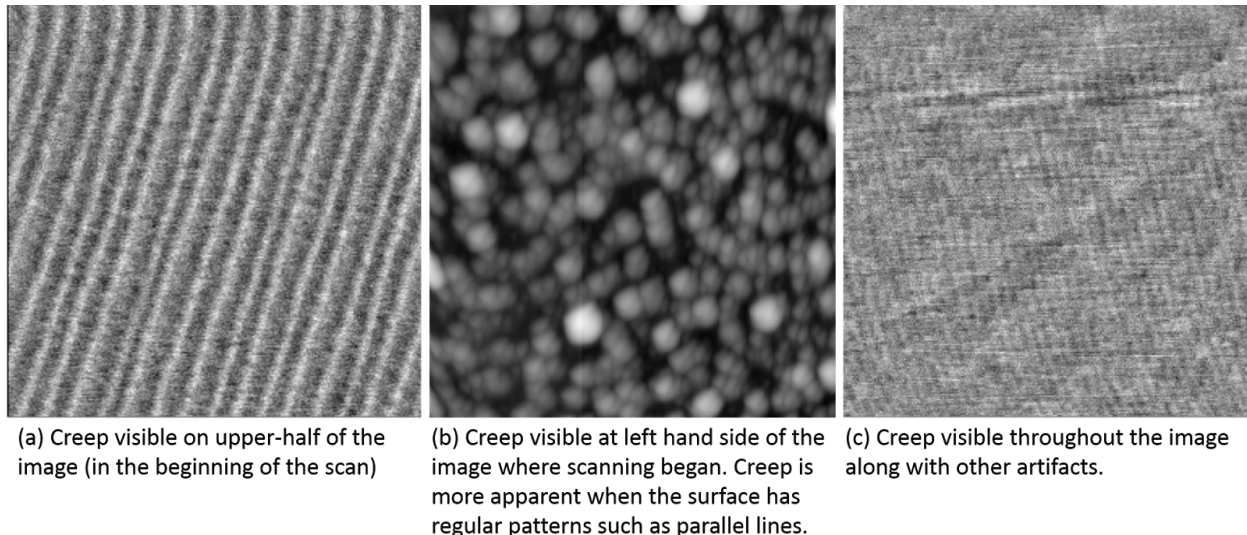
Fig. 12: Distortions introduced by scanner drift or "creep".

Piezo-scanners are electro-mechanical devices and exhibit a certain lag in response to the applied (or driving) voltage. When the variation in driving voltage is very fast, this lag renders the scanner unable change its position as rapidly as the driving voltage. This effect is known as "creep" and it manifests as a peculiar distortion in the image. If a surface has a pattern of parallel lines, then creeping shows up as bending of lines in the image. This bending is common in the beginning of a scan but could persist throughout the image depending upon the scan rate and surface features. Creep also causes drift while zooming into a specific region of a scanned area resulting as improper centering of the zoomed in region. As a result, the zoomed-in image appears somewhat drifted or not centered as originally intended. This may not be an issue where the scan areas are large but could pose a problem with high resolution scans.

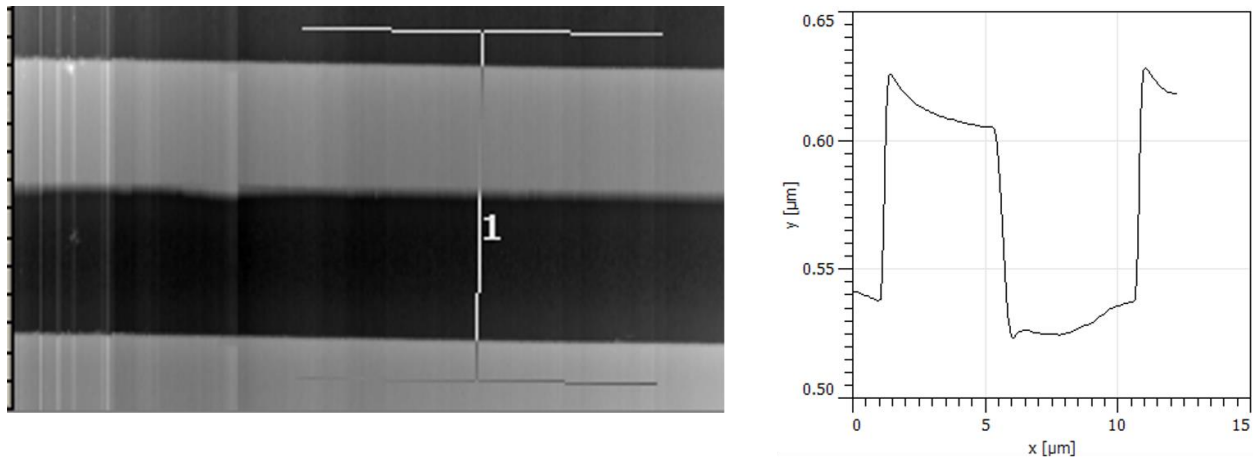
Overshoot at an edge

Fig. 13: Overshoot and undershoot across an edge

Along the z-direction, creep becomes apparent as overshoots across features with steep gradation in height such as step-terrace morphology on (0001) alumina or (001) STO, etc. These overshoots appear as enhanced contrast and could easily lead to over-estimation of heights of steep features. *Artifacts due to creep can be avoided by scanning at a lower rate.*

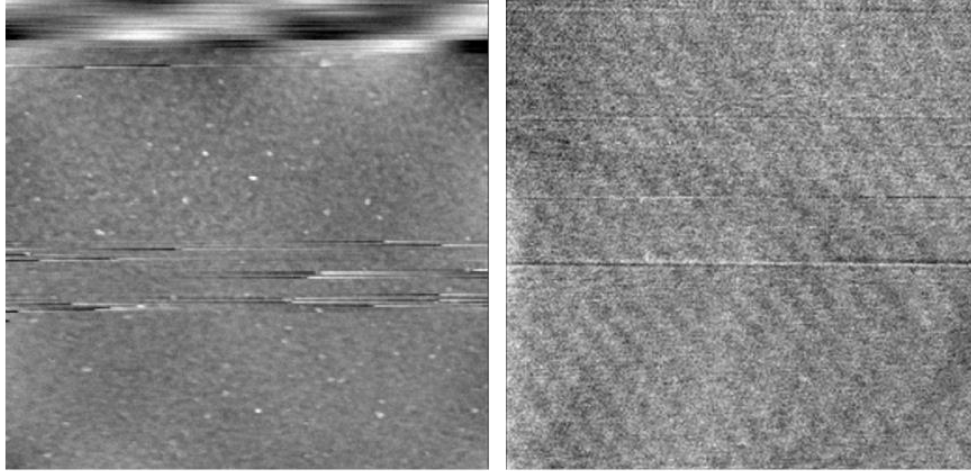
Streaks across an image are usually due to vibrational noise. Similar streaks are observed when scanning condition is changed abruptly during an ongoing scan. Artifact on upper half of the first image is due to failure of probe to track the surface. The second image also exhibits electronic noise and creep.

Fig. 14: Artifacts due to vibrational noise

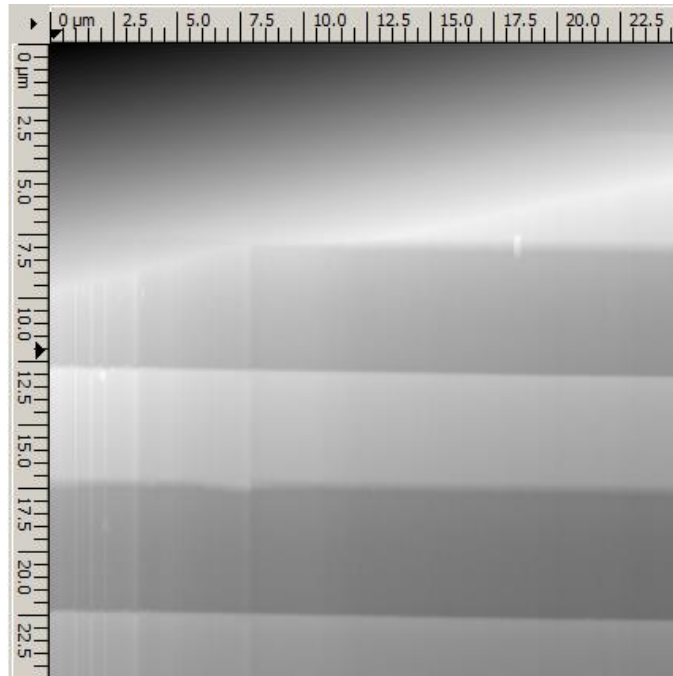
Fig. 15: Artifact due to not having the surface at the center of z-piezo scanner range.

The range of motion of a piezo-scanner is determined by the gain value of the sensor (strain gauge) attached to that scanner. (This gain is different from the gain in GPID parameters). Before beginning the scan, it is imperative to ensure that the sample surface lies at the center of this range. If the surface lies close to any extremity of this range, the probe may go into open loop feedback while scanning. This shows up as a part of the image being completely blank as shown in fig. 15.

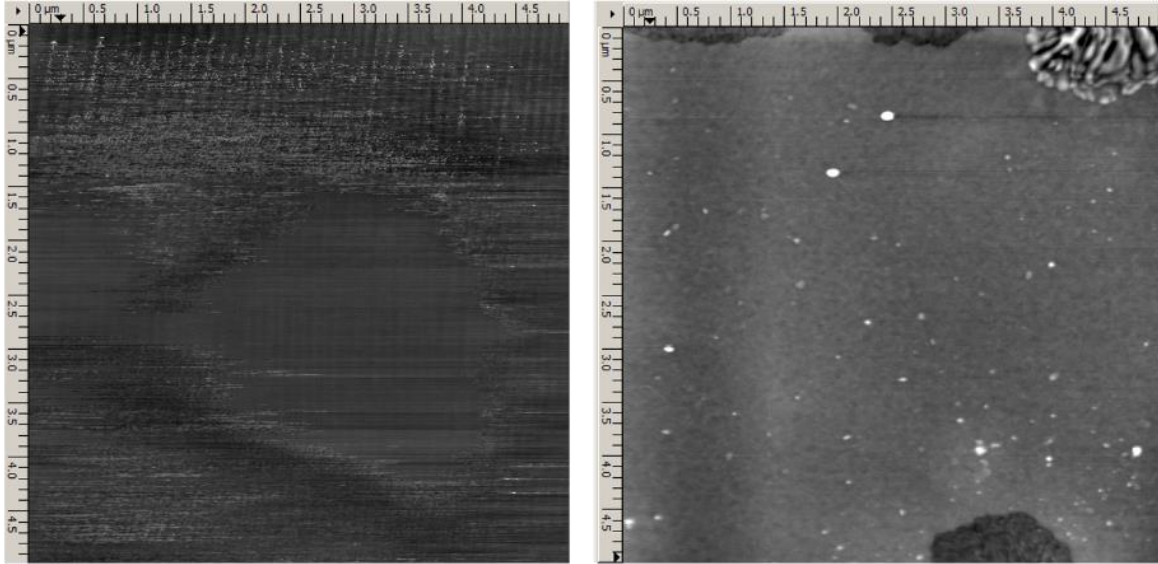
(a) When the gain is too low, probe cannot track the surface consistently resulting in smearing of features on parts of the image

(b) Effect of not having GPID parameters optimized. Low sensor gain when scanning area is large usually results in appearance of one or multiple broad lines across the image (along y-axis toward left in this image, scan is done along x-axis).

Images below are typical examples of not having optimum GPID parameters. The first image exhibits smearing of features in certain regions of the image. This is due to low gain value for z piezo-scanner. Whereas the second image demonstrates the effect of low gain value for xy piezo-scanners (this type of artifact can be eliminated using selective line-leveling along y -direction). Feedback parameters, which include GPID, determine the response of a probe to the surface features during scanning process. Requirements for optimum response of a probe depend on the type of surface being scanned. Severity of artifacts depend on how far GPID parameters are from optimum values. Along with GPID parameters, other factors that affect image quality are scan speed, amplitude of probe vibration and dampening (in AC mode), deflection (in DC mode), calibration and linearity. All of these parameters are surface specific in AFM.
