MPR-SAT-FE-73-1

FEBRUARY 28, 1973

SATURN V LAUNCH VEHICLE FLIGHT EVALUATION REPORT-AS-512 APOLLO 17 MISSION

PREPARED BY
SATURN FLIGHT EVALUATION WORKING GROUP

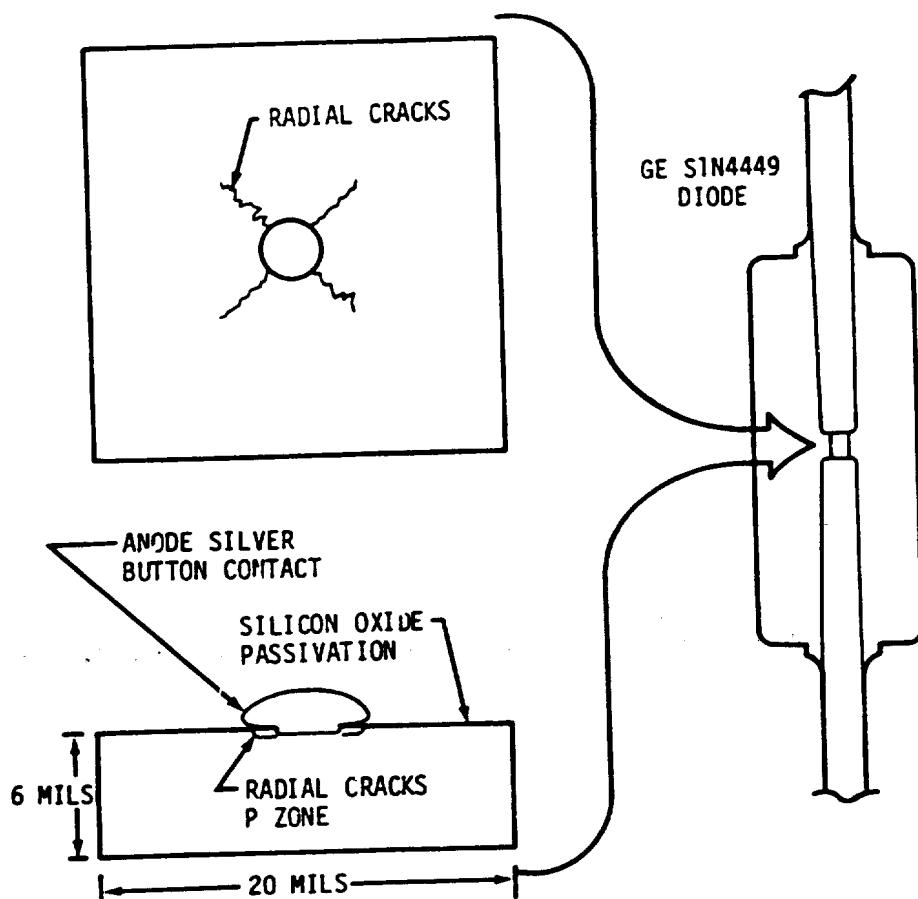
Figure 3-2. Diode Chip Detail

Since deposition of contamination in microscopic cracks (Figure 3-2) was consistently observed in the failed diodes, this is considered to be the most probable failure mode. However, the investigation as to the cause of the cracks and subsequent contamination deposition is still underway and cannot be considered conclusive at this time.

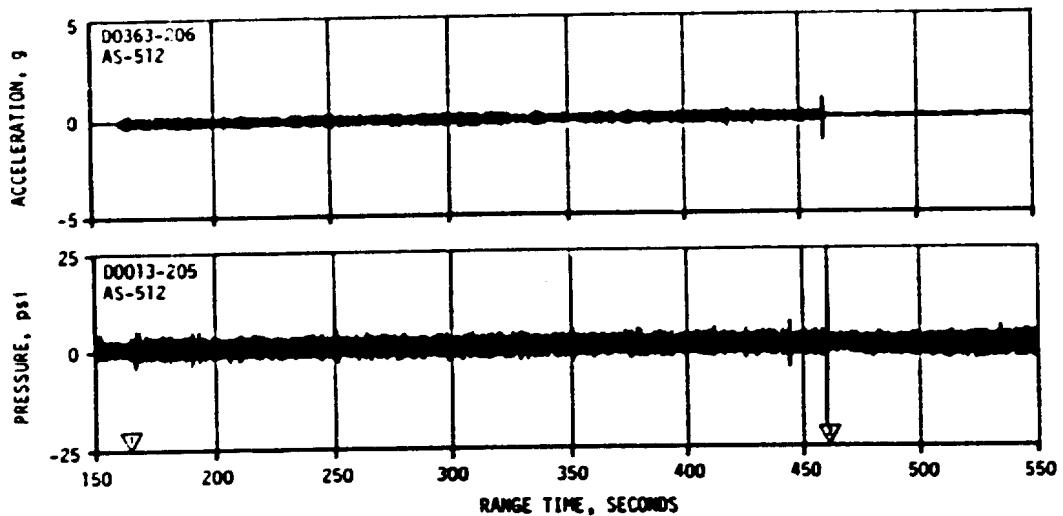
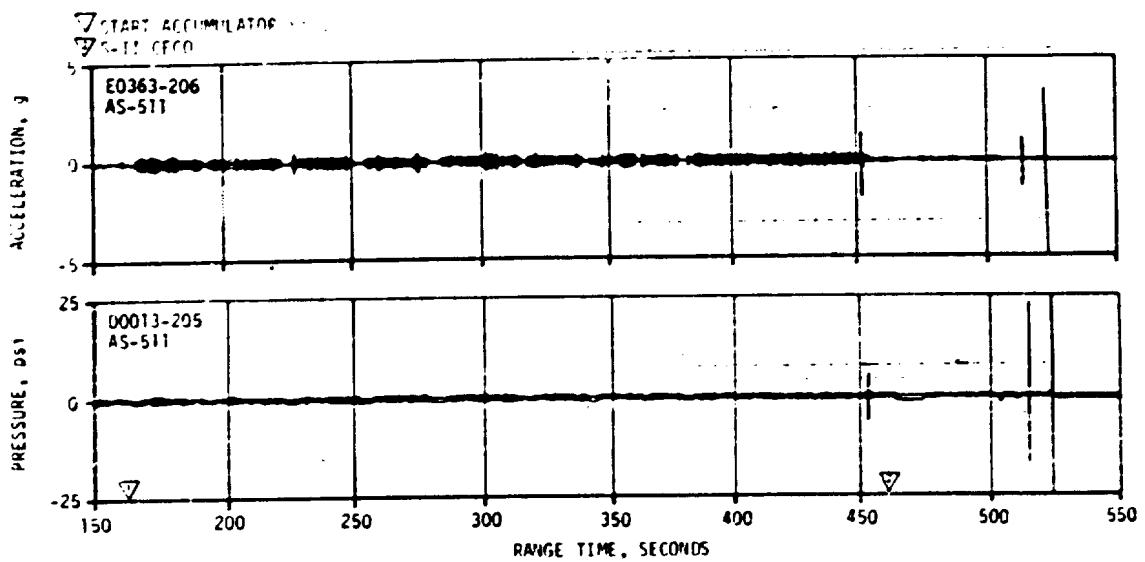
Figure 8-8. AS-512 Center Engine Chamber Pressure and Gimbal Pad Acceleration During S-II Burn (8 to 20 Hz Filter) Compared to AS-511

The S-II stage center engine accumulator effectively suppressed the 16 hertz POGO phenomenon. The flight data show that the 16 hertz oscillations were inhibited with amplitudes comparable to those seen on AS-511, Figure 8-8. The peak 14 to 20 hertz center engine gimbal response was approximately ± 0.4 g, as compared to ± 0.5 g on AS-511. POGO did not occur.

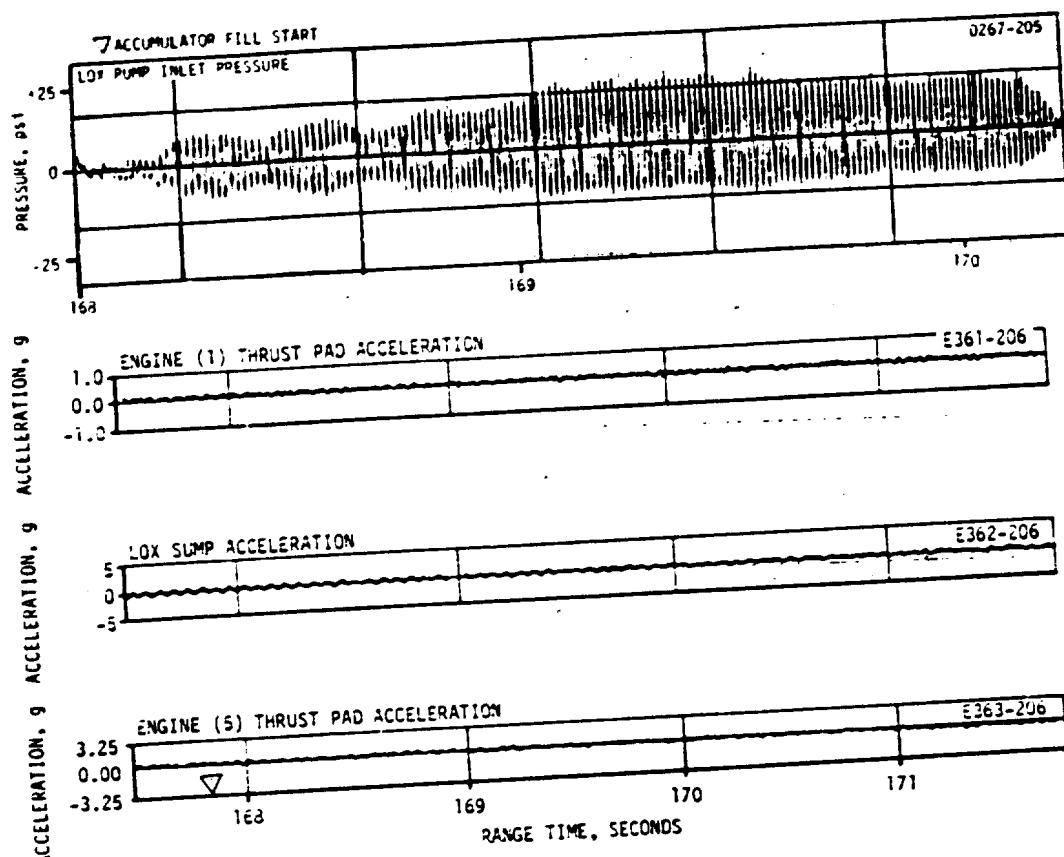
Figure 8-9. AS-512 Dynamic Responses During S-II Accumulator Fill
(1-110 Hz Filter)

The usual transient response in the center engine LOX pump inlet pressure was experienced shortly after accumulator fill was initiated. The peak response was approximately 34 psi peak-to-peak with a frequency of approximately 70 hertz, Figure 8-9. The LOX pump inlet pressure on AS-511 had a higher frequency content, a longer duration, and lower amplitude (13 psi peak-to-peak) but AS-512 is similar to AS-510 (45 psi peak-to-peak at 68 hertz). Such variations are not unique and the causes are attributed to the individual pump characteristics. There are no parallel increases in responses among the other engine pressures and the structural accelerations which again indicates the lack of strong coupling between the transient pressure response and the structural accelerations.

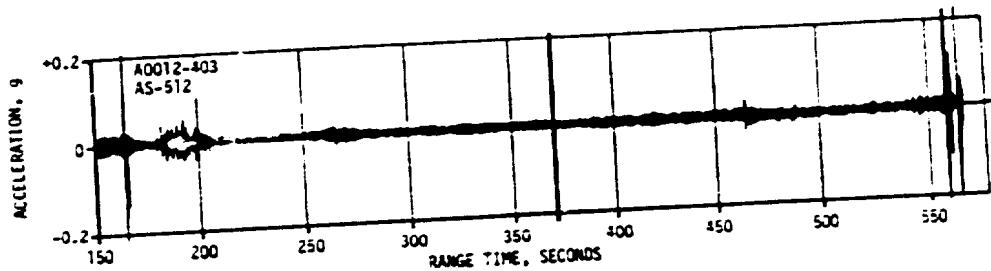
Figure 8-10. AS-512 S-IVB Gimbal Block Acceleration During S-II Burn -
Longitudinal (8 to 20 Hz Filter)

During S-II burn, between 184 and 207 seconds range time, the vibration level on the S-IVB gimbal block was discernible above the noise floor, Figure 8-10. The maximum acceleration of the gimbal block in this interval was about ± 0.06 g. The signature of this signal appears to be wide band random. No signature similar to the S-IVB gimbal block oscillation was apparent on the various S-II dynamic parameters, i.e., the structural vibrations, the LOX pump inlet pressure fluctuations and the combustion chamber pressure fluctuation. Figure 8-11 compares the spectrum of the S-IVB gimbal block signal with the spectrum of the S-II center engine thrust pad. The spectrum associated with the center engine indicates a very low level response concentrated in the 20 hertz region. The S-IVB gimbal block has the character of a random response across the frequency spectrum. This demonstrates that the S-IVB phenomena is

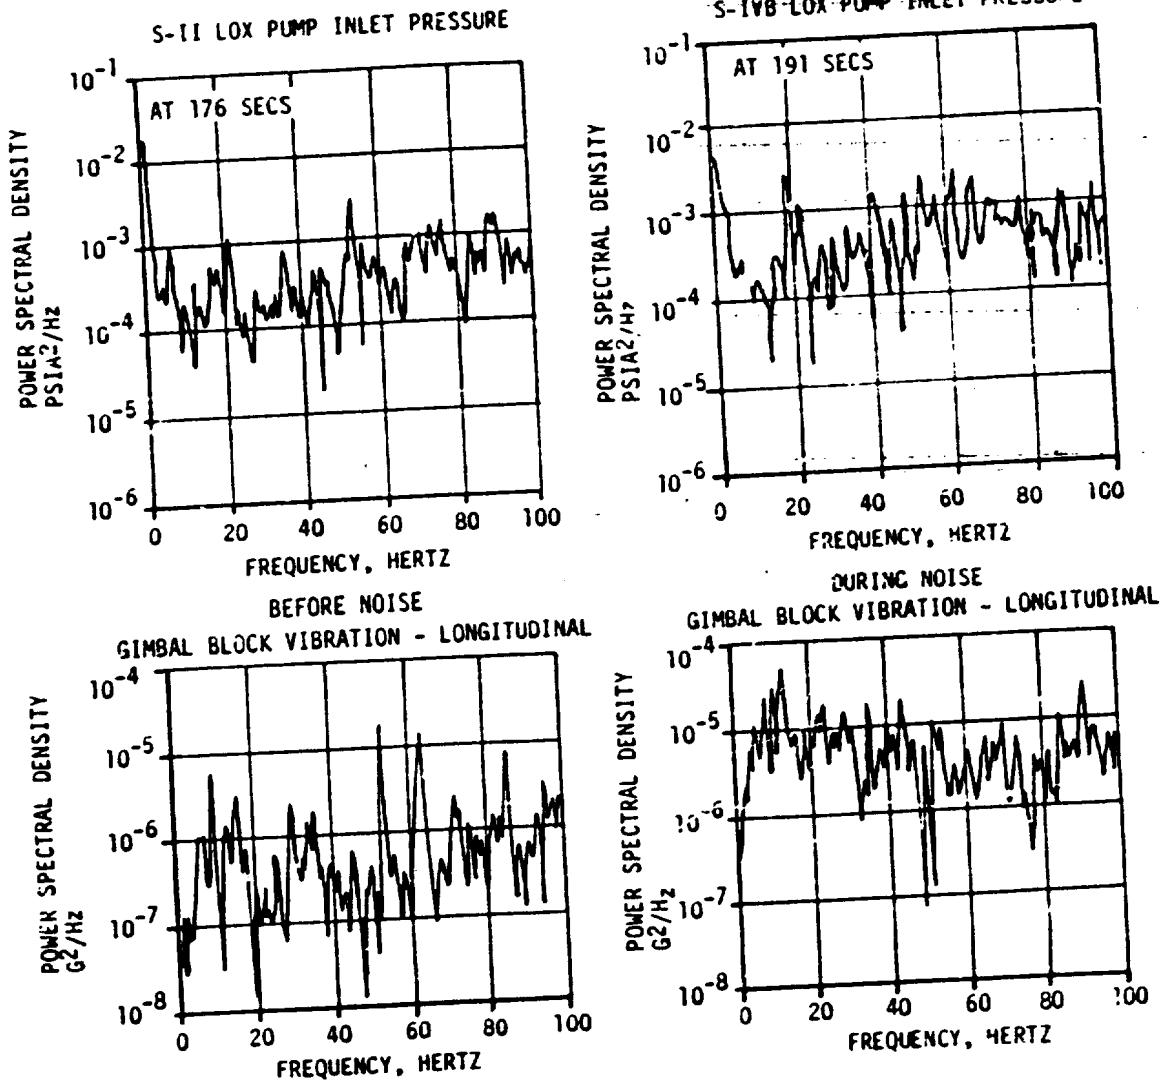
Figure 8-12. Noise on S-IVB Gimbal Block During S-II Burn

not the result of a forced response due to an excitation emanating from the S-II. The S-IVB gimbal block vibration spectrum shows an order of magnitude increase when the noise occurs whereas the S-IVB LOX pump inlet pressure shows little change, Figure 8-12. The higher levels at frequencies from 5 to 20 hertz on the gimbal block do not occur in the LOX pump inlet pressure. Therefore it is concluded that the disturbance is not valid vibration data. Also, the amplitude during this disturbance, if valid, would produce insignificant dynamic loads on the stage.

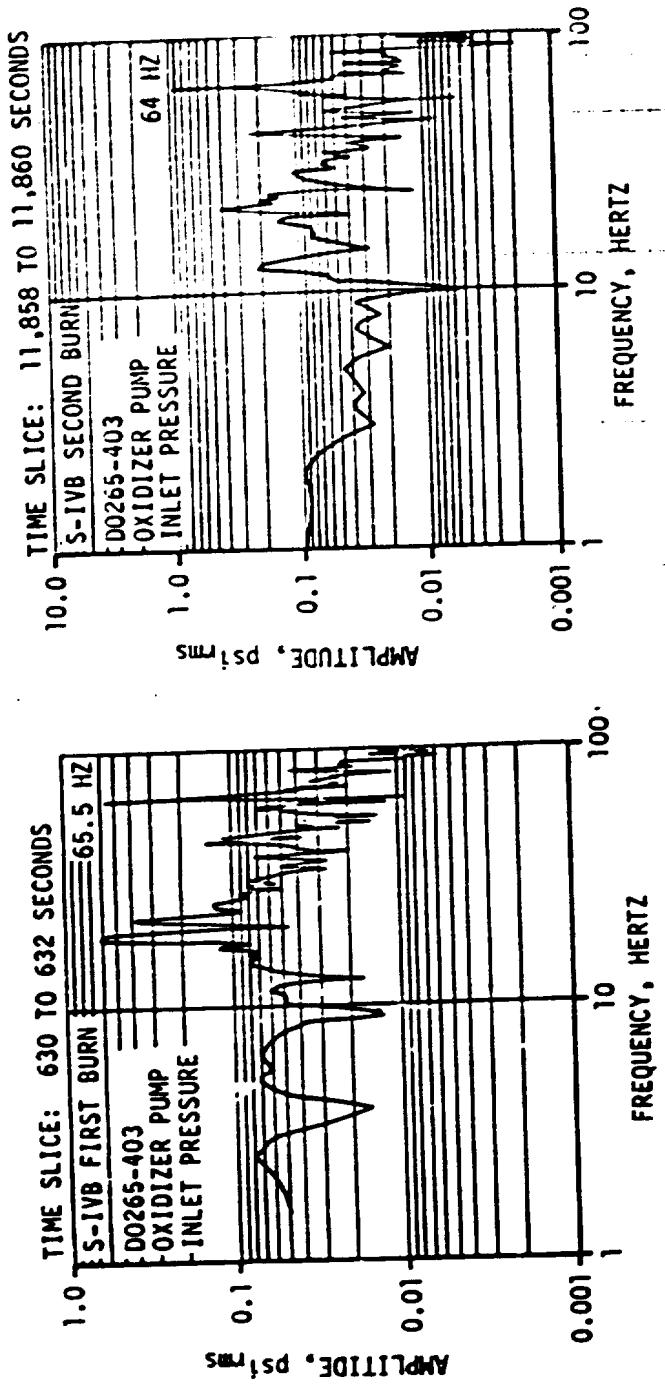
Figure 8-13. AS-512 S-IVB Pump Inlet Pressure Spectra

The "buzz" reported by the astronauts on AS-511 flight is again apparent on AS-512 at approximately 63 hertz in the pump inlet pressure measurement as it has been on previous flights. The vibrations can also be seen on selected propulsion pressure measurements (Figure 8-13). The AS-512 data show amplitudes similar to AS-511 (less than 1.0 psi rms). A review of AS-510 data showed similar vibration at approximately 72 hertz. The vibration is related to normal stage propulsion system operation and probably characteristic of the J-2 turbomachinery. These vibrations pose no POGO or any other structural concerns, and are of very low amplitude.

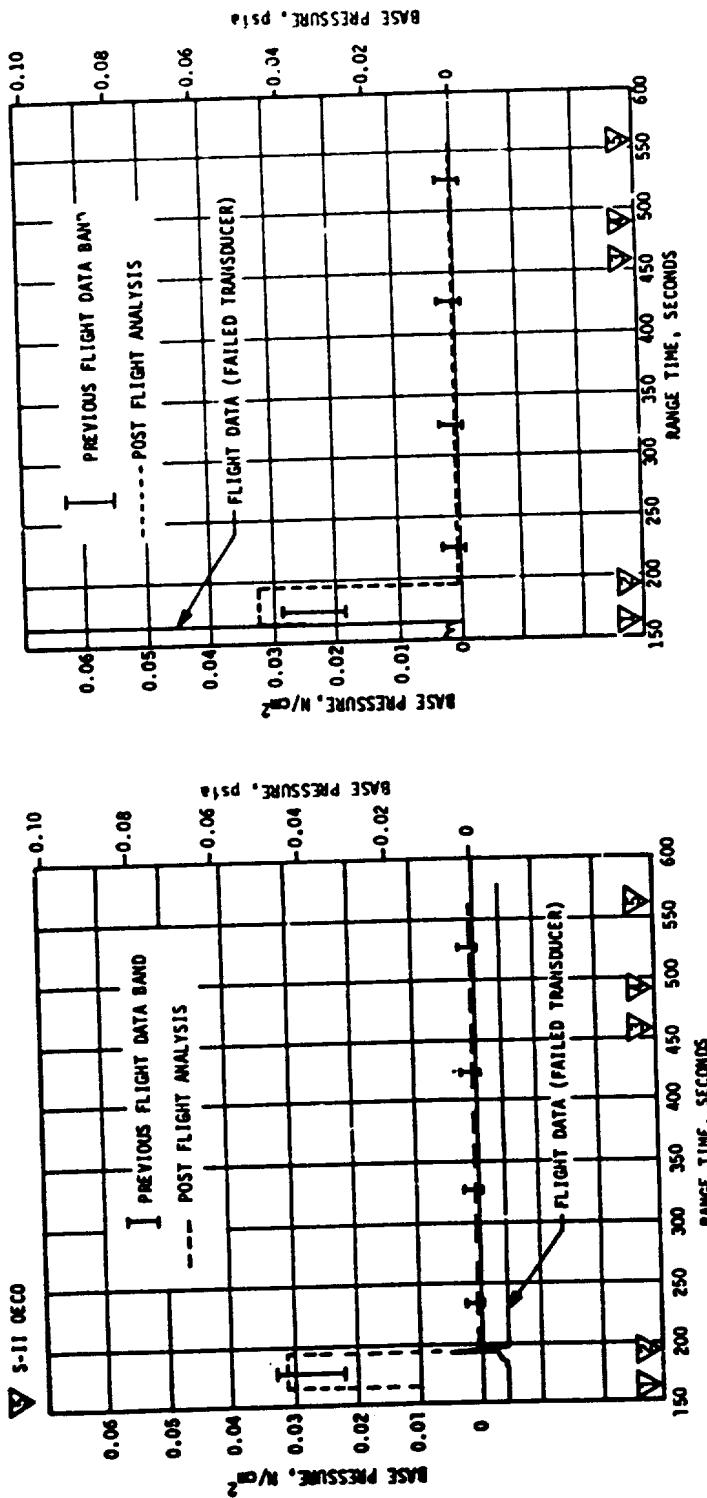
Figure 12-1 shows the AS-512 post-flight heat shield forward face pressure data. The heat shield forward face pressure transducer (D150-206) provided no useful data during S-II mainstage. Post-flight analysis, using semi-empirical correlations based on 1/25 scale model hot flow test results, indicated that the S-II-12 heat shield forward face pressures were within the previous flight data band.

The higher pressures in the S-II-12 base region as indicated by post-flight analysis and measured flight data, are attributed to further inboard deflections of the engines than on previous flights. Effective with AS-510, the S-II engine precent angle was reduced from 1.8° to 0.6°. Since base pressures result from reverse flow of the engine exhaust gases, a further inboard deflection would

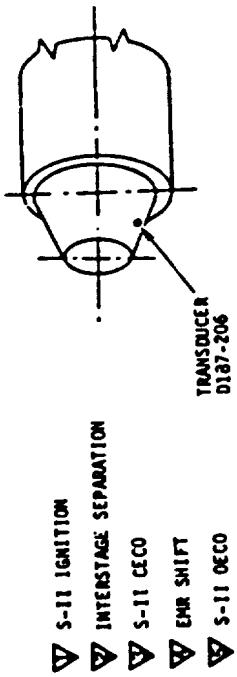
The thrust cone post flight reconstruction is shown in Figure 12-2. The thrust cone pressure transducer (D187-206) provided no useful data during S-II mainstage. Post-flight analysis based on the semi-empirical correlations mentioned above indicates higher thrust cone pressures, prior to interstage separation, than previous flight data.

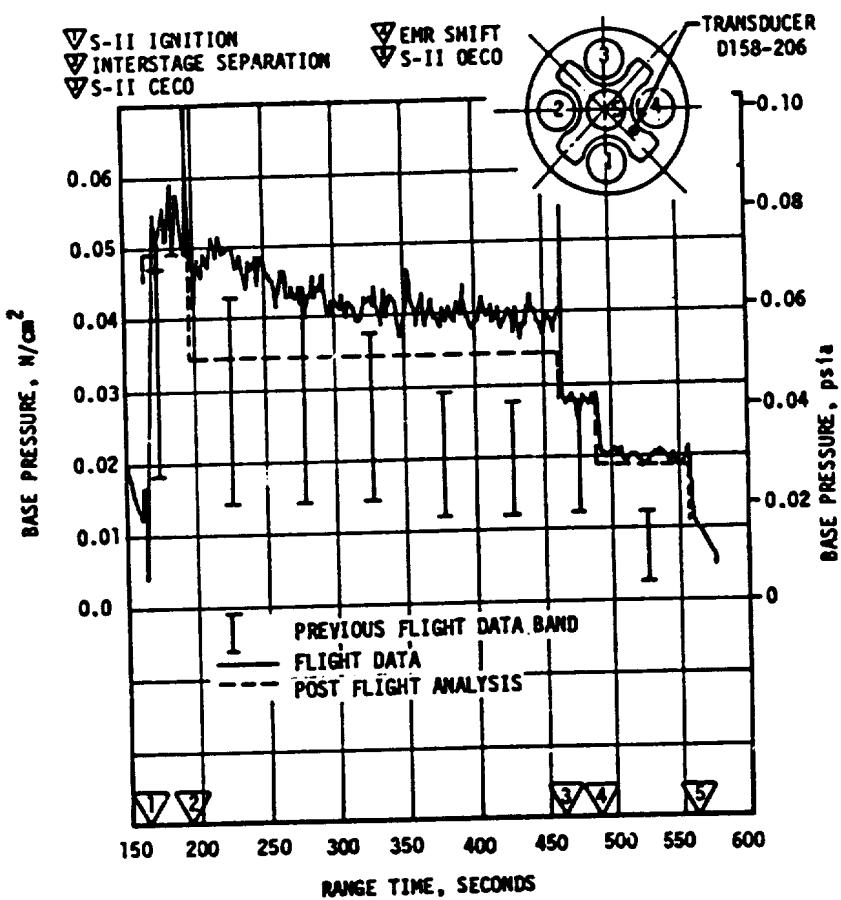
Figure 12-3. S-II Heat Shield Aft Face Pressure

The heat shield aft face pressures, shown in Figure 12-3, were higher than those seen on previous flights.

cause higher pressures in the base region.

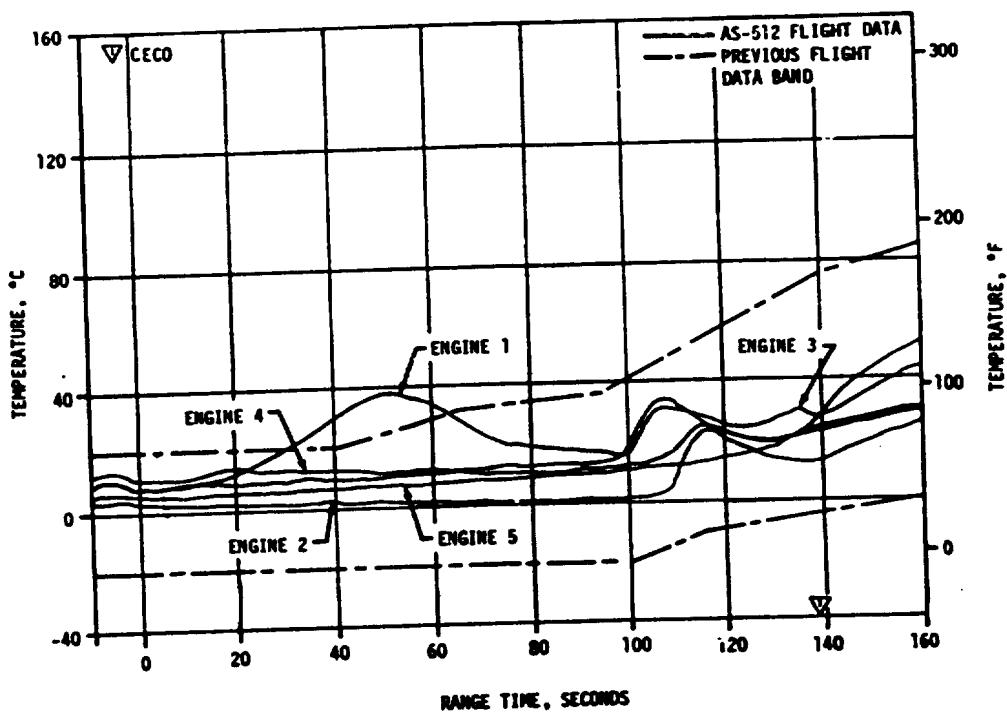
Figure 13-2. S-IC Ambient Gas Temperature Under Engine Cocoon

There are two possible causes for this anomaly:

1. The first possibility is that hot gas from the Gas Generator (GG) may have leaked through the GG drain port. This port is plugged in flight and opened only during ground operations. Leakage past the plug has occurred in the past during low pressure ground checkout. The temperature sensor is located in

the vicinity of the GG drain port and a leak of about 0.003 lb/sec would propagate enough hot gas under the cocoon to cause such a temperature rise. A leak of such small magnitude would tend to be self-sealing due to the deposition of hydrocarbon solids from the fuel-rich GG combustion gases. This could explain why the temperature reading returned to the normal level.

2. The second possibility is a temporary loss of cocoon insulation integrity (possible loose combustion drain access cover) which later corrected itself, allowing the instrument to return to the normal temperature level. The temperature rise was coincident with the normal rise in base heating rate which peaks at about 50 seconds as shown in Figure 13-1. A loss of cocoon insulation integrity would show up in a temperature rise. However, the loss of cocoon insulation integrity would have to have been temporary because the temperature rise did not recur when the base heating rate peaked the second time at about 110 seconds (a normal occurrence). Base heating rates and temperatures do not show any unusual excursions during S-IC flight, indicating normal gas flow in the base region.

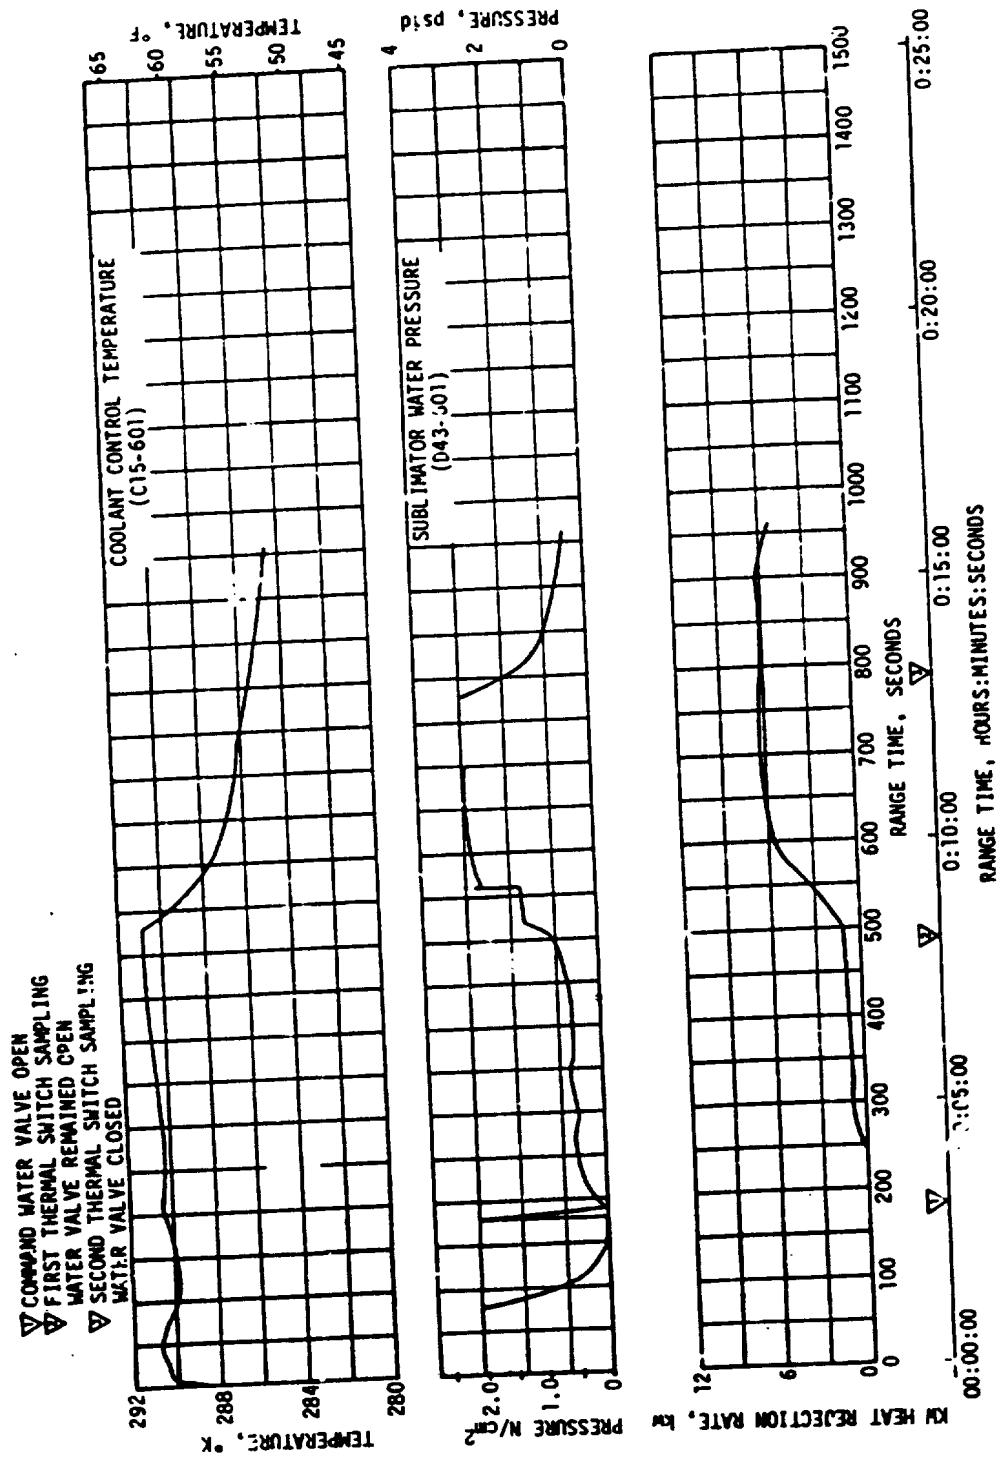
Figure 14-2: IU Sublimator Performance During Ascent

Sublimator cooling was nominal as evidenced by normal coolant temperature (C15-601) cycling through approximately 21,000 seconds. Following water valve closure at 19,060 seconds the water line pressure indication, measurement D43-601, leveled off at about 1.4 psia rather than continuously decreasing to zero as is normally expected during the sublimator drying out cycle. The indicated pressure remained at this level until about 27,000 seconds, at which time the indicated pressure did begin a gradual decrease to zero (Figure 14-1). This same general condition has occurred on a number of previous missions and is due to either water

freeze-up in the pressure pick up line, or icing at the pressure transducer resulting in the diaphragm of the transducer locking in a fixed position. The latter condition is thought to be the case, though in either event system performance is unaffected, and the true pressure in the water supply line decays nominally.

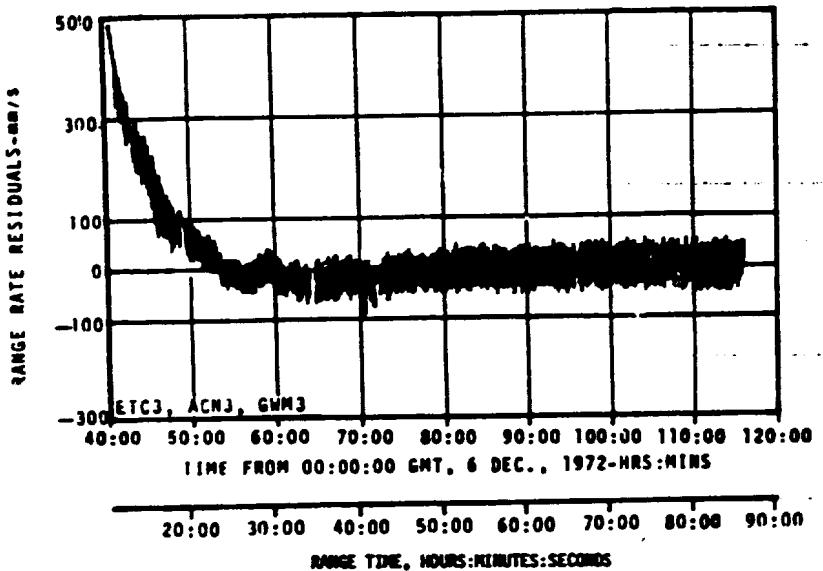
Figure 17-3. Gravity-Only Lunar Impact Trajectory Residuals

order of 0.04 mm/s^2 continued to act for at least 18 hours. Figure 17-3 shows range-rate residuals produced by fitting a gravity only trajectory to the last 46 hours of tracking data. The deviations in residuals at the beginning of this time span indicate that non-gravitational accelerations acted on the S-IVB/IU.

A small additional vent of 0.09 N due to the S-IVB LOX chilldown pump purge has been identified. This purge force is expected to act continuously until lunar impact and therefore, does not correlate with the 18-hour perturbation period identified in Figure 17-3.

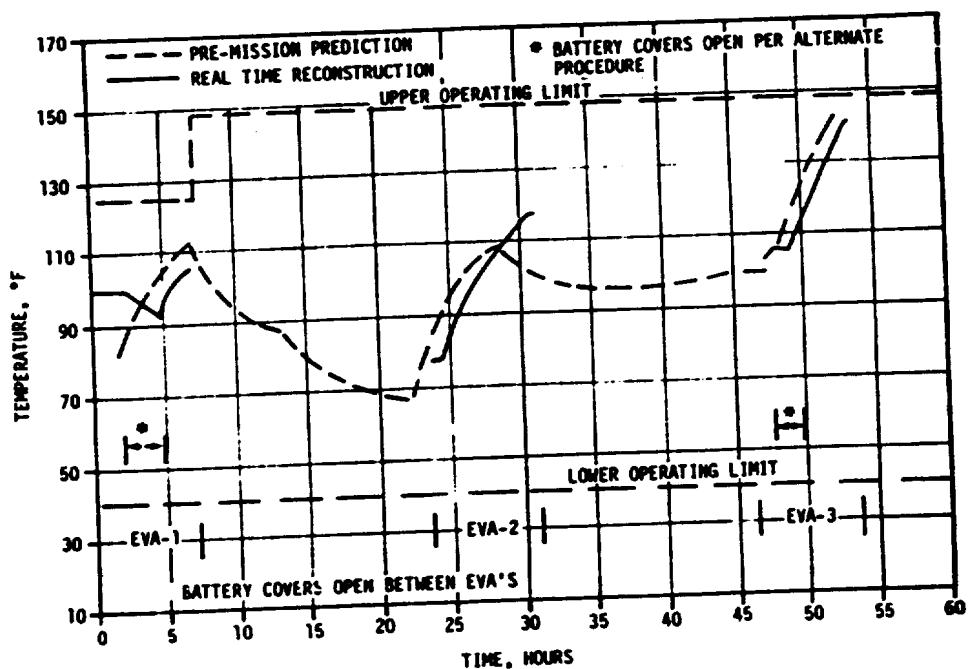
Figure 20-4. LRV Battery No. 1 (Left) Temperature

Figures 20-4 and 20-5 present the battery profiles for the three EVA's. Because of the high battery temperatures at initial power-up the LRV was parked heading up-sun for best radiation to deep space and the dust covers were opened during the ALSEP deployment period. The anticipated cooldown of 10°F (6°C)* for Battery 2, and 4°F (2°C)* for Battery No. 1 was achieved. The battery 1 and 2 temperatures, with the LRV supplying LCRU power, were 108°F (42°C) and 123°F (51°C)* at the end of EVA-1.
