LAPORAN REPAIR KOMATSU INDONESIA

Tanggal Repair	19-Jun-23
Jam Berangkat	10.50 WIB
Jam Repair	13.30 S/D 16.15
Jam Kembali	19.30 WIB
Qty Unit Repair	11 pcs
Assy No	-
Type Unit	PC210 HARVESTER
Jumlah Man Power	1 Orang
Driver	1 Orang
Method Repair	Potong Wire ganti terminal dan pasang connector

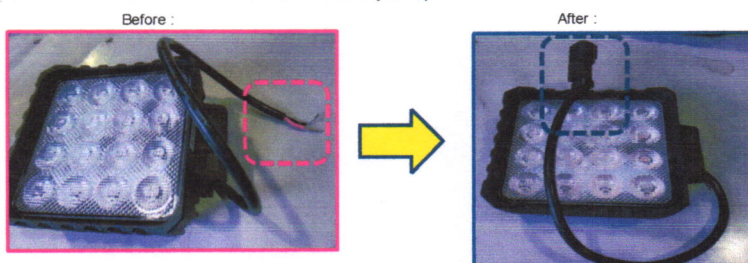
1. Modif wire harness PC210 HARVESTER sebanyak 2 pcs
