EQUITY BANK LTD

PREVENTATIVE MAINTENANCE REPORT

Site: Buruburu Branch

Preventative maintenance of branch UPS.

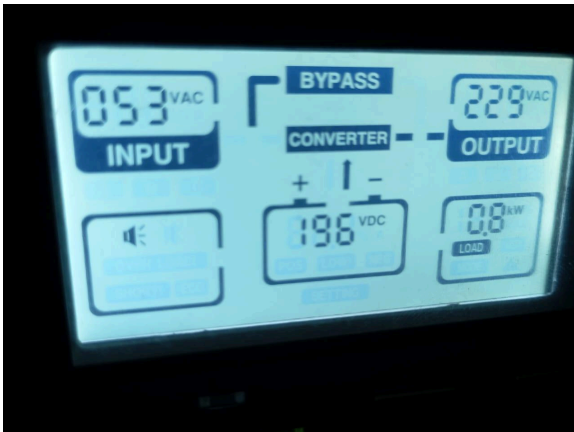
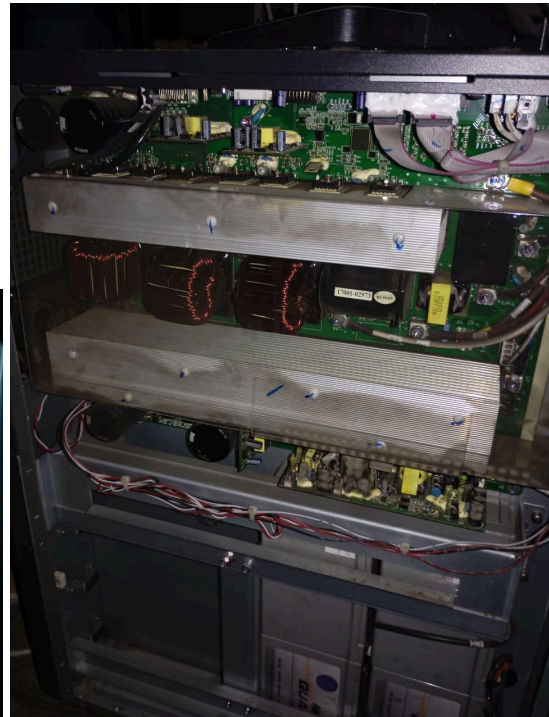
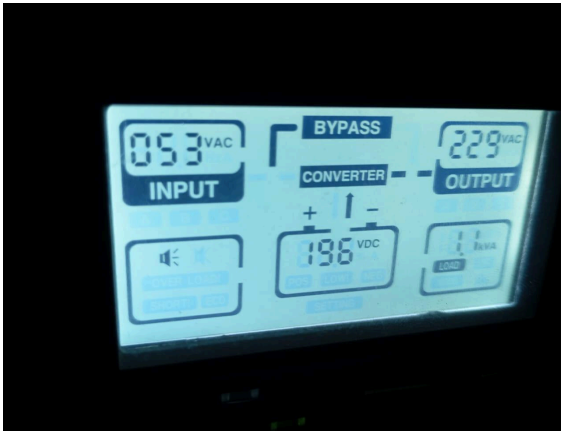
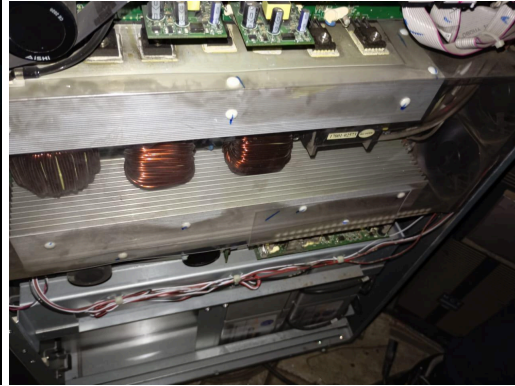
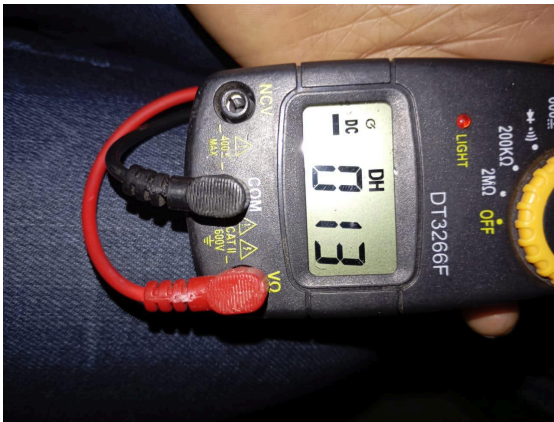
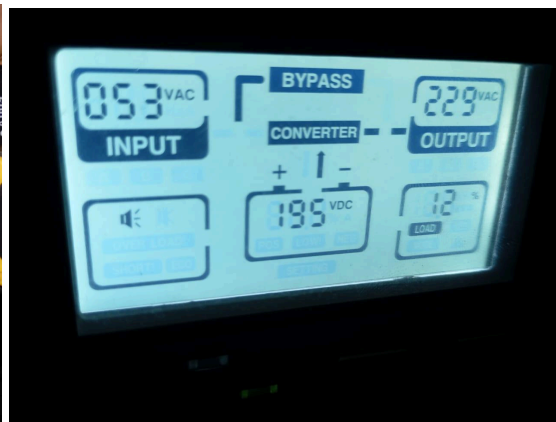
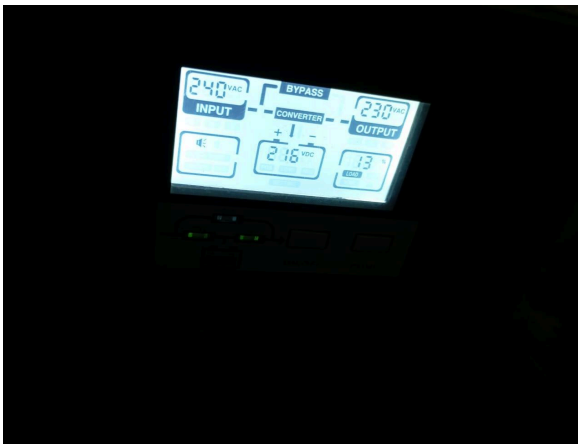
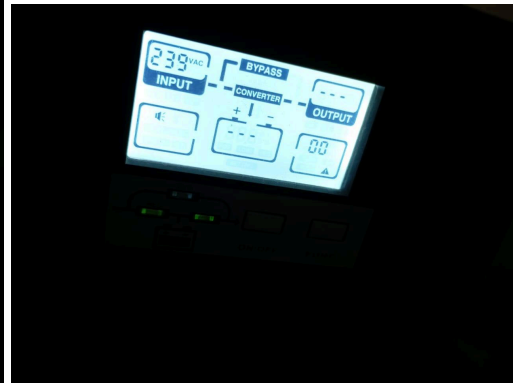
6. Site Photos

- The UPS internal components were checked and no issues were noted.
- The unit's batteries were tested and are in good condition. The interconnecting cables were checked and are okay, and the connections are good.
- The UPS was tested in normal, bypass, and battery mode and the unit works well.
- The UPS was cleaned and serviced.
- Power loss was simulated and the unit provided the expected backup time.
