LAPORAN REPAIR KOMATSU INDONESIA

Tanggal Repair	26-Mar-24
Jam Berangkat	08.25 WIB
Jam Repair	10.30 S/D 15.05
Jam Kembali	17.05 WIB
Qty Unit Repair	20 pcs
Assy No	-
Type Unit	PC135 HARVESTER
Jumlah Man Power	1 Orang
Driver	1 Orang
Methode Repair	Potong Wire ganti terminal dan pasang connector

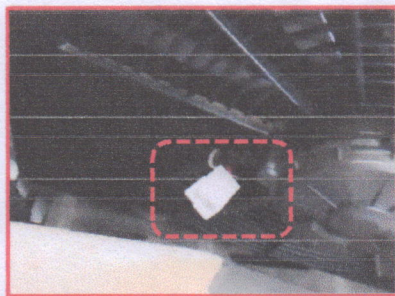
Before :

1.Modif connector untuk OILCOOLER PC135 HARVESTER sebanyak 20 pcs
