Unnamed tributary		ok-0415-r-001	Sedimentation Risk Index <b>32</b>																																																																		
<u>Common:</u> 5.8mi NW of Crestview <u>Drainage:</u> Cotton Creek <u>GPS:</u> 30.822903945, -86.637095506 <u>Land owner:</u> Ronald Lemoyne Showers-US, Leah Helms-DS		<u>County:</u> Okaloosa <u>State:</u> Florida <u>PLSS(T-R-S):</u> 4N-24-27 <u>Parcel No.:</u> 4-023/4-000 <u>Road Name:</u> Cotton Creek Rd

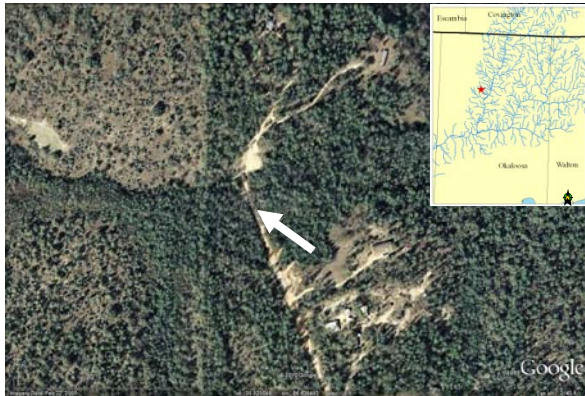
Crossing Structure: DS		DS																																																																			
<table border="1"> <thead> <tr> <th>Risk Factor</th> <th>Ranking</th> <th>Score</th> </tr> </thead> <tbody> <tr><td>US Channel Morph</td><td>E</td><td>5</td></tr> <tr><td>DS Channel Morph</td><td>DA</td><td>3</td></tr> <tr><td>DS Bank Alteration</td><td>HIGH</td><td>1</td></tr> <tr><td>Upstream Skew Angle</td><td>&lt;5°</td><td>5</td></tr> <tr><td>Crossing fill condition</td><td>Poor/Bare soil</td><td>1</td></tr> <tr><td>Inlet/Outlet Condition</td><td>Sed Islands/Scouring</td><td>3</td></tr> <tr><td>Road Approach Material</td><td>All Sand/Clay</td><td>3</td></tr> <tr><td>Potential Eroded Volume Mean</td><td>&gt;40 y<sup>3</sup></td><td>1</td></tr> <tr><td>Approach Slope Mean</td><td>&gt;4%</td><td>1</td></tr> <tr><td>Soil K Factor</td><td>0.21-0.40</td><td>3</td></tr> <tr><td>Upstream Rt Outlet</td><td>Bare soil</td><td>0</td></tr> <tr><td>Upstream Lt Outlet</td><td>Vegetated</td><td>1</td></tr> <tr><td>Upstream Rt Ditch</td><td>Bare soil</td><td>0</td></tr> <tr><td>Upstream Lt Ditch</td><td>Bare soil</td><td>0</td></tr> <tr><td>Downstream Rt Outlet</td><td>Bare soil</td><td>0</td></tr> <tr><td>Downstream Lt Outlet</td><td>Bare soil</td><td>0</td></tr> <tr><td>Downstream Rt Ditch</td><td>Vegetated</td><td>1</td></tr> <tr><td>Downstream Lt Ditch</td><td>Vegetated</td><td>1</td></tr> <tr><td>Outlet Total</td><td>Partially Improved Outlet System</td><td>3</td></tr> <tr><td>Ditches Total</td><td>Partially Improved Drainage System</td><td>3</td></tr> <tr><td><b>SRI Total</b></td><td><b>High Risk</b></td><td><b>32</b></td></tr> </tbody> </table>		Risk Factor	Ranking	Score	US Channel Morph	E	5	DS Channel Morph	DA	3	DS Bank Alteration	HIGH	1	Upstream Skew Angle	<5°	5	Crossing fill condition	Poor/Bare soil	1	Inlet/Outlet Condition	Sed Islands/Scouring	3	Road Approach Material	All Sand/Clay	3	Potential Eroded Volume Mean	>40 y <sup>3</sup>	1	Approach Slope Mean	>4%	1	Soil K Factor	0.21-0.40	3	Upstream Rt Outlet	Bare soil	0	Upstream Lt Outlet	Vegetated	1	Upstream Rt Ditch	Bare soil	0	Upstream Lt Ditch	Bare soil	0	Downstream Rt Outlet	Bare soil	0	Downstream Lt Outlet	Bare soil	0	Downstream Rt Ditch	Vegetated	1	Downstream Lt Ditch	Vegetated	1	Outlet Total	Partially Improved Outlet System	3	Ditches Total	Partially Improved Drainage System	3	<b>SRI Total</b>	<b>High Risk</b>	<b>32</b>
