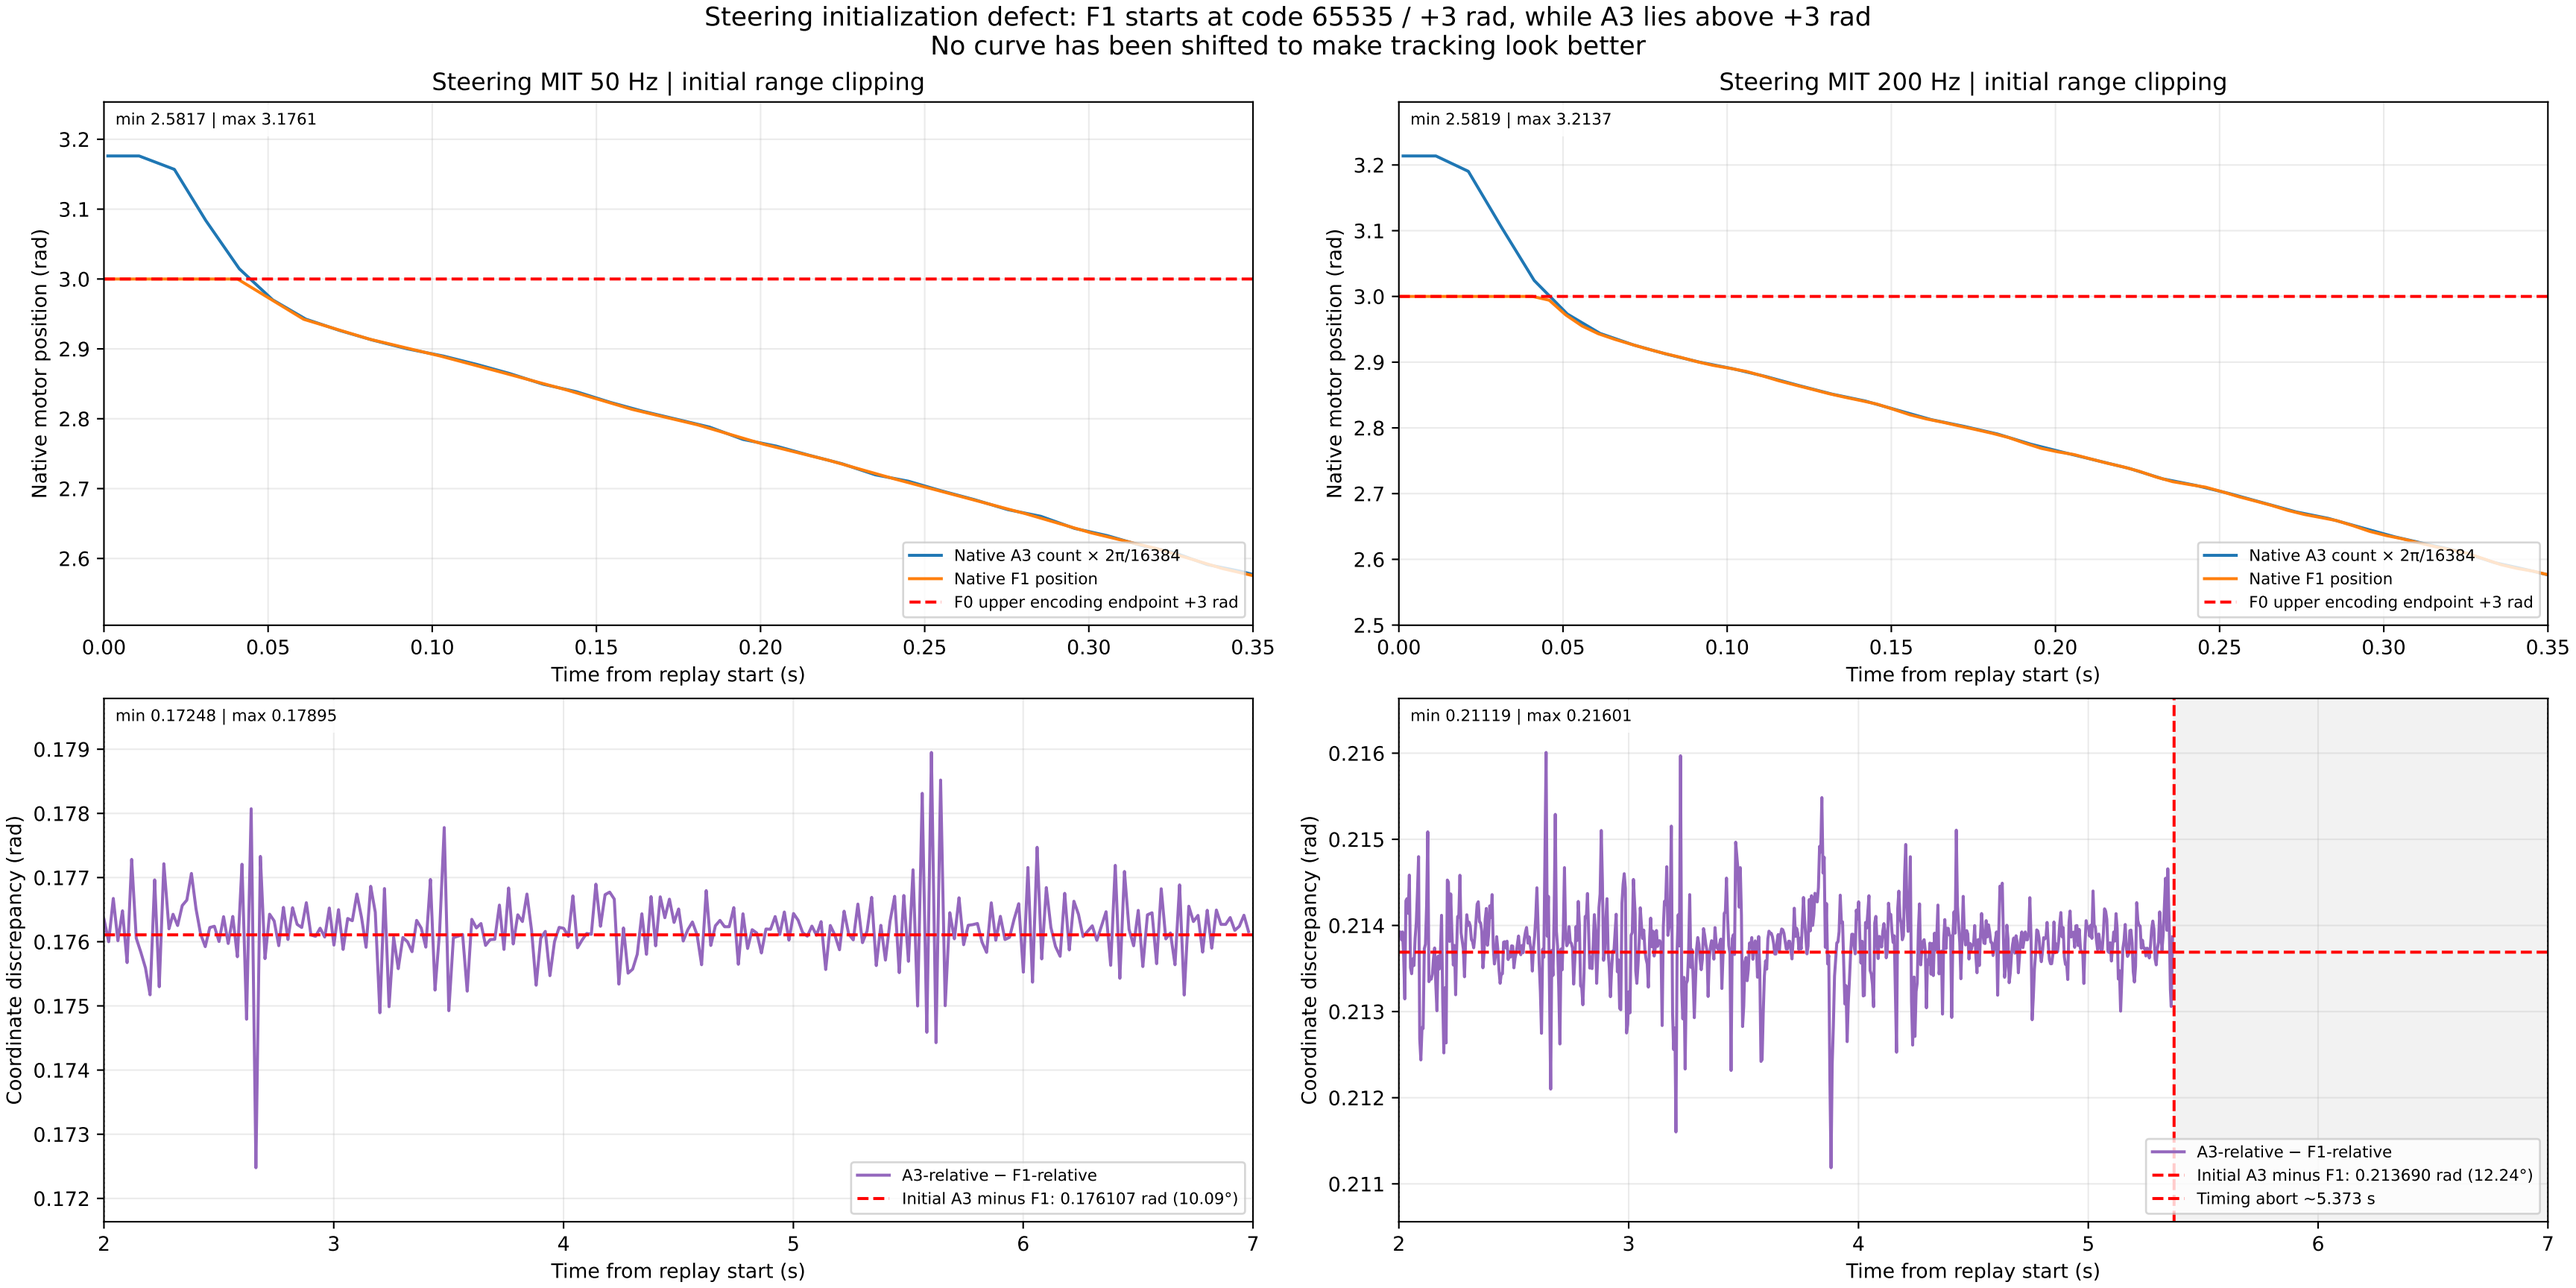
Steering initialization defect: F1 starts at code 65535 / +3 rad, while A3 lies above +3 rad
No curve has been shifted to make tracking look better
Steering MIT 50 Hz | initial range clipping
min 2.5817 | max 3.1761
Native motor position (rad)
Time from replay start (s)
Native A3 count × 2π/16384
Native F1 position
F0 upper encoding endpoint +3 rad
Steering MIT 200 Hz | initial range clipping
min 2.5819 | max 3.2137
Native motor position (rad)
Time from replay start (s)
Native A3 count × 2π/16384
Native F1 position
F0 upper encoding endpoint +3 rad
min 0.17248 | max 0.17895
Coordinate discrepancy (rad)
Time from replay start (s)
A3-relative − F1-relative
Initial A3 minus F1: 0.176107 rad (10.09°)
min 0.21119 | max 0.21601
Coordinate discrepancy (rad)
Time from replay start (s)
A3-relative − F1-relative
Initial A3 minus F1: 0.213690 rad (12.24°)
Timing abort ~5.373 s
