H3C B5 Mini B5MiniV100R005 router, the latest version of simulation overview:

The H3C B5 Mini B5MiniV100R005 router was found to have a stack overflow vulnerability in the Edit_BasicSSID function. An attacker can obtain a stable root shell through a carefully constructed payload.

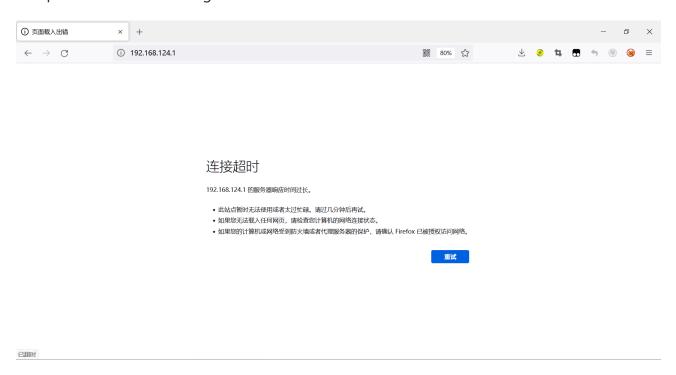
级别	信息来源	信息内容
error	系统	webs进程已重启。

The picture above is the log information.
