Good Springs Creek		co-1102-r-004		Sedimentation Risk Index 46																																																																			
<u>Common:</u> 2.1mi S of Five Points <u>Drainage:</u> Poley Creek <u>GPS:</u> 31.410927205,-86.301856745 <u>Land owner:</u> Charles & Stacy Hinds		<u>County:</u> Covington <u>PLSS (T-R-S):</u> 5N-17E-12 <u>Parcel No.:</u> ? <u>Road Name:</u> Chaker Rd		<u>State:</u> Alabama

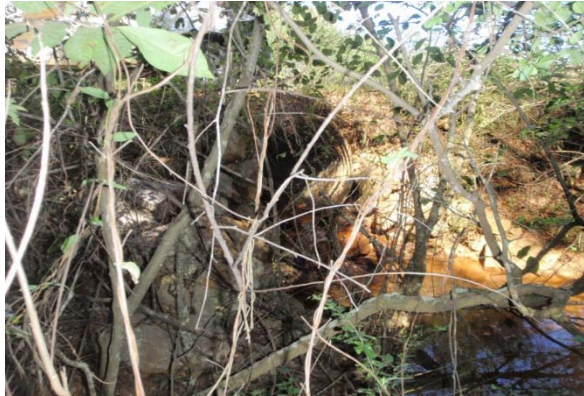
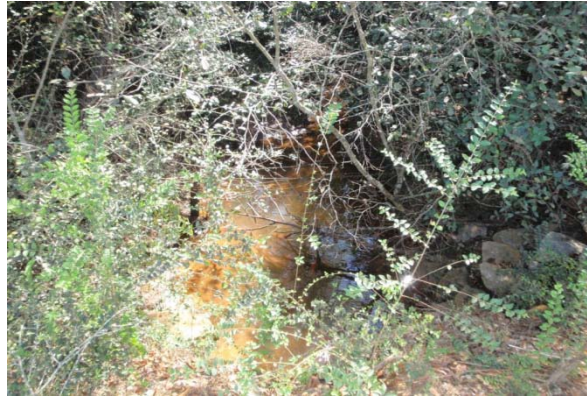
Crossing Structure: DS		DS																																																																					
<table border="1"> <thead> <tr> <th>Risk Factor</th> <th>Ranking</th> <th>Score</th> </tr> </thead> <tbody> <tr><td>US Channel Morph</td><td>C</td><td>5</td></tr> <tr><td>DS Channel Morph</td><td>C</td><td>5</td></tr> <tr><td>DS Bank Alteration</td><td>MINOR/PARTIAL</td><td>3</td></tr> <tr><td>Upstream Skew Angle</td><td><5°</td><td>5</td></tr> <tr><td>Crossing fill condition</td><td>Fair/Rip Rap</td><td>3</td></tr> <tr><td>Inlet/Outlet Condition</td><td>No Impairment</td><td>5</td></tr> <tr><td>Road Approach Material</td><td>All Sand/Clay</td><td>3</td></tr> <tr><td>Potential Eroded Volume Mean</td><td><21 y³</td><td>5</td></tr> <tr><td>Approach Slope Mean</td><td>2.1-4%</td><td>3</td></tr> <tr><td>Soil K Factor</td><td>0.21-0.40</td><td>3</td></tr> <tr><td>Upstream Rt Outlet</td><td>Bare soil</td><td>0</td></tr> <tr><td>Upstream Lt Outlet</td><td>Vegetated</td><td>1</td></tr> <tr><td>Upstream Rt Ditch</td><td>Vegetated</td><td>1</td></tr> <tr><td>Upstream Lt Ditch</td><td>Vegetated</td><td>1</td></tr> <tr><td>Downstream Rt Outlet</td><td>Vegetated</td><td>1</td></tr> <tr><td>Downstream Lt Outlet</td><td>Vegetated</td><td>1</td></tr> <tr><td>Downstream Rt Ditch</td><td>Bare soil</td><td>0</td></tr> <tr><td>Downstream Lt Ditch</td><td>Bare soil</td><td>0</td></tr> <tr><td>Outlet Total</td><td>Partially Improved Outlet System</td><td>3</td></tr> <tr><td>Ditches Total</td><td>Partially Improved Drainage System</td><td>3</td></tr> <tr><td>SRI Total</td><td>Low Risk</td><td>46</td></tr> </tbody> </table>						Risk Factor	Ranking	Score	US Channel Morph	C	5	DS Channel Morph	C	5	DS Bank Alteration	MINOR/PARTIAL	3	Upstream Skew Angle	<5°	5	Crossing fill condition	Fair/Rip Rap	3	Inlet/Outlet Condition	No Impairment	5	Road Approach Material	All Sand/Clay	3	Potential Eroded Volume Mean	<21 y ³	5	Approach Slope Mean	2.1-4%	3	Soil K Factor	0.21-0.40	3	Upstream Rt Outlet	Bare soil	0	Upstream Lt Outlet	Vegetated	1	Upstream Rt Ditch	Vegetated	1	Upstream Lt Ditch	Vegetated	1	Downstream Rt Outlet	Vegetated	1	Downstream Lt Outlet	Vegetated	1	Downstream Rt Ditch	Bare soil	0	Downstream Lt Ditch	Bare soil	0	Outlet Total	Partially Improved Outlet System	3	Ditches Total	Partially Improved Drainage System	3	SRI Total	Low Risk	46
