Unnamed tributary		co-0731-r-007	Sedimentation Risk Index <b>44</b>																																																																		
<u>Common:</u> 3.6mi NW of Florala <u>Drainage:</u> Horsehead Creek <u>GPS:</u> 30.993519, -86.484894 <u>Land owner:</u> Rayonier Forest Resources LP		<u>County:</u> Covington <u>State:</u> Alabama <u>PLSS (T-R-S):</u> 1N-17E-30 <u>Parcel No.:</u> 1 <u>Road Name:</u> Union Church Rd

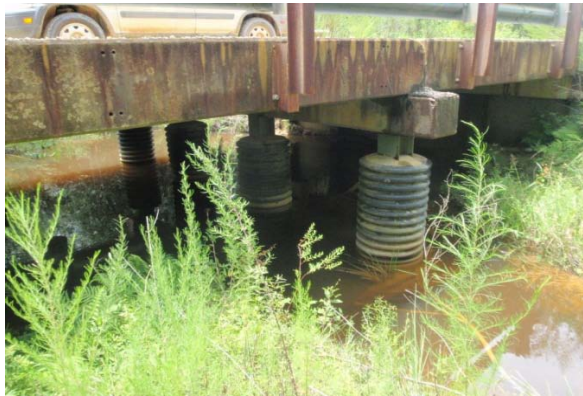
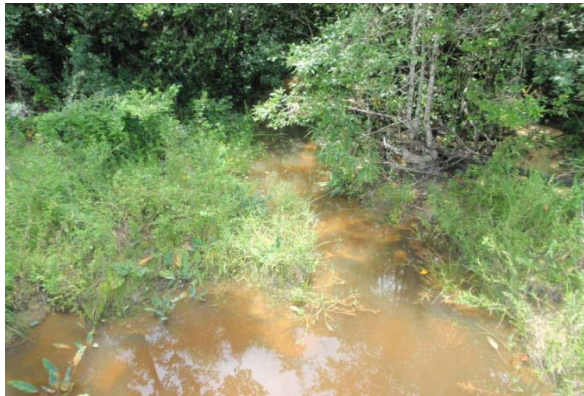
Crossing Structure: US		DS																																																																			
<table border="1"> <thead> <tr> <th>Risk Factor</th> <th>Ranking</th> <th>Score</th> </tr> </thead> <tbody> <tr><td>US Channel Morph</td><td>C</td><td>5</td></tr> <tr><td>DS Channel Morph</td><td>C</td><td>5</td></tr> <tr><td>DS Bank Alteration</td><td>HIGH</td><td>1</td></tr> <tr><td>Upstream Skew Angle</td><td>&lt;5°</td><td>5</td></tr> <tr><td>Crossing fill condition</td><td>Good/Vegetated</td><td>5</td></tr> <tr><td>Inlet/Outlet Condition</td><td>No Impairment</td><td>5</td></tr> <tr><td>Road Approach Material</td><td>All Sand/Clay</td><td>3</td></tr> <tr><td>Potential Eroded Volume Mean</td><td>&gt;40 y<sup>3</sup></td><td>1</td></tr> <tr><td>Approach Slope Mean</td><td>2.1-4%</td><td>3</td></tr> <tr><td>Soil K Factor</td><td>&lt;0.20</td><td>5</td></tr> <tr><td>Upstream Rt Outlet</td><td>Vegetated</td><td>1</td></tr> <tr><td>Upstream Lt Outlet</td><td>Vegetated</td><td>1</td></tr> <tr><td>Upstream Rt Ditch</td><td>Bare soil</td><td>0</td></tr> <tr><td>Upstream Lt Ditch</td><td>Bare soil</td><td>0</td></tr> <tr><td>Downstream Rt Outlet</td><td>Vegetated</td><td>1</td></tr> <tr><td>Downstream Lt Outlet</td><td>Vegetated</td><td>1</td></tr> <tr><td>Downstream Rt Ditch</td><td>Bare soil</td><td>0</td></tr> <tr><td>Downstream Lt Ditch</td><td>Bare soil</td><td>0</td></tr> <tr><td>Outlet Total</td><td>Improved Outlet System</td><td>5</td></tr> <tr><td>Ditches Total</td><td>Unimproved Drainage System</td><td>1</td></tr> <tr><td><b>SRI Total</b></td><td><b>Medium Risk</b></td><td><b>44</b></td></tr> </tbody> </table>				Risk Factor	Ranking	Score	US Channel Morph	C	5	DS Channel Morph	C	5	DS Bank Alteration	HIGH	1	Upstream Skew Angle	<5°	5	Crossing fill condition	Good/Vegetated	5	Inlet/Outlet Condition	No Impairment	5	Road Approach Material	All Sand/Clay	3	Potential Eroded Volume Mean	>40 y <sup>3</sup>	1	Approach Slope Mean	2.1-4%	3	Soil K Factor	<0.20	5	Upstream Rt Outlet	Vegetated	1	Upstream Lt Outlet	Vegetated	1	Upstream Rt Ditch	Bare soil	0	Upstream Lt Ditch	Bare soil	0	Downstream Rt Outlet	Vegetated	1	Downstream Lt Outlet	Vegetated	1	Downstream Rt Ditch	Bare soil	0	Downstream Lt Ditch	Bare soil	0	Outlet Total	Improved Outlet System	5	Ditches Total	Unimproved Drainage System	1	<b>SRI Total</b>	<b>Medium Risk</b>	<b>44</b>

Ditches Total	Unimproved Drainage System	1																																																																			
<b>SRI Total</b>	<b>Medium Risk</b>	<b>44</b>																																																																			
<b>Additional Site Features</b> <u>Crossing Type and Quantity:</u> Bridge, 1 <u>Crossing Materials:</u> Reinforced Concrete <u>Soil Types:</u> CdB,CdC,DmB,MBA <u>Rt Approach Prism Fill:</u> 2.0in <u>Lt Approach Prism Fill:</u> 3.0in
