## **Vulnerability details**

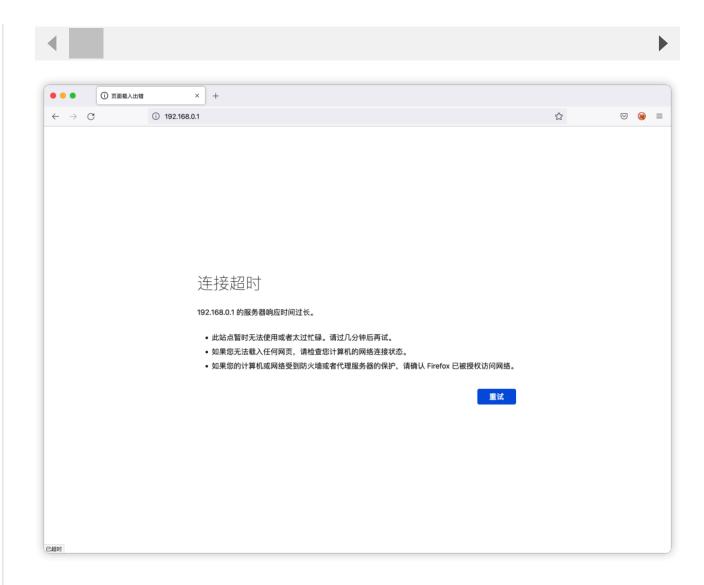
The content obtained by the program through the urladd parameter is passed to V2, and then V2 is assigned to V9 Finally, through the streat function, V9 is added to the stack of v10. There is no size check, so there is a stack overflow vulnerability.

Figure 2 POC attack effect
