TOTOLink A3700R V9.1.2u.6134_B20201202 has a stack overflow vulnerability

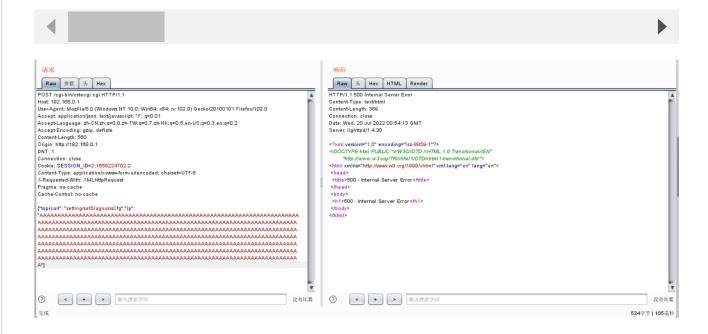
Var is formatted into V6 through sprintf function, and Var is the value of ip we enter. The size of the format string is not limited, resulting in stack overflow.

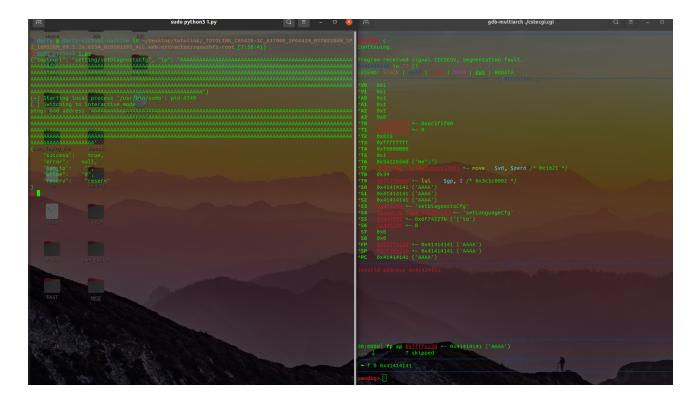
The above figure shows the POC attack effect

As shown in the figure above, we can hijack PC registers.
