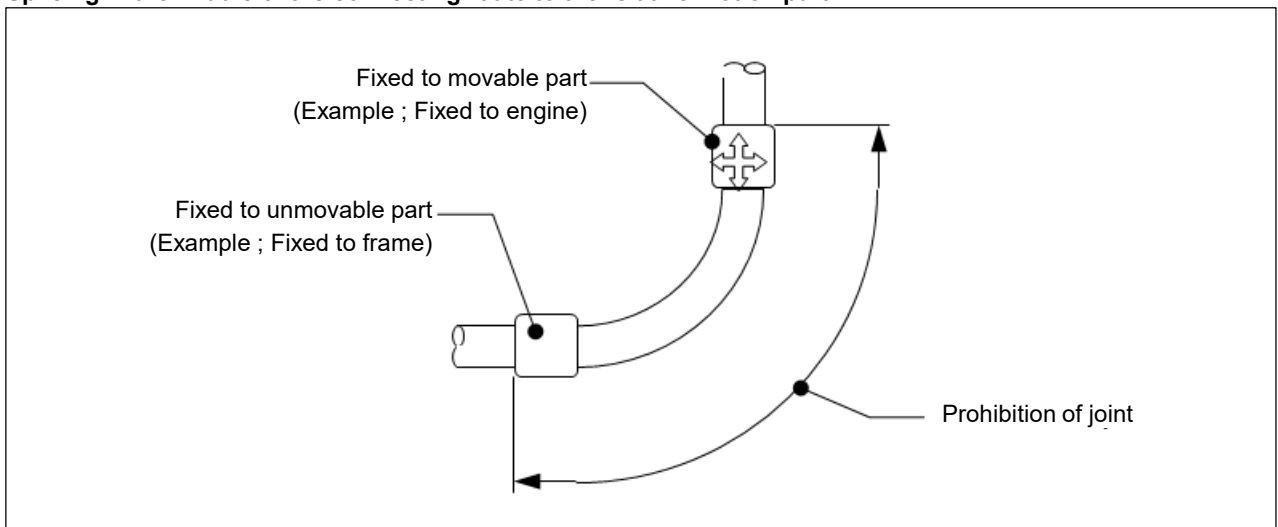
- Do not splice in the following area; bent location of harness, area of large vibration, and area of high temperature.
 - Since the flexibility is reduced at splicing portion as compared with other portions, it is possible that harness route may not return to the original.
 - Possibility of disconnection occurrence will be higher, because flutter increases due to larger weight.
 - Decide the position of the splice carefully
- In case of performing the splicing in the middle of the connecting route to the relative motion part (cab to frame, engine/mission to frame), there is a risk of breakage caused by bending input. Perform the splicing out of the connection area by replacing the lengthened wire all spans the area.

Splicing in the middle of the connecting route to the relative motion part
