## **Product Information**

H3C B5 Mini B5MiniV100R005 router, the latest version of simulation overview:

The H3C B5 Mini B5MiniV100R005 router was found to have a stack overflow vulnerability in the WlanWpsSet function. An attacker can obtain a stable root shell through a carefully constructed payload.

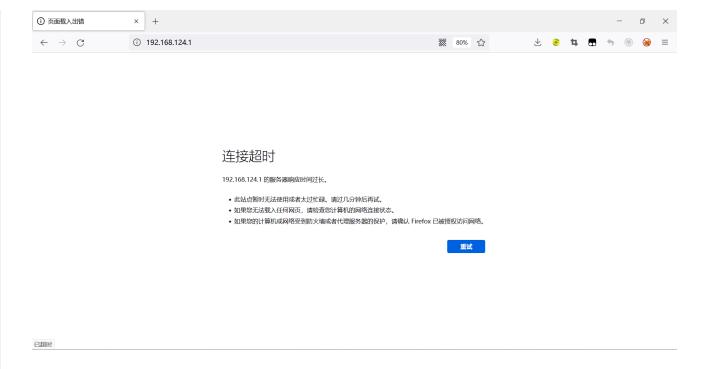
级别	信息来源	信息内容
error	系统	webs进程已重启。

The picture above is the log information.
