RN0074
Release Notes
CoreFIFO v3.0

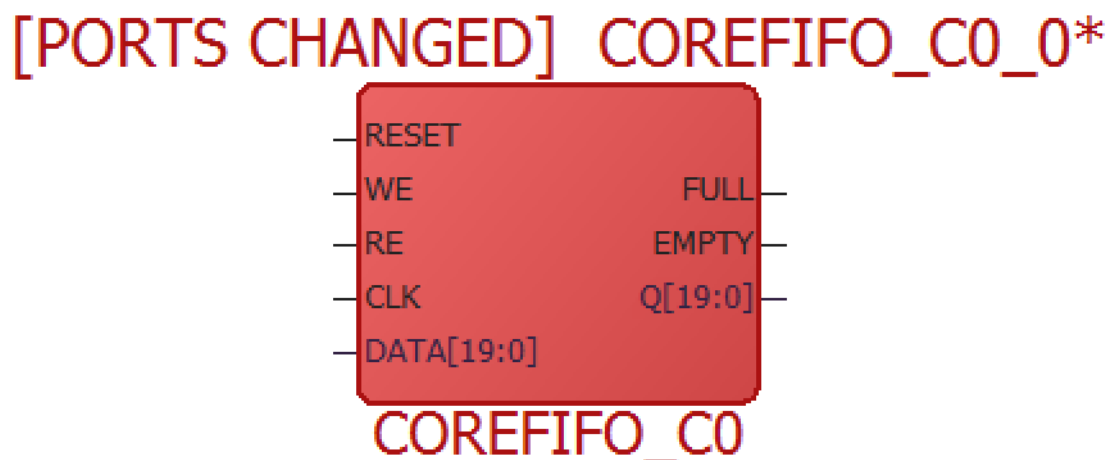
- When migrating to CoreFIFO v3.0 from earlier versions the user can expect following SmartDesign and logs windows.

Figure 1 • Expected SmartDesign view when migrating to CoreFIFO v3.0

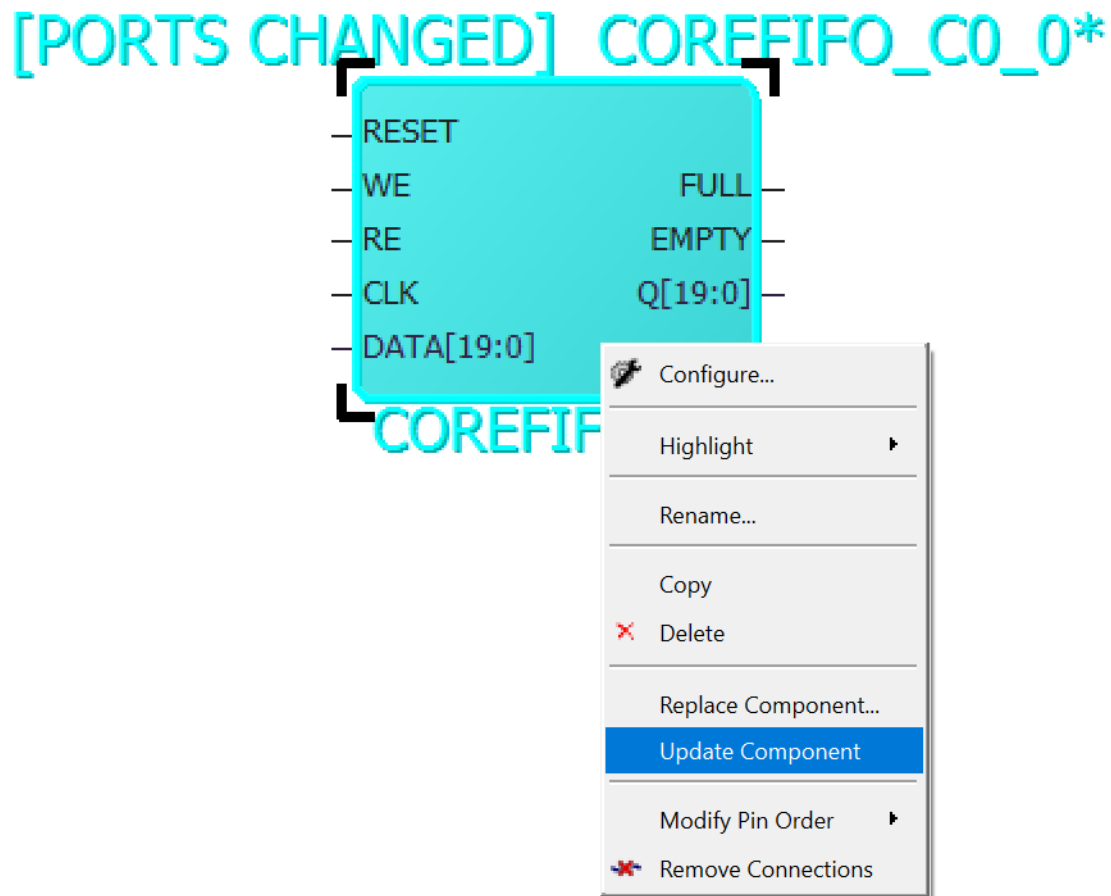
Figure 2 • Updating SmartDesign to CoreFIFO v3.0 using Update Component option

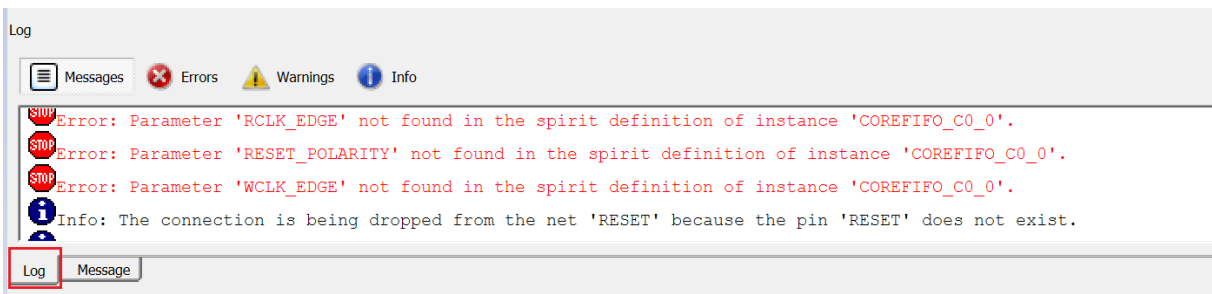
Figure 3 • Log messages window when migrating to CoreFIFO v3.0

Note: User can safely ignore errors reported in the log window.

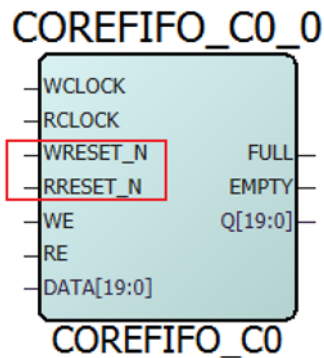
- When Clocks (SYNC) parameter is configured in dual clock mode (SYNC=0), two reset ports, WRESET_N and RRESET_N are exposed to the top-level ports.

Figure 4 • SmartDesign configured for SYNC = 0

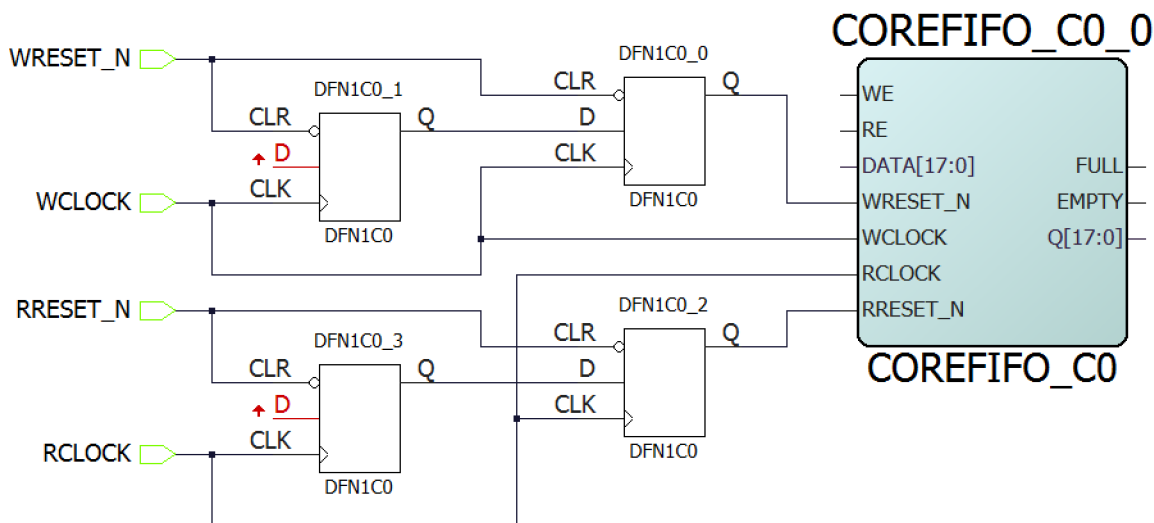
Figure 5 • Asynchronous Reset Synchronizer (When Reset type - SYNC_RESET is set to 0) – external to the IP Core

- In the earlier version of the CoreFIFO, only one reset port (RESET) is used (for dual clock FIFO mode). This reset (RESET) input is synchronized internally with respect to the WCLK and RCLK domains.
- For CoreFIFO v3.0, two separate resets (WRESET_N and RRESET_N) ports (for dual clock FIFO mode) are exposed to the user. The user shall synchronize these two resets into the respective clock domain (WRESET_N in WCLK and RRESET_N in RCLK domain) **external** to the IP core.
- CoreFIFO v3.0 is not backward compatible for RESET port connection.
- User can refer to Figure 5 and Figure 6 for asynchronous and synchronous reset synchronizer respectively

Note: In the above example figures only two flop synchronisers are shown.

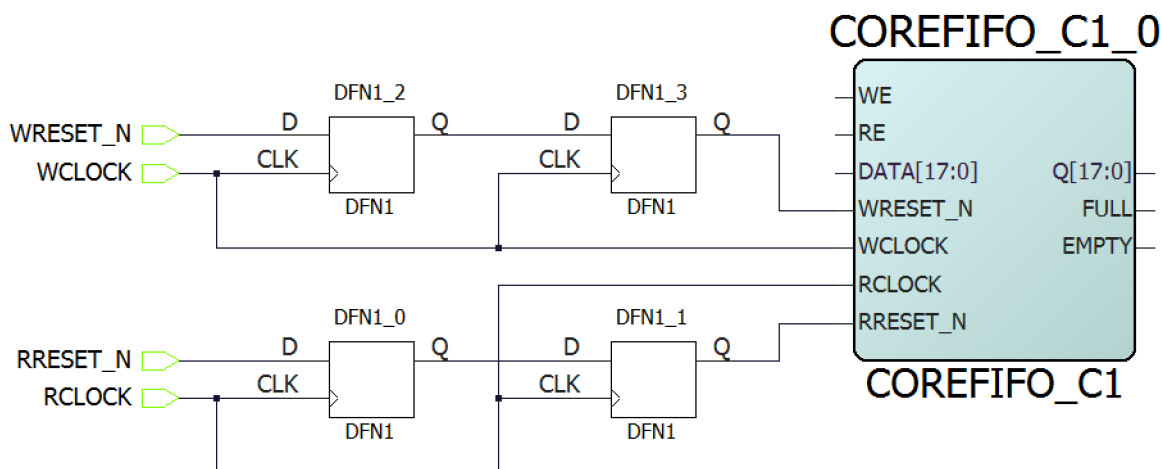
Figure 6 • Synchronous Reset Synchroniser (When SYNC_RESET is set to 1) – external to the IP Core
