DST CTD & DST Logic CTD

Troubleshooter

STAR : ODDI

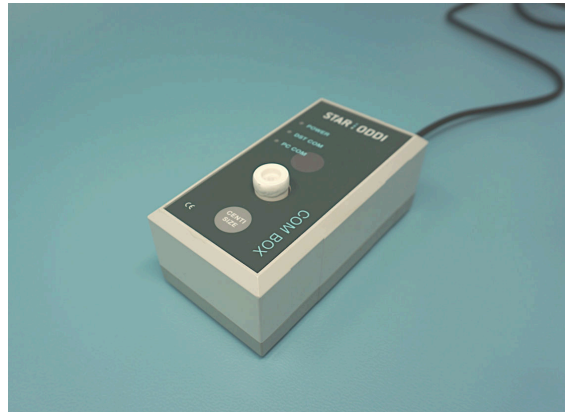
In order to be able to communicate with the recorder, the three diodes on the communication box need to be lit. POWER (red) diode shows that power is fed from the power supply to the Communication Box. PC COM (yellow) diode shows that SeaStar has connected with the box and that the correct COM port has been selected. DST COM (green) shows that the recorder is in a correct position for seeking connection.

Figure 1.1: Communication Box with recorder inserted.

1. Check if the red and yellow lights are on.
2. Check if the logger is inserted correctly into the hole in the box. The spherical end should face down.
3. If the recorder has been recording in water, please wipe it dry before inserting it into the box.
