2022-11-07

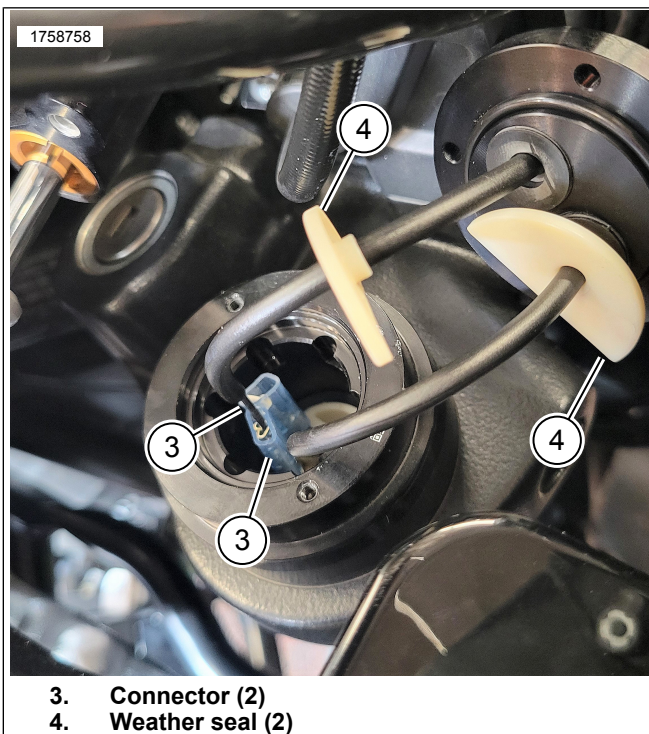
Figure 3. Connectors

3. See Figure 3. Reposition weather seals (4) on the Adaptive Ride Height (ARH) wires.
4. Inspect that both connectors (3) are secure and firmly in place. Make sure wires are properly crimped to terminals.

If connectors are found to be loose or disconnected, tighten and reinstall. If connectors are damaged, the fork will need to be replaced. After reassembly verify that Diagnostic Trouble

Codes (DTCs) do not return. If connectors are found to be in place with a tight fit, then continue with suggested repair given by the EDM and DT II guided diagnostics.
