When ATC meets TCAS II ...

Editorial

John Law Mode S and ACAS Programme Manager, **EUROCONTROL** November 2007

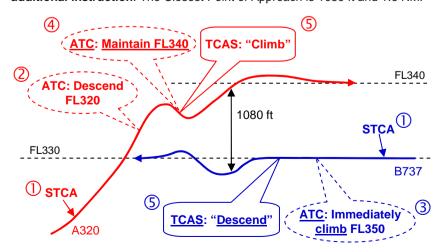
Event 1: Correct response to RA disregarding ATC instruction

As the A320 begins to climb, a Short Term Conflict Alert (STCA) is displayed to the controller ①. He assesses the situation and instructs the A320 to descend back to FL320 @ and the B737 to climb immediately to FL350 3.

However, due to latency of the altitude display, the vertical situation shown to the controller does not match the actual one and the A320 is already above the B737 (700 ft as later reported by the A320 pilot).

The subsequent update of the controller's radar display confirms the A320 above the B737. The controller issues an instruction to the A320 to maintain FL340 @. However, the A320 pilot has already initiated a descent in compliance with the first instruction. Immediately after this instruction, both aircraft receive coordinated RAs S triggered by the descent initiated by the A320.

The A320 receives a "Climb" RA, which is consistent with the controller's second avoiding instruction and the B737 a "Descend" RA contrary to the ATC instruction to climb.

The pilots of both aircraft follow their RA and report them to the controller, who acknowledges the messages and does not provide any additional instruction. The Closest Point of Approach is 1080 ft and 1.6 NM.

The figure depicts the aircraft vertical trajectories, not the altitudes displayed to the controller.

"Pilots shall follow the RA even if there is a conflict between the RA and an ATC instruction to manoeuvre" (ICAO PANS-OPS)

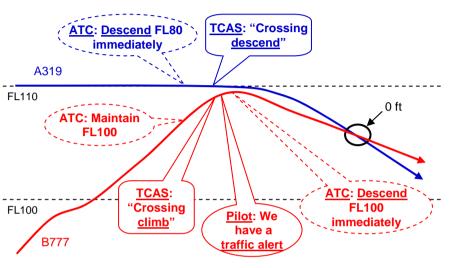
Event 2: Opposite reaction to RA following ATC instruction

At about the same time, both aircraft's TCAS trigger coordinated RAs:

- a "Crossing descend" for the A319
- a "Crossing climb" for the B777

The B777 pilot reports to the controller: "We have a traffic alert". As he did not use the standard phraseology, the controller is not aware of the RA and instructs the B777 to immediately descend to FL100 and seconds later to turn further right heading 180.

In the meantime, the A319 pilot descends following the RA. However, the B777 pilot ignores the coordinated "Climb" RA and also descends in response to the ATC instruction. As a result, the aircraft are only 1.6 NM apart as they both pass FL106

Use of correct RA reporting phraseology by the pilot will reduce the risk of ATC issuing avoiding instructions that are contradictory to the RA

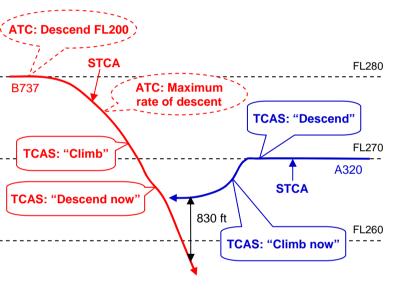
Event 3: Efficient horizontal avoiding instructions issued by ATC

A B737, heading North, is cleared to descend from FL280 to FL200. The pilot initiates the descent and this triggers a STCA warning against a conflicting A320 at FL270, 10 NM ahead, on opposite track, that the controller has overlooked.

The controller immediately instructs the B737, which is still above the A320, to descend at the maximum rate and to turn right heading 090. Then, the controller instructs the A320 to turn immediately heading 270. While the turns begin to provide some horizontal spacing, both aircraft receive coordinated RAs.

- The B737 receives a "Climb" RA
- The A320 receives a "Descend" RA

When the B737 pilot receives the "Climb" RA, the aircraft is just increasing the rate of descent to more than 3000 fpm. Because TCAS reassesses the conflict geometry every second it reverses the RA into a "Descend now" RA. In response, the pilot increases the rate of descent to more than 4000 fpm.

In the meantime, the A320 pilot, who is following the "Descend" RA, receives a coordinated reversal "Climb now" RA. In response, the pilot only stops the descent.

None of the RAs are reported to the controller. Consequently, when he detects on the radar display that the A320 is descending, he reminds the pilot that his clearance is FL270. The pilot then replies that he had to follow a "Descend" RA and that he is now climbing back to FL270.

As a result of the manoeuvres, both horizontal and vertical, the Closest Point of Approach is 3.7 NM and 830 ft. Without the turns, the extrapolation of the aircraft trajectories shows that they would have passed at 0.2 NM.

However, in the absence of an RA report, ATC horizontal avoiding instructions will not adversely affect any TCAS II RA.

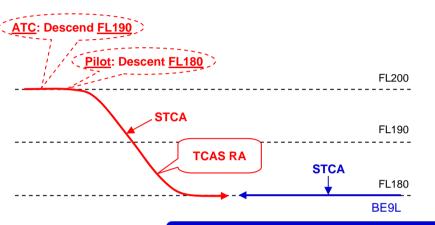
Event 4: Incorrect responses to alerts generated by TCAS and STCA

A Beech King (BE9L) aircraft, without TCAS, is heading East at FL180. A converging southbound Canadair Regional Jet (CRJ) is cleared from FL200 to FL190. There is no read-back from the CRJ pilot and so the controller repeats the descent clearance.

The pilot responds incorrectly with 'FL180' but the discrepancy is not noticed by the controller who responds "Affirm". The pilot then transmits: "Okay, descending level one eight zero, thank you" but the incorrect read-back is still not detected by the controller.

As the CRJ is passing FL192, a STCA warning is displayed on the controllers radar display, but there is no reaction from the controller who then communicates with two other aircraft. Finally, the controller asks the CRJ pilot to confirm his level but offers no avoiding action to either aircraft. The CRJ pilot responds: "We are level now, [callsign] and we had a TCAS... resolution advisory". The pilot, however, does not state the level that he is maintaining.

Following this, the controller and the pilot engage for almost 30 seconds in a discussion about the discrepancy in the cleared level. Although he reports the RA to ATC, the CRJ pilot does not modify the aircraft trajectory.

As a result, the aircraft horizontal spacing was only 1.6 NM at the same level. The CRJ pilot has not filed an incident report, so the type of the RA he received can not be established.

Pilots and controllers <u>must</u> respond promptly to any alerts generated by TCAS and STCA to ensure that flight safety is not compromised
