Reduction of defects in Kanger 2(TATA Motors)

Kanger 2 was the name given to the now known as Nexon EV in the market. Defect reduction usually involves the following steps that I focused on-

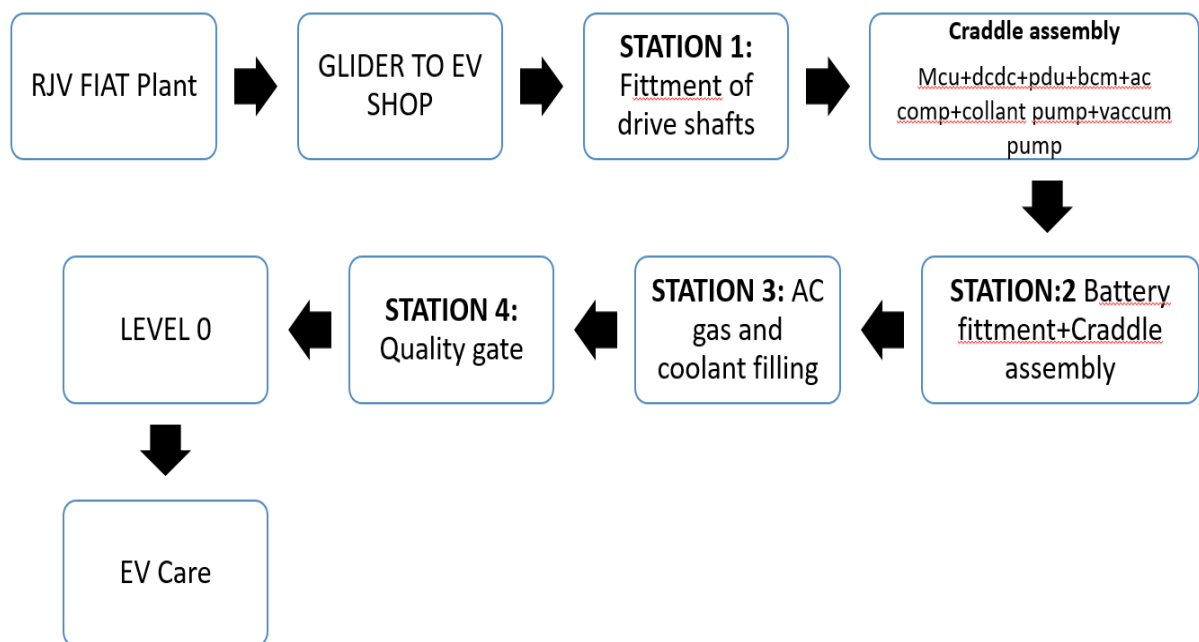
EV Shop layout

The image below shows the path of production of this vehicle-

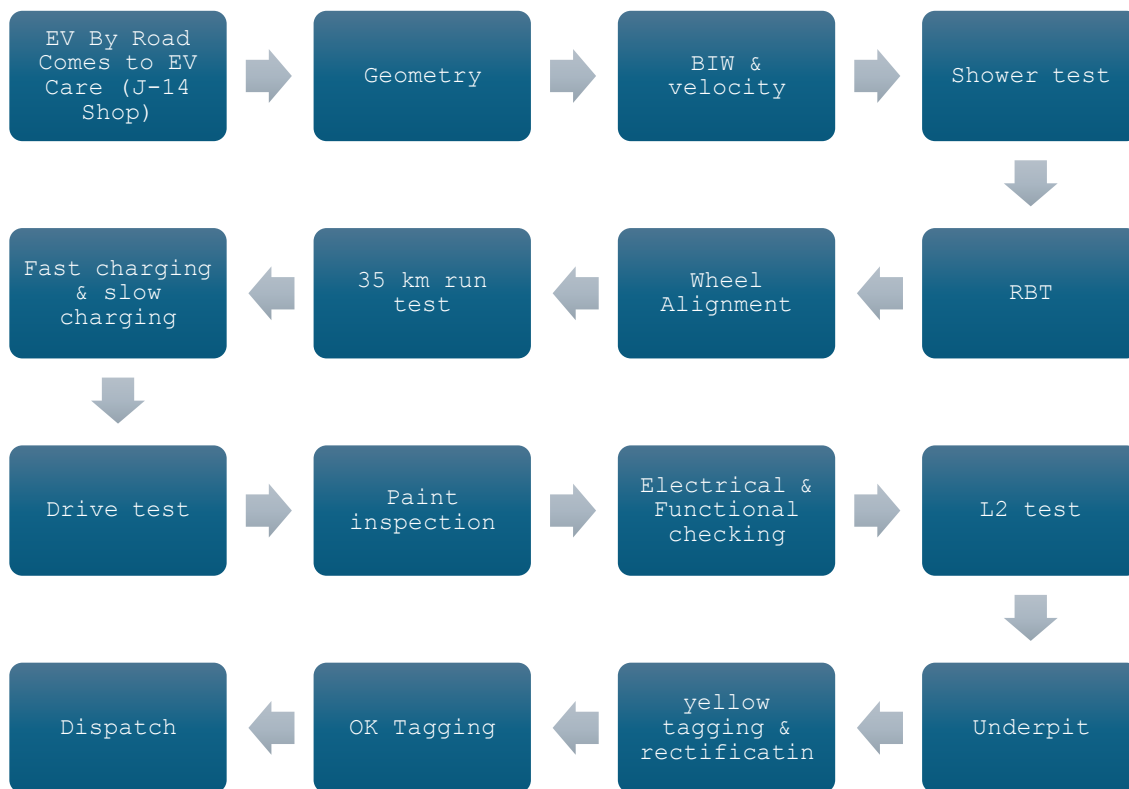
After the vehicle reaches EV care the image below will show the next operations needed to be conducted.

This is where my work begins. I had to majorly focus on the processes mentioned above in the image and make sure that there are no repeated defects. I also had to inspect the defected vehicles, identifying the root cause and avoiding the repetition of these errors. The SOP of the production process was quite set before my arrival as Tata Motors is a big firm so I could focus completely on defects occurred in each station and could work on each defect individually.
