Incorrect ...

Editorial

This ACAS Bulletin includes some actual events where problems arose due to misinterpretation of the TCAS II traffic display, and provides some insight into why these events occurred.

John Law Mode S and ACAS Programme Manager, **EUROCONTROL** March 2005

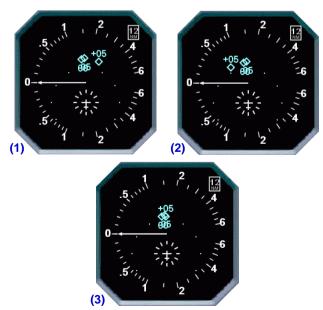
The following illustrations show the TCAS traffic displays of an event recorded during a TCAS II trial. There were 3 intruder aircraft, in the 12 o'clock position, but separated by 500 ft vertically. However, the intruder at +05 (i.e. 500 ft above) appears at 6 seconds intervals, on the right of the group of targets (1) and then on the left (2), before being shown in the correct 12 o'clock position (3).

In the worst case, bearing error could cause a target on one side of the aircraft to be displayed to the other. This emphasises the danger of undertaking a horizontal manoeuvre based solely on the TCAS traffic display.

Bearing variations from +17° to -26° and then to 02°
