Comparison of X-ray Computed Tomography and Ultrasonic C-Scan Techniques and Numerical Modelling of Impact Damage in a CFRP Composite Laminate

Two different experimental techniques are employed to visualize the impact damage generated by a low-velocity impact on a carbon-fibre reinforced-polymer (CFRP) composite laminate. At the relatively low impact-velocity of 1.69 m.s^{-1} , and a corresponding impact energy of 7.5 J , used in the present work the damage induced in the CFRP panel is barely visible to the naked eye but the techniques of ultrasonic C-scan and X-ray computed tomography (CT) can detect the damage that has occurred. This damage is mostly inter-laminar damage, i.e. delaminations, between the plies due to a change in modulus from one ply to the next in the laminate. This interlaminar damage is usually accompanied by intralaminar damage, e.g. matrix cracking, in the ply itself. The type and extent of damage detected from using these two techniques is discussed and the relative merits of these techniques are compared. In general, the CT gave the better resolved picture of damage but the lateral extent of the damage was underestimated relative to C-scan which was more se

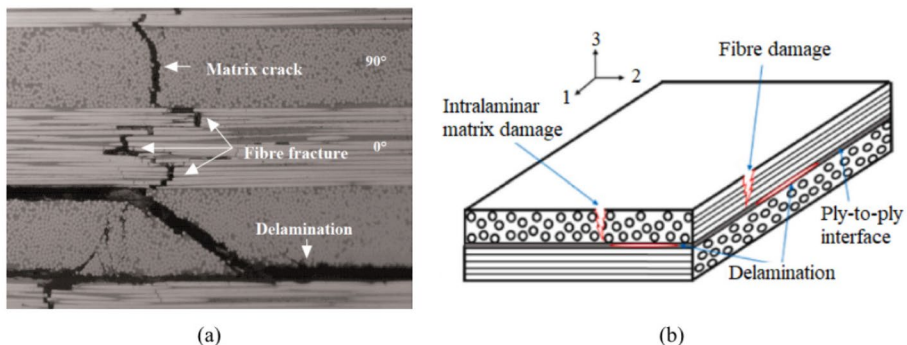
Fig. 1 Different types of damage in a composite laminate subjected to an impact load [10]

The major damage mechanisms observed [e.g. 7–10] when a CFRP composite is impacted at a relatively low-velocity (of up to about 5 m.s^{-1}) are: (a) intralaminar damage which typically involves plastic deformation of the matrix, matrix cracking, fibre debonding and localised fibre failure and (b) interlaminar damage which typically involves the initiation and growth of delaminations between the layers, i.e. plies, that form the composite laminate. These main damage mechanisms are illustrated in Fig. 1.

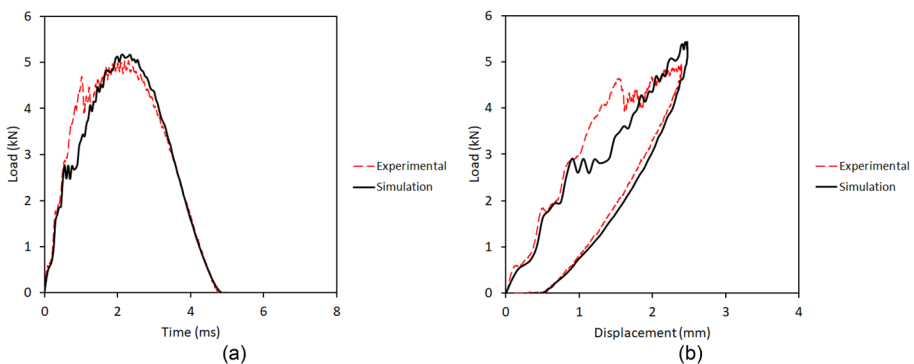
Fig. 2 The experimental and predicted load versus time and load versus displacement curves for the impacted CFRP panels. The red dashed line is a typical experimental test. A duplicate test showed similar behaviour. The black solid line shows the simulation prediction for load versus time and load versus displacement

The load versus time and load versus displacement responses for the rectangular composite panel, subject to the drop-weight impact test, are shown in Fig. 2. Relatively small amplitude, sinusoidal oscillations can be seen on the rising part of the load versus time, and the load versus displacement, experimental curves. These sinusoidal oscillations have previously been discussed in detail [9] and are indicative of mass-spring oscillations. On the experimental load versus time curve (red dashed line), there is a distinct load drop at a load of approximately 4.7 kN at a time of 1 ms, followed by oscillations indicative on the onset of damage initiation. This is also apparent on the load versus displacement curve. A duplicate test showed very similar behaviour. The predictions from the simulation numerical modelling (black solid line), see [9] and as discussed below, also show these effects; albeit the load at which damage initiation occurs in the model is somewhat lower. However, the overall response of the experimental load versus time and load versus displacement curves are very similar to those predicted from the modelling simulations. For example, for both the experimental and modelling results, the maximum load achieved is approximately 5 kN, the duration of impact event is approximately 4.6 ms and the overall displacement is approximately 2.5 mm.

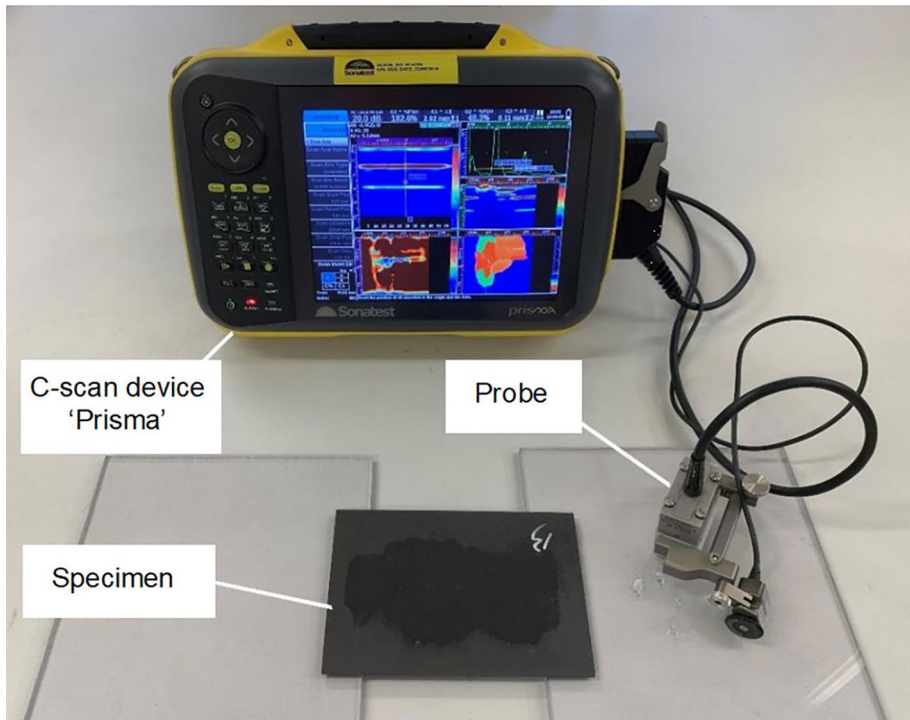
Fig. 3 Photograph of the ultrasonic C-scan equipment

The impacted CFRP panels were inspected using a Prisma portable ultrasonic C-scanner supplied by Sonatest Ltd, UK, see Fig. 3, to detect any interlaminar damage that resulted from the impact loading. This technique has been discussed in detail elsewhere [9]. Essentially, a water spray is applied to the surface to act as a contact agent to ensure effective transmission of the ultrasonic waves from the transducer probe through the composite, using a scanning frequency of 5 MHz. These waves are reflected back to the transducer upon interacting with any delamination damage in the panel, and the position and size of the interlaminar damage can be determined from the total travel time and amplitude received by the transducer, respectively. The C-scanning equipment gave images with a scale from 0 to 4.58 mm, i.e. the thickness, t , of the panel. For this study, the reflection from the rear face of the panel was selected to be black so that all reflections from delaminations are coloured dark red through to dark blue. The total damage area was then calculated by counting the number of pixels that were not black in colour, since black corresponded to a region of the laminate free from interlaminar damage.

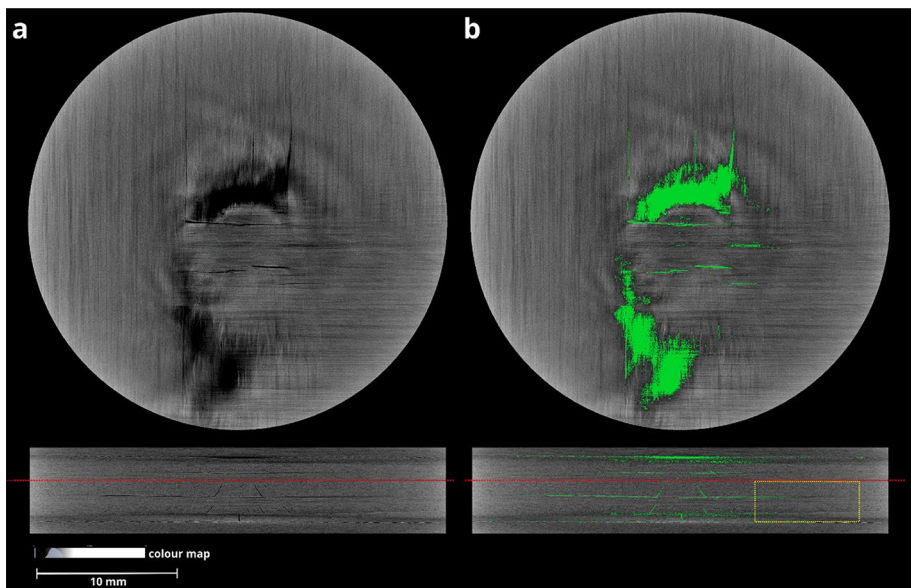
Fig. 4 Orthogonal regions of interest (at the same scale) taken from the X-ray CT data X–Y (top) and X–Z (bottom) slices: **a** prior to segmentation and **b** with the segmentation of the damage (rendered green) super-imposed on the 17 μm pixel size dataset. The red dashed lines show the location of the other orthogonal slice. The yellow box region is referred to in Fig. 7. (The X-ray CT scan is performed on a central disc taken from the rectangular specimen.)

Flux Bay'). The specimen from the impacted CFRP panel was sandwiched between two additional pieces of CFRP of the same type to help reduce scatter on the upper and lower surfaces of the specimen. The system was equipped with a 225 kV static tungsten reflection target source with a minimum focal spot size of 3 μm (at low wattage) and a PerkinElmer 4096 \times 4096 pixels 16-bit amorphous silicon flat-panel detector. The X-rays were generated using a voltage of 120 kV and a current of 88 μA (with power of 10.56 W). Each radiograph (projection) was acquired with an exposure time of 1000 ms, a gain of five, using binning of two, giving an effective detector size of 2048 \times 2048 pixels, with an effective pixel pitch of 200 μm . The total number of projections was 3181, which was fixed using an optimisation based on the Nyquist–Shannon sampling theorem. Eight frames were taken per projection giving an approximate total scan time of 7 h per scan. The specimen was scanned twice at two different resolutions, using the same X-ray and exposure settings, giving two data sets with isotropic pixels sizes of 27 μm and 17 μm . The 3-D volumes were reconstructed from the projection data at full resolution as 16-bit tiff stacks using Nikon's 'CT Pro 3-D software', supplied by Nikon X-Tek Systems Ltd, UK. Orthogonal CT slices from the tomogram are shown in Fig. 4 of the central disc containing the impact damage.

found that the lateral extent of the segmented damage was confined within the field of view scanned by the 17 μm dataset. When directly comparing the two datasets, it was evident that many of the fine features had not been resolved in the 27 μm dataset. Therefore, even if the lateral extent of the damage region did extend beyond the 17 μm dataset, those features would not have been resolved. (The issue of partial volume effects and limitations of the segmentation of the CT data is highlighted again later in Section 3.4 and Fig. 7).

Finally, one feature seen in the X-ray CT data that is not evident in the C-scan data, and is apparent in the modelling simulation (see below), is the presence of distinct intralaminar matrix cracking. This can be best seen in the cross-section in Fig. 4 (in the lower images), Fig. 7 and the coloured X-ray CT slice in Fig. 8. Matrix cracking is expected to result from the present impact tests and a detail to note is where the lateral extent of the delaminations are abruptly terminated by linear features that are angled relative to the longitudinal fibre direction in the adjacent ply. These linear features are intralaminar matrix fractures that cross-cut the matrix at approximately 45° to the plane of the ply, as may be seen in the cross-sections in Fig. 4 (in the lower images) and Fig. 8. This suggests a mechanism of energy transfer down and laterally through the impacted specimen.

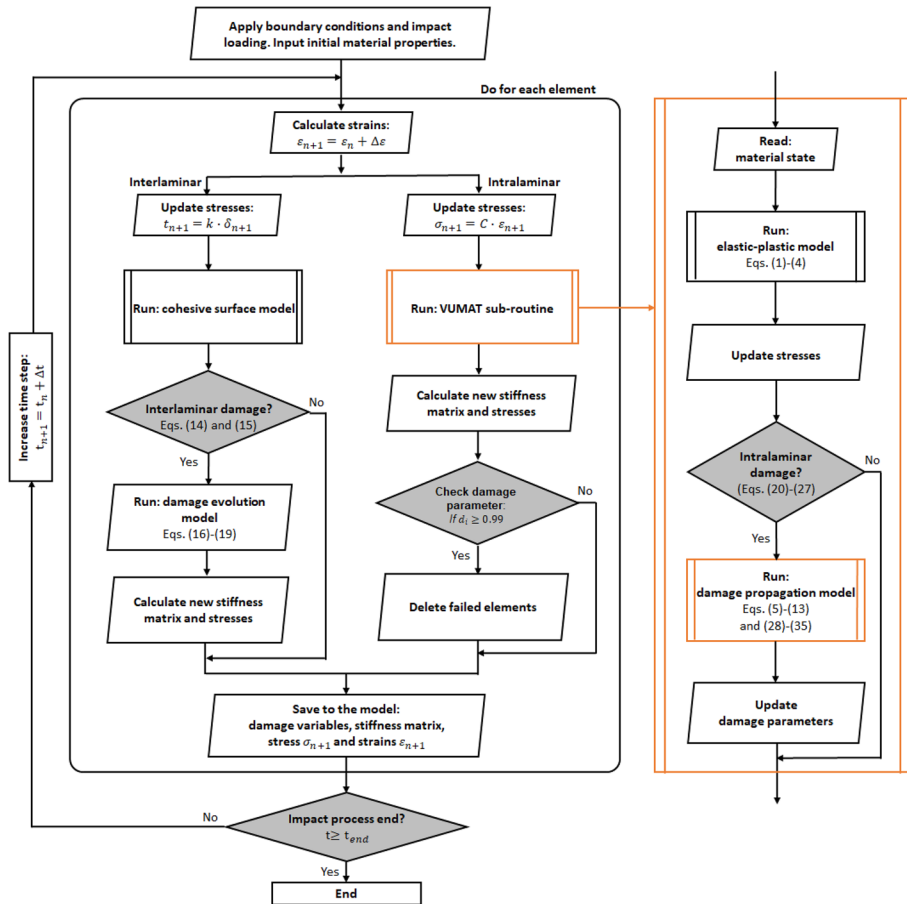
Fig. 5 The implementation of the E-P, 3-D FEA numerical damage model showing schematically the overall flowchart for one computational time-step and a single integration point. Both the flowcharts for the main model and for the elastic-plastic (E-P) user-defined sub-routine are shown. This FEA modelling simulation of the impact event would be run typically over a timescale, t , of 0 to ca. 8 ms, with ca. 100 time-steps being employed. The simulation runs were stopped when the defined total computation time for the impact simulation event had expired. (All the methodologies and equations that are used in the above FEA model are derived and presented in [9], where the equations are numbered as above.)

A 3-D, elastic–plastic (E-P), finite element analysis (FEA) numerical damage model has been previously developed and verified [9, 27, 28] for predicting interlaminar, intralaminar and other damage processes, such as a permanent plastic indentation in the composite panel caused by the impactor, when subjected to an impact load. Indeed, in the present work, the model has already been shown to be able to predict quite accurately the overall response of the experimental load versus time and load versus displacement curves, see Fig. 2. Thus, next, its ability to predict the type, location and extent of the impact damage introduced into the composite CFRP panel is assessed by comparing the simulation results to the experimental results from the C-scan and X-ray CT techniques. The FEA model was implemented in 'Abaqus 2020' (Dassault Systemes, France) and the overall flow chart is shown in Fig. 5 for the main model and the E-P model, which was incorporated as a user-defined material ('VUMAT') sub-routine into the main FEA code. This flow-chart provides the sequence of the modelling steps and the relevant equation numbers, as previously given and explained in [9]. The flow-chart in Fig. 5, together with reference [9], allows the reader to follow the logical computational sequence of the numerical model: including

the novel E-P model, the failure criteria used and how crack initiation and propagation for the intralaminar and interlaminar damage regions are defined and quantitatively modelled. For the modelling studies the basic mechanical properties of the composite plies, including strength, modulus, Poisson's ratio and fracture toughness, etc., that are required for the modelling simulation were obtained from the manufacturer's data sheets and from the literature [9, 27] and are given in Table 1.

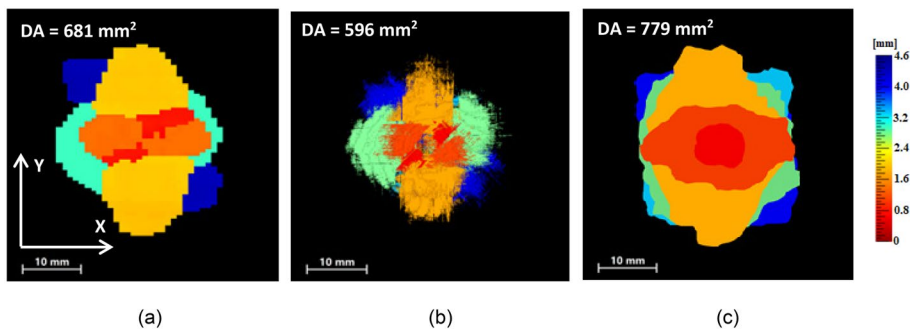
Fig. 6 Typical damage maps in the X–Y plane from **a** the experimental ultrasonic C-scan inspection technique, **b** the experimental X-ray CT technique and **c** the numerical modelling predictions. The impact was on the top surface and the layers are colour-coded from the top (red) surface to the bottom (black) as indicated by the damage depth colour bar

The damage maps from the C-scan and X-ray computed tomography (CT) experimental techniques, and from the numerical simulation predictions, for the delamination footprint, with the associated damage area (labelled ‘DA’), are presented in Fig. 6. The rear surface was selected to be black so that delaminations at different depths through the thickness of the specimen would be more clearly visible. The 0° fibre direction is along the X-direction, i.e. the longest edge of the rectangular 150 × 100 mm specimen. The areal footprint of the damage, i.e. the damage area (labelled ‘DA’), is given at the top left in each case and this

was determined by counting the number of pixels which had a colour that was not black for the damage footprint as a whole as viewed from the top surface. (Delaminations overlap so the total area of delamination between plies would be higher but the delamination footprint is considered as a good indicator of the areal extent of damage.)

The C-scan damage map in Fig. 6(a) is based on ultrasonic wave reflection with a transducer and detector on the upper surface. This process can detect very accurately any separation, i.e. delamination, between the ply interfaces. However, the C-scan spatial resolution is about 1 pixel per mm² and this is evident in the pixelated nature of the C-scan image.

Now, the given damage area was determined for interlaminar damage, i.e. delaminations, in the CFRP panel resulting from the impact event, as shown in Fig. 6. Delaminations initiate and grow at interfaces where the fibre direction is different in the plies below and above the interface. The propagation of the delamination is dominated by the fibre direction of the ply furthest from the impact surface. Localised deformation drives the initiation of matrix cracking and subsequent delamination. Due to the changes in stiffness across the interface between composite plies in different directions, the interfacial shear stresses can drive the crack growth mainly in Mode II (or shear loading) to form a larger delamination area. As the composite specimen has a symmetric layup of $[45_2/-45_2/0_2/90_2]_s$, the interfaces at each change of fibre orientation initiate delaminations which grow in the direction of the fibre on the lower ply, and this gives the characteristic delamination rosette, seen in Fig. 6(a).

Nevertheless, the orientation and relative size of the delaminations, at the respective interfaces, of the composite laminate are very similar from both techniques, see Fig. 6(a) and (b) which have similar colour coding to show the depth of the delamination through the thickness of the composite specimen. In Fig. 6(b) the results from the X-ray CT scan reveal that the striations and other features indicate very clearly that the delaminations are growing in the direction of the plies beneath each ply interface. Figure 6(a) for the C-scan image identifies the delaminations in the same locations through the depth of the composite as the results from the X-ray CT scan and also confirms that the delaminations are growing in the direction of the plies beneath each ply interface. Figure 6(a) for the C-scan and Fig. 6(b) for the X-ray CT scan both show a similar characteristic rosette indicative of the delaminations, observed at the ply interfaces, for the fibre layup of $[45_2/-45_2/0_2/90_2]_s$. Thus, the overall shape and locations of the delaminations are very similar as determined from both the X-ray CT and the ultrasonic C-scan inspection techniques. However, the detail and resolution of the X-ray CT image are much sharper than for the C-scan image, as would be expected.

Figure 6(c) shows the results from the numerical modelling simulations for the delamination damage and a delamination rosette is predicted from these studies with all the features observed from the experimental ultrasonic C-scan and X-ray CT techniques, see Fig. 6(a) and (b) respectively. This is with delaminations occurring at the interfaces between plies and growing in the fibre direction below the ply interface. The overall delamination damage area (DA) appears to be slightly overestimated in Fig. 6(c) but when considering the complexity of the damage processes involved, and the fact that all the main processes of the impact event and damage are captured in the model without any fitting factors, it is considered that the predictions are in very reasonable agreement with the experimental results.

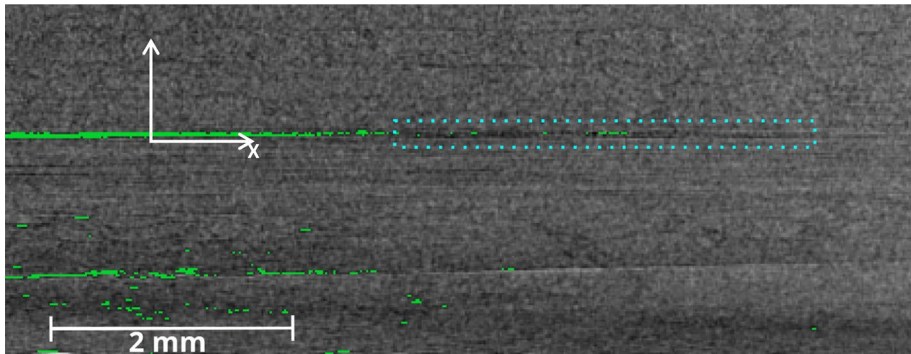
Fig. 7 Enlarged region taken from the edge of the damaged zone in the black and white CT slice in Fig. 4 (indicated by the yellow box) showing the tendency for the segmentation to underestimate the extent of the delamination observed. The dashed-cyan outlined box shows the discontinuous segmentation at the delamination front. Although a linear damage feature can be seen by eye, the change in attenuation and decrease in contrast between the fracture and the background composite makes the feature extremely difficult to segment automatically

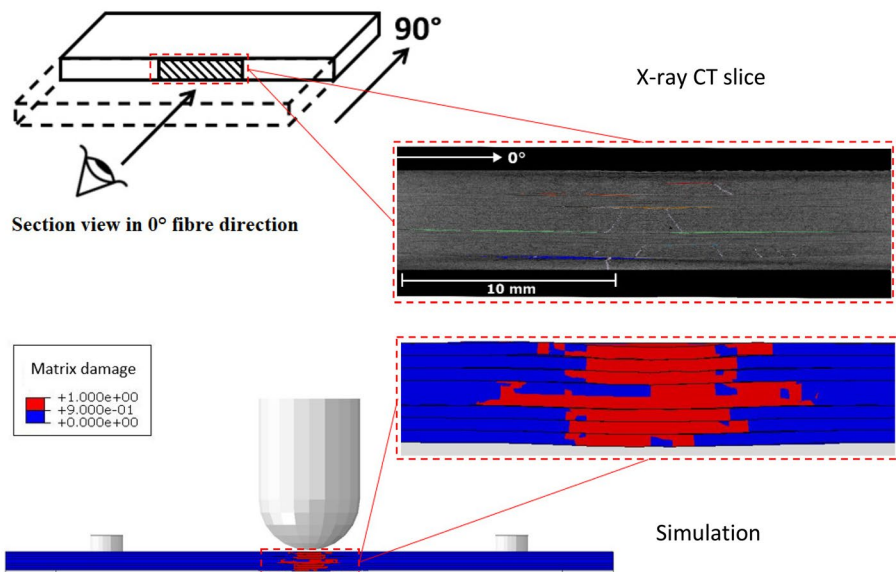
Fig. 8 Intralaminar damage along the 0° fibre direction, comparing the results from the experimental X-ray CT technique with those from the numerical modelling studies. (The text box shows that the value of the damage parameter for intralaminar damage to be initiated in the modelling studies was taken to be equal to, or greater, than 0.9 [9].)

Figure 8 shows an X-ray CT section with intralaminar matrix cracking clearly visible. This is compared with the intralaminar matrix cracking as predicted by the numerical modelling

studies and there is good agreement with respect to the extent and location of the intralaminar matrix cracking. Again, it should be noted that the ultrasonic C-scan technique used is not able to detect matrix cracking, so this is a clear advantage of the X-ray CT imaging technique.

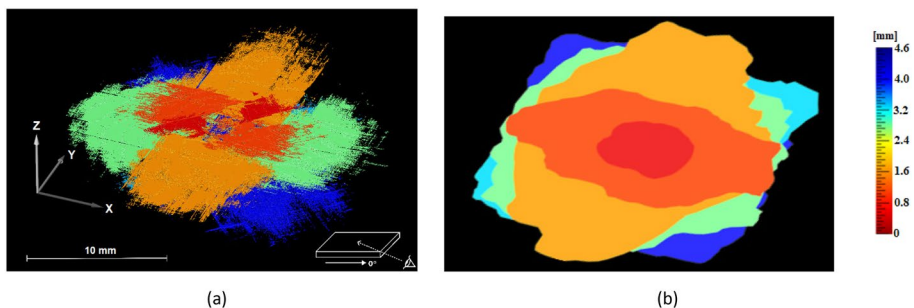
Fig. 9 Interlaminar damage in a 3D view, comparing the results from **a** the experimental X-ray CT technique and **b** the numerical modelling predictions. The impact was on the top surface and the layers are colour-coded from the top (red) surface to the bottom (black) as indicated by the colour bar

Figure 9 compares the experimental X-ray CT data and the predictions from the numerical modelling studies from an isometric viewpoint and illustrates more clearly the orientation of the interlaminar delaminations through the thickness. As described above, striations that are visible in Figs. 6(b) and 9(a), occur where the separation of the delamination is sufficient to give significant change in the attenuation within the measurement voxel. These striations follow the fibre direction in the lower layer. The overall shape and locations of the delaminations are very similar as determined from both the experimental X-ray CT technique (Fig. 9(a)) and the numerical modelling predictions (Fig. 9(b)).

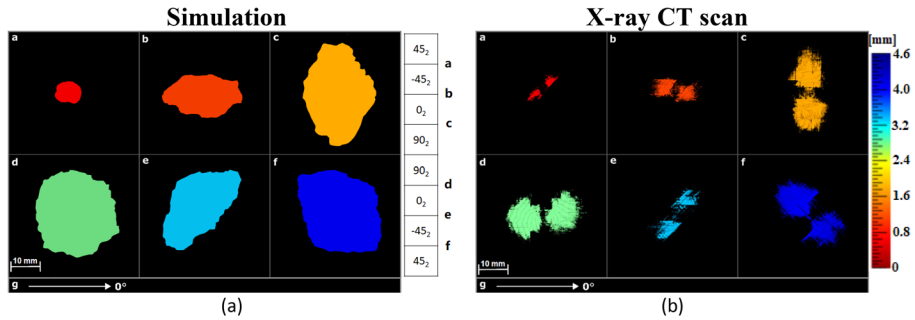
Fig. 10 Interlaminar damage between blocking plies, comparing the results from **a** the numerical modelling with those from **b** the experimental X-ray CT scan

Figure 10 shows the damage numerically predicted and experimentally recorded for the X-ray CT scan for delamination at each of the interfaces between differently oriented plies through the thickness of the composite panel for the present CFRP layup of 45₂, -45₂, 0₂, 90₂, 90₂, 0₂, 45₂, 45₂. The numerical prediction, in Fig. 10(a), shows that delaminations tend to grow in the fibre direction that is present below the interface. For comparison, the experimental X-ray CT scan delamination map is shown in Fig. 10(b) and there is good agreement with the simulation results with respect to the shape and location of such interlaminar damage, although again the experimental X-ray CT technique does appear to underestimate the areal extent of the delaminations.
