MT2503 Download Debug SOP V0.1

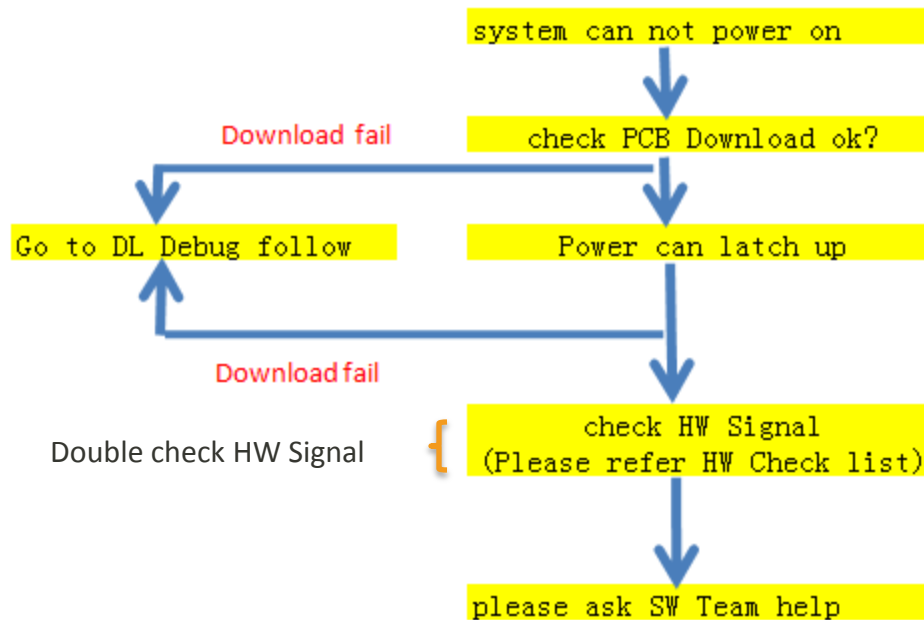
Power on issue Debug Follow1/2

download pass fail HW issue power on debug sop download ok power
ready ok SW log
