TCAS 11 -European RVSM airspace

Editorial

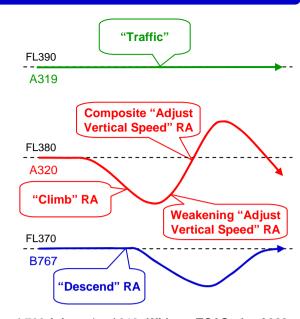
A coordinated "Climb" RA is issued to the A320 and the pilot responds correctly. However, he does not respond to a subsequent weakening "Adjust Vertical Speed" RA and continues climbing. As a result, TCAS declared the A319 above to be a threat and a composite "Adjust Vertical Speed" RA requiring neither to climb nor to descend (i.e. to level-off) is triggered in the A320. The pilot responds by stopping the climb. The A320 receives a "Clear of Conflict" for both threats when it is levelling off. The A320 pilot then resumes the descent to FL320 as previously cleared.

Despite the lack of response by the A320 pilot to the weakening RA, the correct response to the subsequent composite RA ensures that no domino effect RA is triggered for the A319, which only receives a Traffic Advisory.

At the closest point, the A320 passed approximately 1700 ft from the B767 and 700 ft from the A319. Without TCAS, the A320 would have passed through the level of the B767 at a distance of only 1.4 NM.

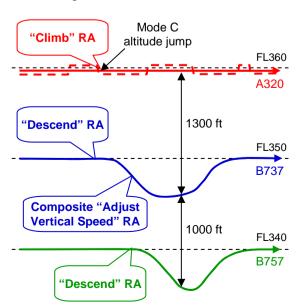
However, the A320 transponder is incorrectly reporting its altitude. Although the aircraft is level, **the altitude reports indicate frequent abnormal 100-foot "jumps"**. As this aircraft is reporting altitude in 25-foot increments, the TCAS on the B737 is tracking some high vertical rate variations for the A320.

One of these erroneous altitude reporting jumps occurred some 30 seconds before the crossing, consequently the TCAS on the B737 computes that the A320 is descending at 3300 fpm and is a threat. A "Descend" RA is then triggered for the B737. This is not a normal TCAS event where aircraft in level flight are separated by 1000 ft.

Finally, aircraft operators are reminded that accurate altitude reporting is a fundamental requirement for effective TCAS safety performance.
