Service Bulletin

Number: A6-87-17

SL-P1200
Compact Disc Player

Number: A6-88-11

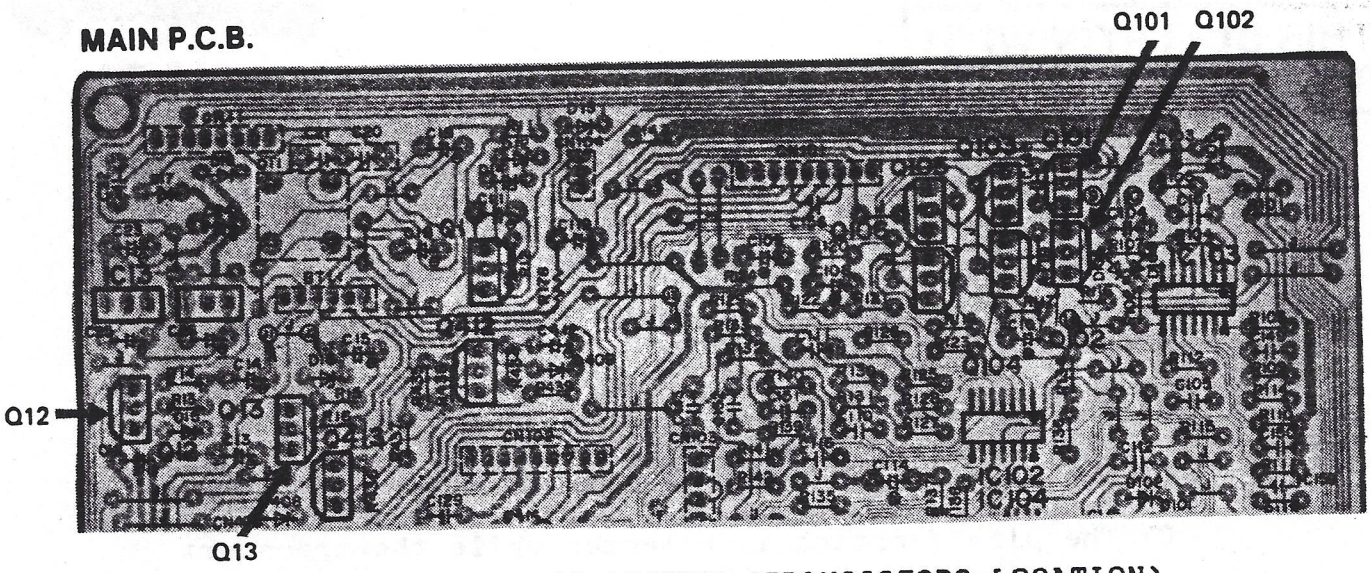
FIGURE 1 - PCB LAYOUT (TRANSISTORS LOCATION)

Symptom: 1) No operation at all.
2) Unit reads the T.O.C. but fails to enter the play mode.

Cause: The spindle drive IC (AN8290S) overheats and locks-up when:

A) The unit is subjected to excessive vibration during play causing the pick-up to skip.
B) The unit is subjected to excessive use of the skip function.
C) The play function is selected while the transport lock shaft is not set free.

Each of the above conditions cause Q12, Q13, Q101, and Q102 to overheat and become damaged. The excessive heat causes the transistor's solder joints to dry and therefore cause poor connection, or solder bridges.

Remedy: 1) Order kit number SZZP1093C. Refer to the kit contents below.
2) Replace the transistors as indicated in Figure 1.
3) Mount the heat sink to IC501 as shown and indicated in Figure 2.

Regardless of customer's complaint, perform the modification on units having serial number suffix up to and including "J", as indicated below:

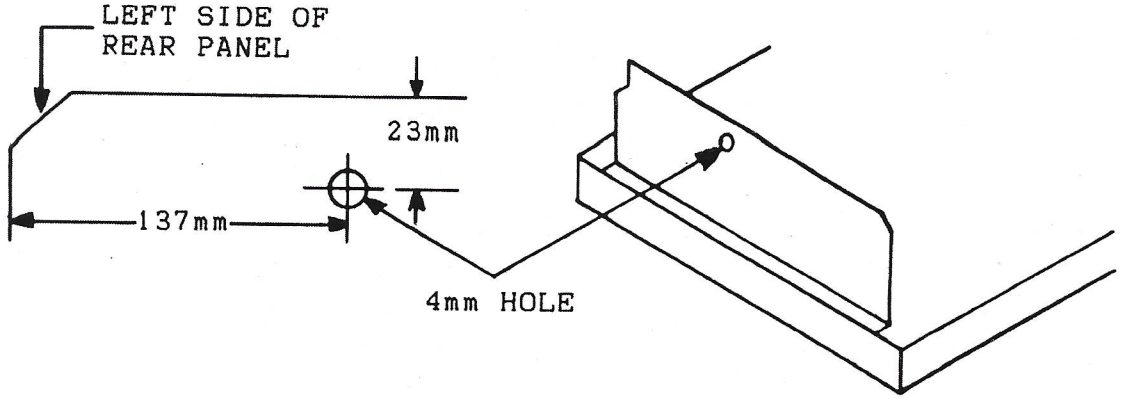
1) A popping noise is heard through the Audio output when PLAY initiates.
2) The PLAY function is accidently interrupted; the pick-up remains at the current location or resets to its rest position. In either case erratic operation is noticed.
3) The unit does not respond to the wired remote control PLAY command.
4) The unit does not read the Disc's TOC or skips occasionally.

1) Improper grounding between this unit and the rest of the system.
2) The control panel is not properly grounded, causing static electricity to affect normal operation.
3) Switch bouncing causes the unit to misinterpret the PLAY key function.
4) Dust accumulates on the optical pick-up lens. The OPEN/CLOSE detection switch may be defective.
